Appendix F

Cheadle Lake Berm TM

Date: October 23, 2023
To: Mel Damewood, III, P.E., Principal Engineer I
West Yost Associates
From: David L. Running, P.E., G.E.
Senior Geotechnical Engineer
Subject: Cheadle Lake Berm Geotechnical Consultation
Project: Albany Water Master Plan
Project No.: 2221130

DATE: March 22, 2024
TO: Ryan Beathe, PE, City of Albany
CC: Ian Jaffe, Brown and Caldwell, PE 99388
FROM: Alan Peck, Brown and Caldwell, PE 16289
and Jon Harper, Brown and Caldwell, PE 70738
REVIEWED BY: Mel Damewood, West Yost, PE 13672
SUBJECT: Condition Assessments - Santiam Albany Canal
Ancillary Facilities

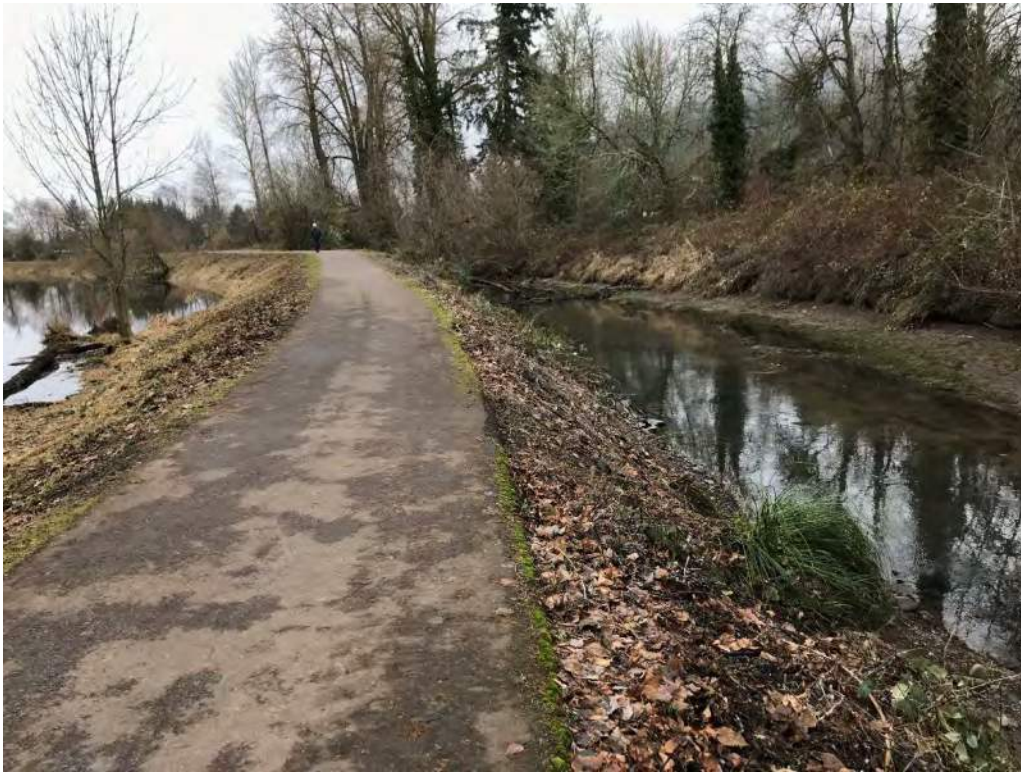
Photo 1. View of the berm at Point A (Figure 1) facing northwest.

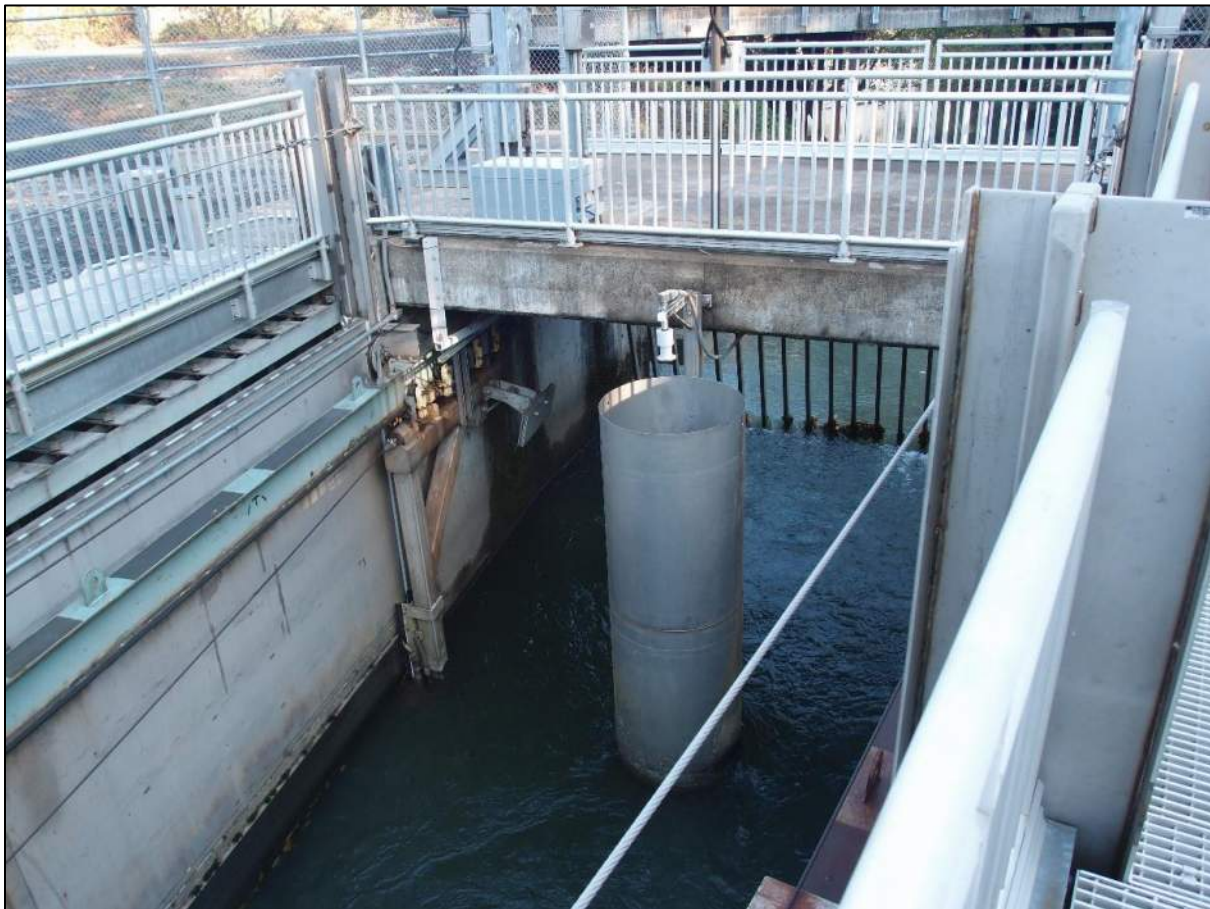
- The hydropneumatics tank and pump system for washdown water is non-functional. Pumps keep burning out and the City staff is not using it.
- The fish screens meet NOAA criteria (See Figure 2). The baffles are adjusted every 5 years and a flow test performed. The screens function well.
- The gate actuators were recently replaced by Beck actuators and are considered very reliable.
- Concrete masonry building and cast-in-place structures present minor evidence of degradation, consistent with the age of the structures. This includes minor cracking at/around the concrete structures as well as rusting at bolt locations.

Figure 2. Fish Screens at Canal Inlet

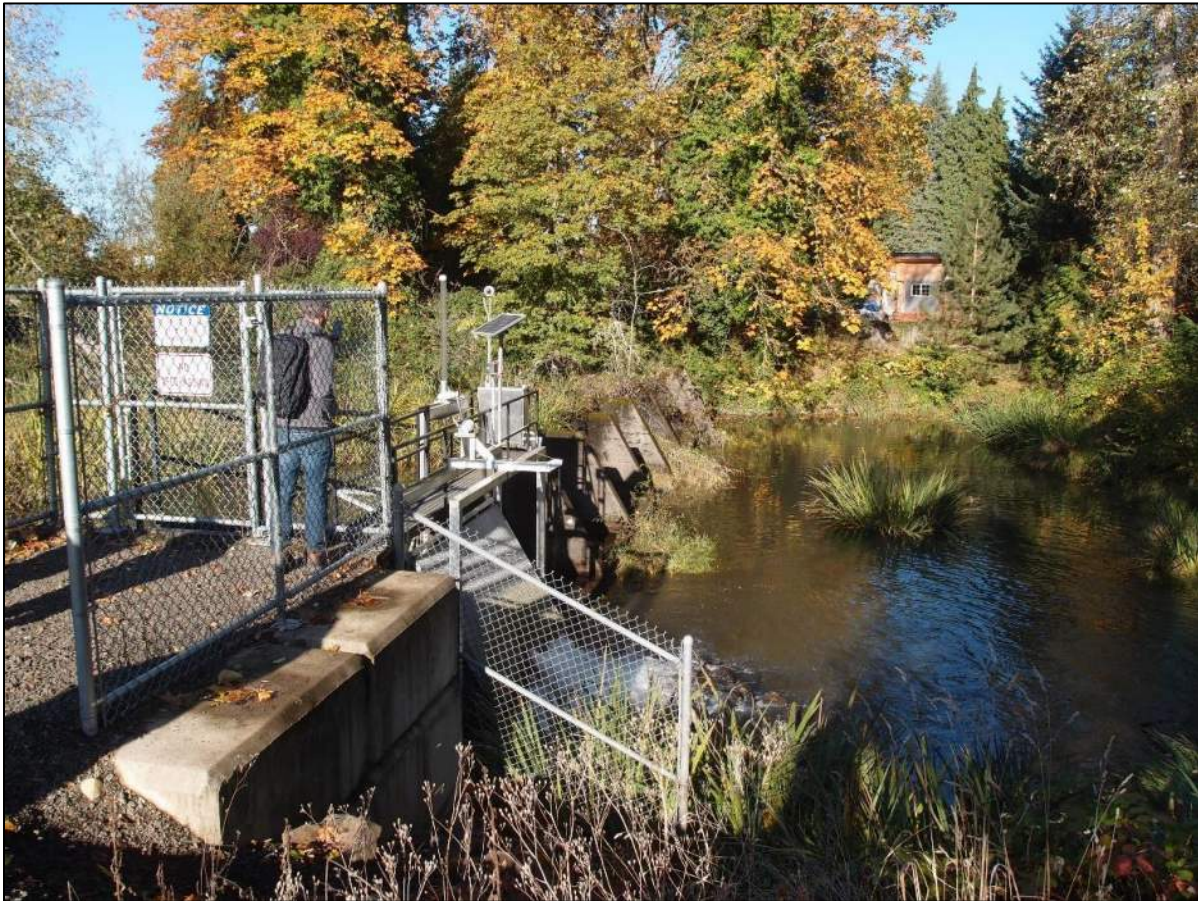
The Marks Slough Diversion (see Figure 3) was upgraded in 2017 and is in good condition and functioning well.

Overall Rating – 2 to 3

- Slide gate, diversion weir, and access platform are in good condition.
- Fish upstream exclusion screen is in good condition and functions well.
- Access was limited for structural observation at this location. Reinforced concrete structure presents minor/moderate evidence of degradation. Minor cracking, general concrete erosion and rusting at select steel members was noted. The score range was extended to a 3 to account for general maintenance and monitoring of cracks that should be implemented if this facility is intended to be used for an extended period.

Figure 3. Mark's Slough Diversion

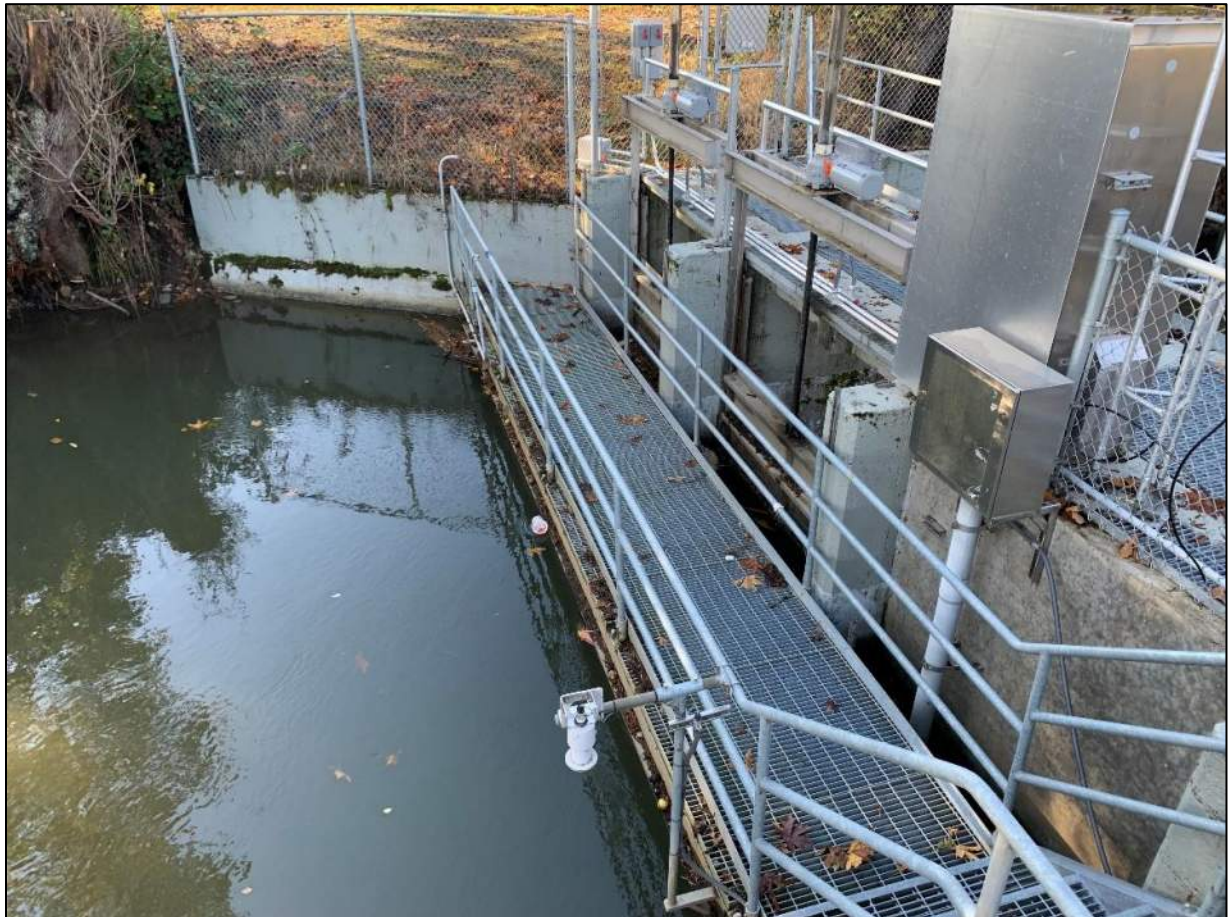
- The gate actuators are EIM. Spare parts are hard to obtain, according to City O&M staff.
- The gates cannot be controlled by SCADA system. Additional equipment is needed for remote control.
- Very minor spalling and cracking of concrete at select locations at structure was noted. Structure noted to be in good condition besides these very minor observations.

Figure 4. Albany Gates

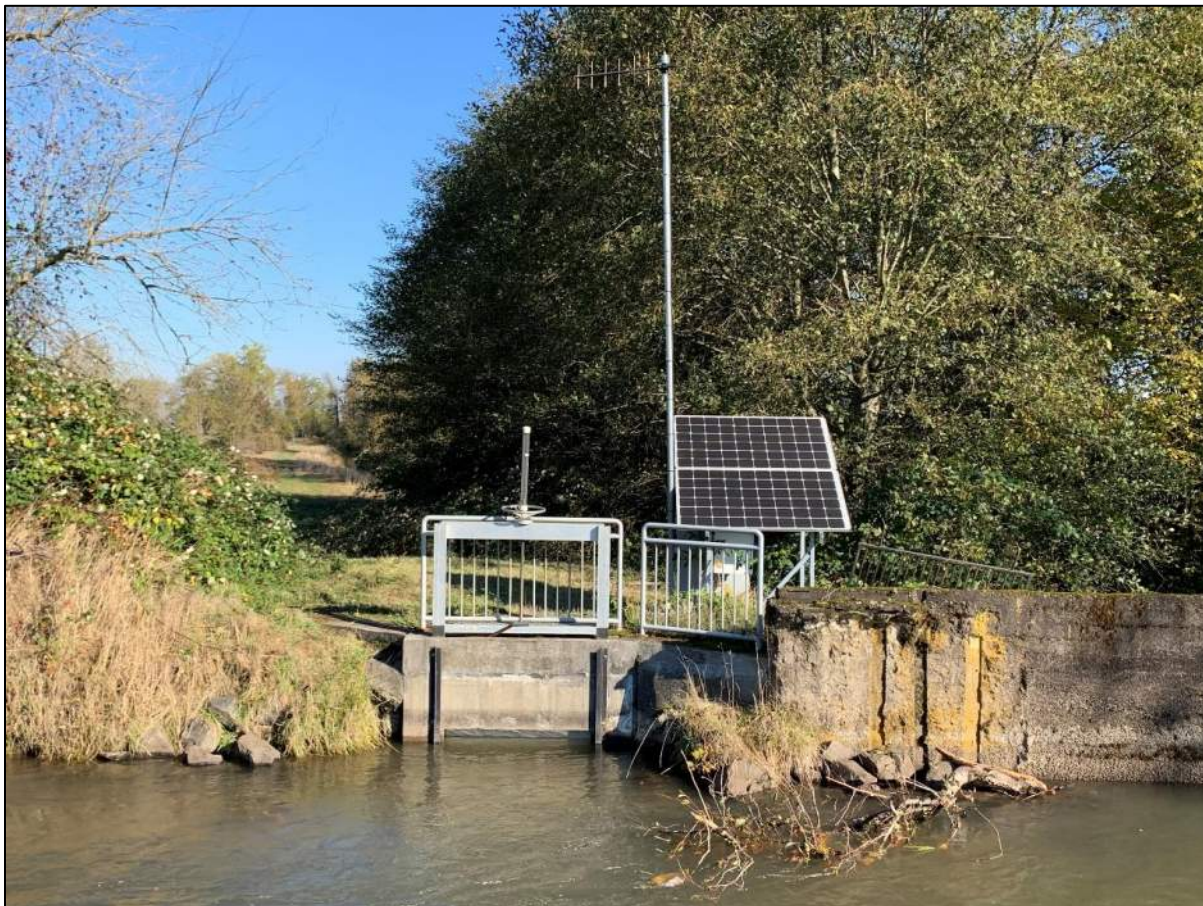
- SCADA links are not working so the O&M staff must visit the sites to collect flow data.
- The bar screens were intended to be cleaned manually, but the sites are too remote to make this feasible. The bar screens have been removed; however, they are not needed.
- The Periwinkle Creek flow diversion is adjacent to a suburban residential area. Fencing the area may help prevent damage and vandalism.

Figure 5. Cox Creek Diversion

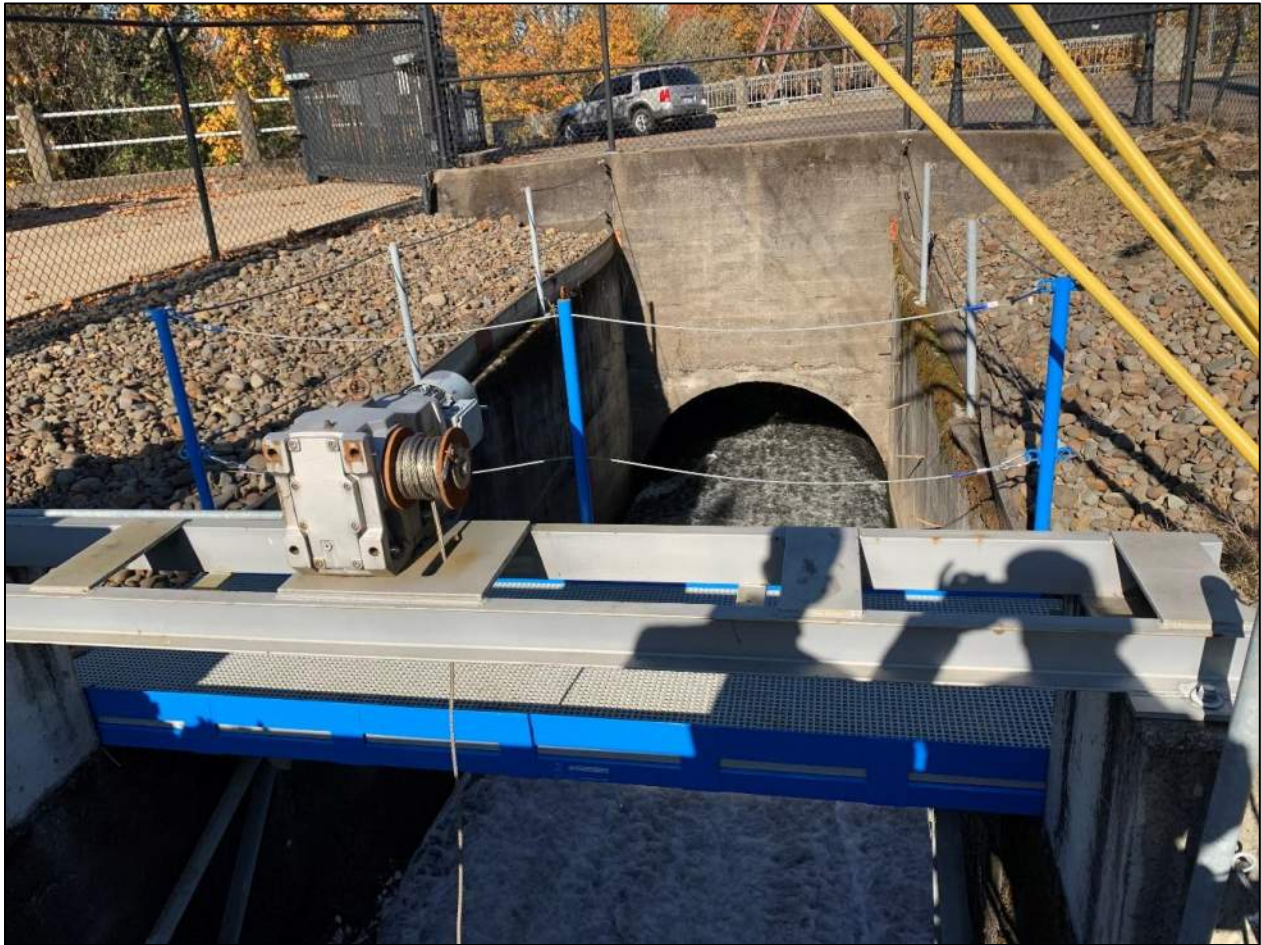
- The outfall channel is concrete dating to 1912 but appears in good condition.
- The radial gate (see Figure 6) was structurally analyzed in 2016 and found to be satisfactory.
- There is an open water hazard where the bar screens are cleaned manually with a rake. Fall protection for this activity is recommended.
- Minor spalling, cracking and general degradation of concrete at select locations at structure was noted. Structure noted to be in good condition besides these very minor observations.

Figure 6. Vine Street Radial Gate Operator and Outfall

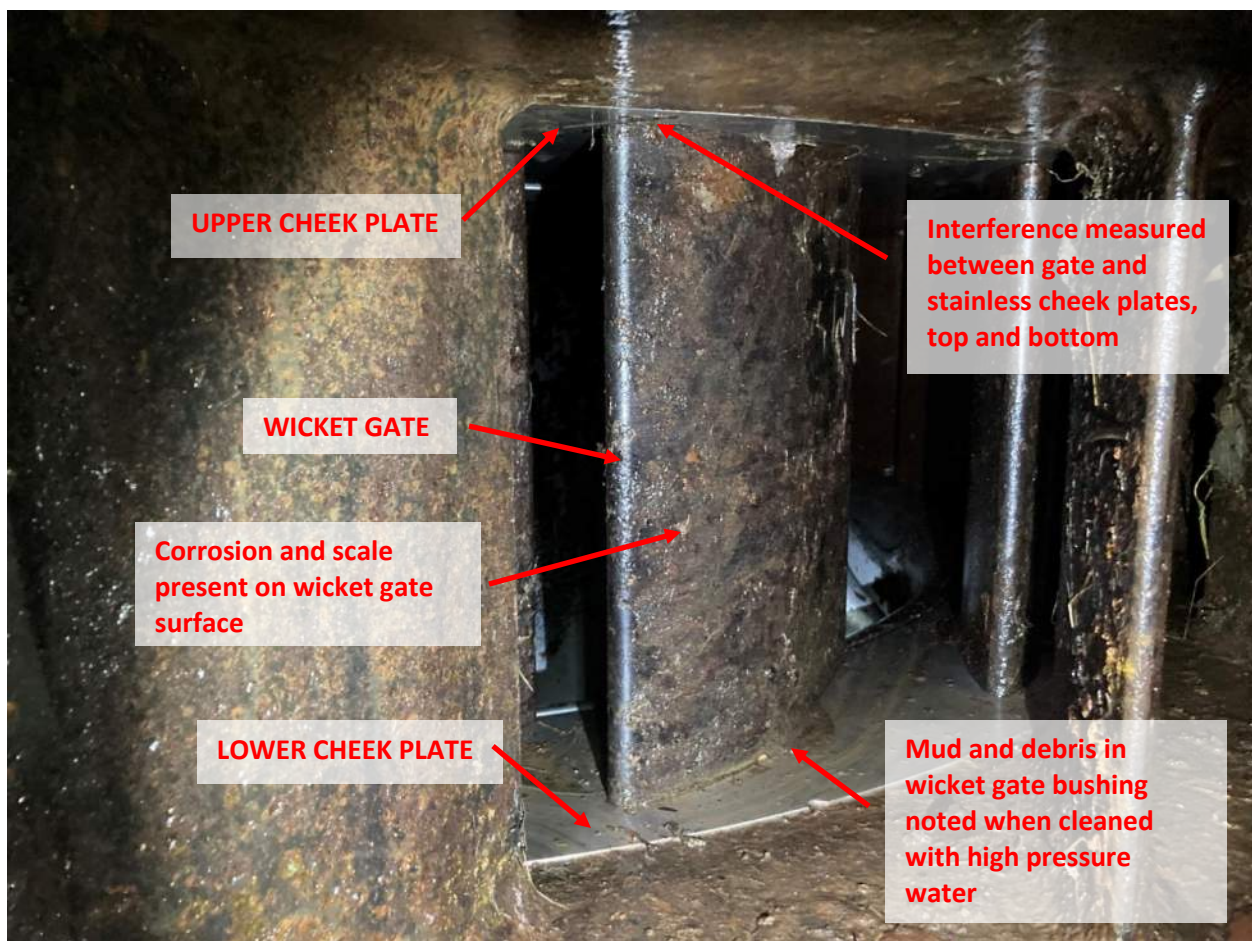
Figure 1. Typical View of the Wicket Gate Showing Corrosion on the Blade Surface and General Locations of Interference and Probable Binding

Several solutions exist to return the wicket gate system to a well-functioning system. The most robust solution would be to manufacture new wicket gates from a corrosion resistant alloy such as stainless steel, as well as manufacture new greaseless wicket gate bushings which contain a seal to better isolate debris from the system. Other solutions include installing stainless steel sleeves onto the existing wicket gate journals along with new greaseless wicket gate bushings. The sleeve technique comes with some risk due to the decreased base metal diameter and related increased stress. Estimated costs for these options are provided below.

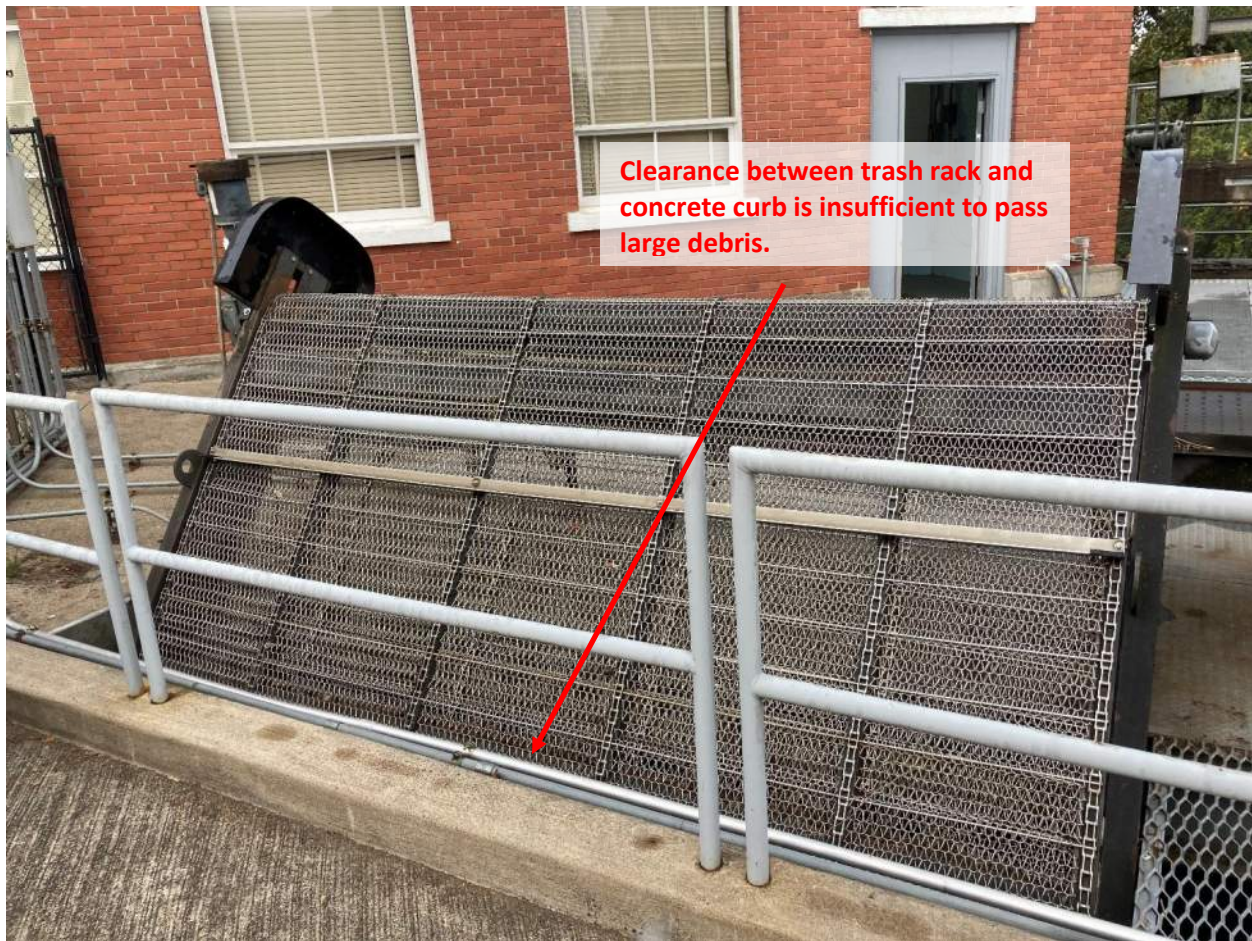
Figure 2. A View of the Upstream Side of the Trash Rack Showing Little Clearance for Large Debris Removal

It is recommended that a cost benefit analysis be done to determine if moving the trash rack slightly down stream could be a viable solution to alleviate problems associated with removing large debris from the forebay. An alternate approach could involve installation of a finer screen upstream of the trash rack and/or a boom to direct large floating debris away from the turbine intake. Further, it is recommended that either the timing on the trash be adjusted to allow for more frequent cleaning, or that the trash rack be actuated by a signal from the controls based on forebay head level.

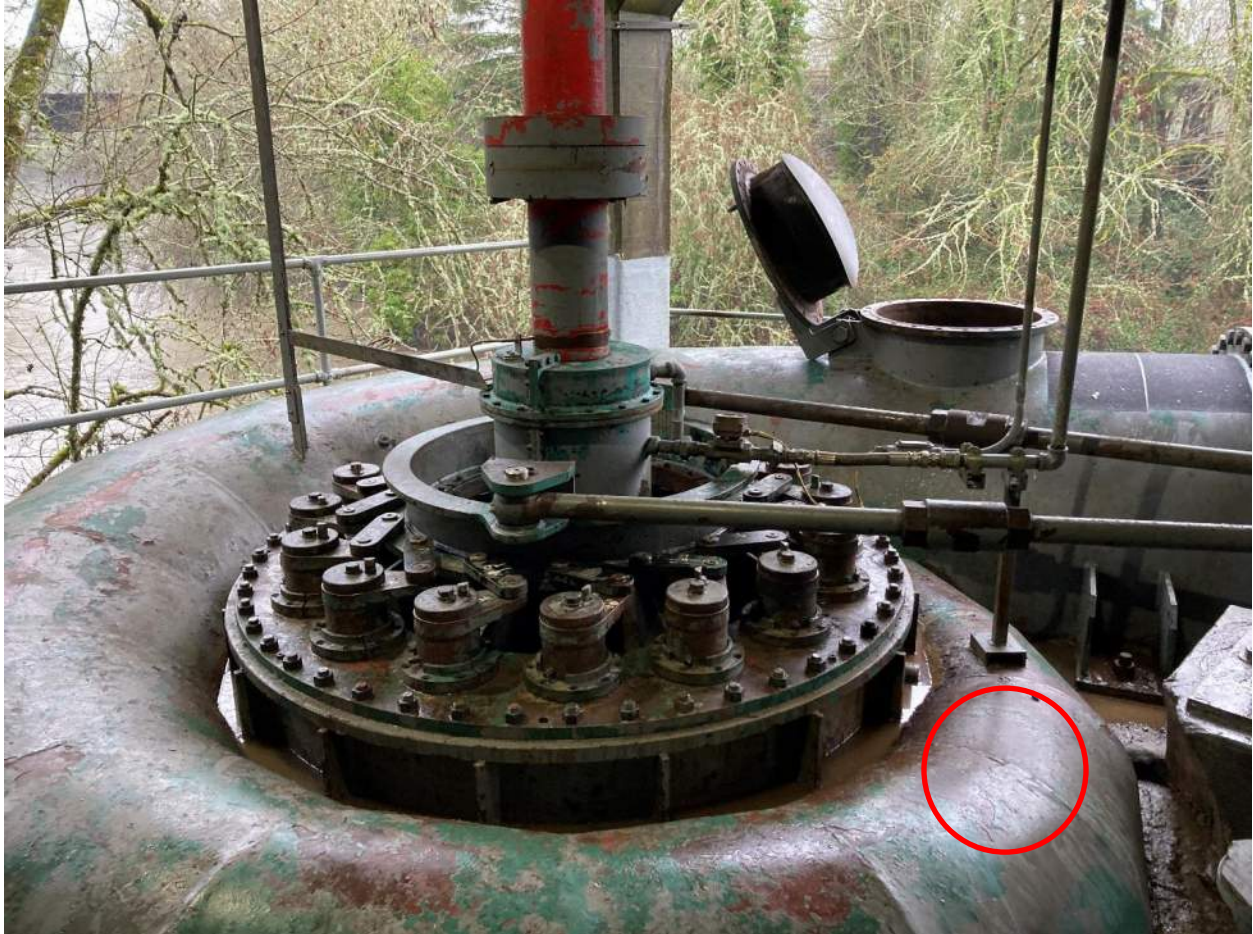
Observations taken in the spiral case indicate that quite a bit of debris passes through the turbine. It is apparent that cleaning the smallest portions of the turbine case of debris is problematic due to the small size of the piping in that area and cramped working conditions. It is recommended that a cleanout flange be installed in the spiral case to facilitate access to this area for removal of debris and inspection.

Figure 4. Approximate Location of the Recommended Cleanout Flange Location on the Spiral Case

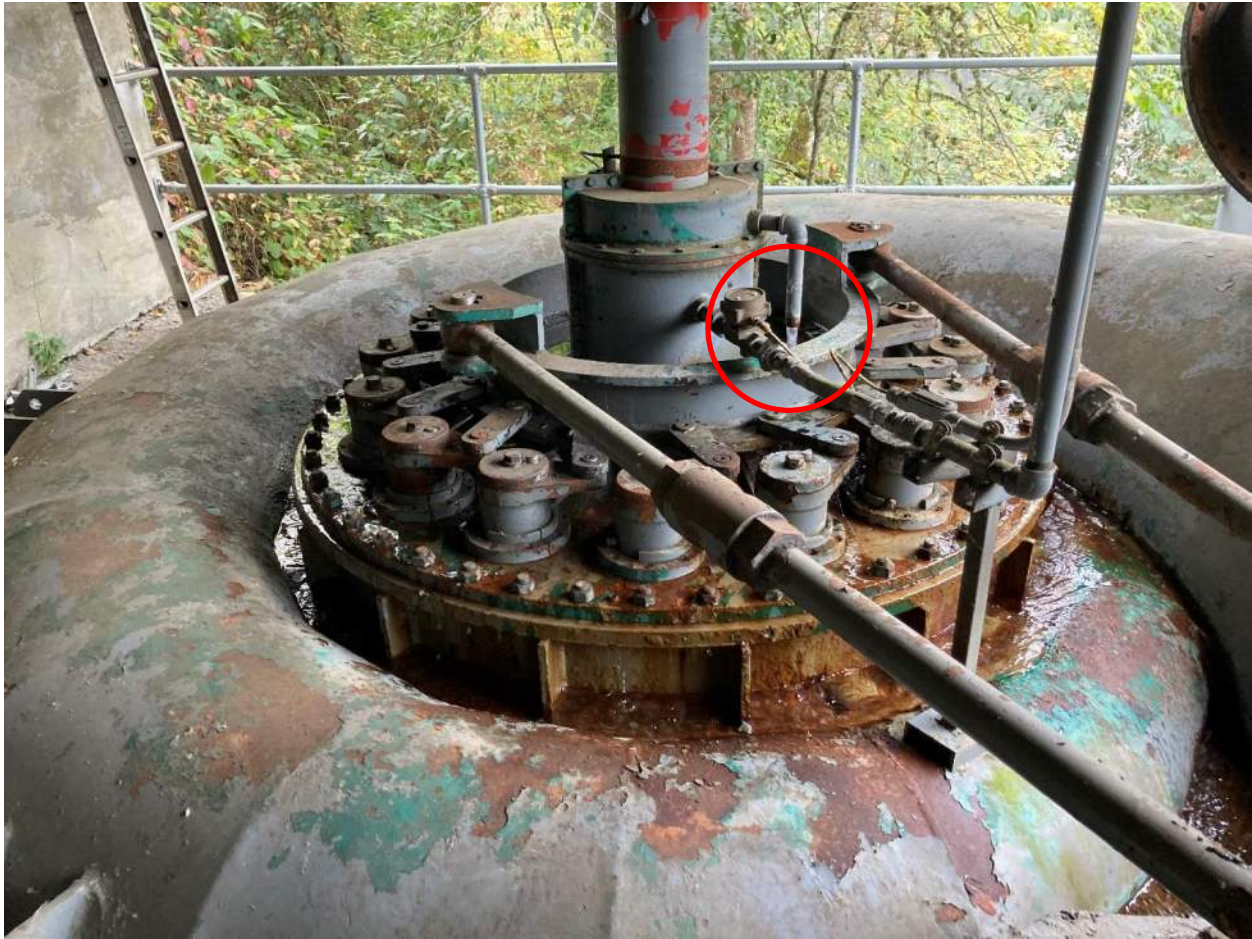
Cooling water for the turbine bearing was observed to be discharging directly onto the turbine headcover. This condition appeared to be contributing to coating failure and corrosion of the headcover and surrounding components. It's possible this could also be contributing to corrosion of the wicket gates shaft in the upper wicket gate bushing journal and ultimately difficult operation of the wicket gates. It was recommended that the cooling water discharge be directed away from the turbine and to a properly configured drain to handle the process water. The City staff has since rerouted the cooling water away from the Turbine.

**Figure 5. Turbine Bearing Cooling Water Discharge Location.
Flooding of Turbine Headcover and Spiral Case is Visible**

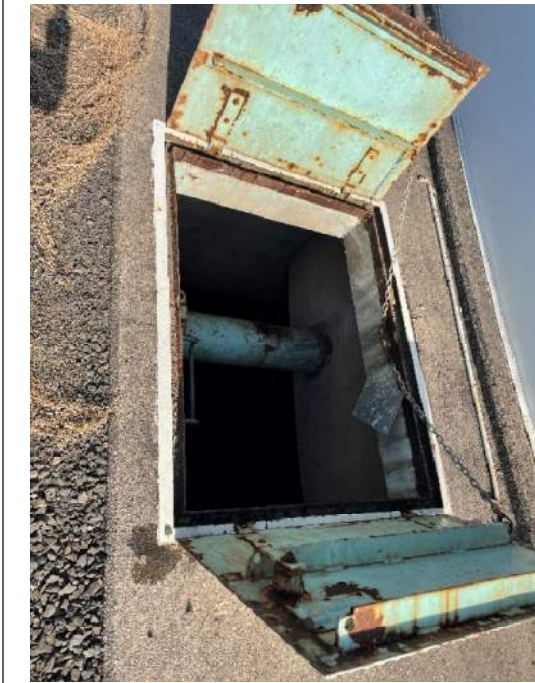
Photo 4-2-1
34th St - Flow Meter Vault – Hatch Corrosion

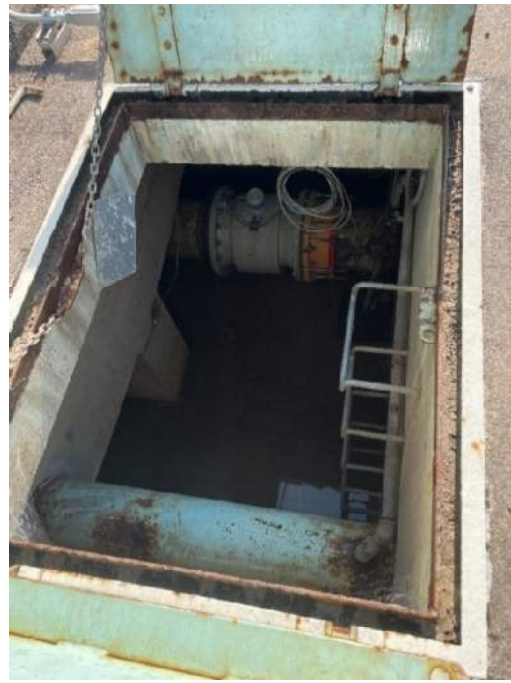
Photo 4-2-2
34th St - Flow Meter Vault – Standing Water

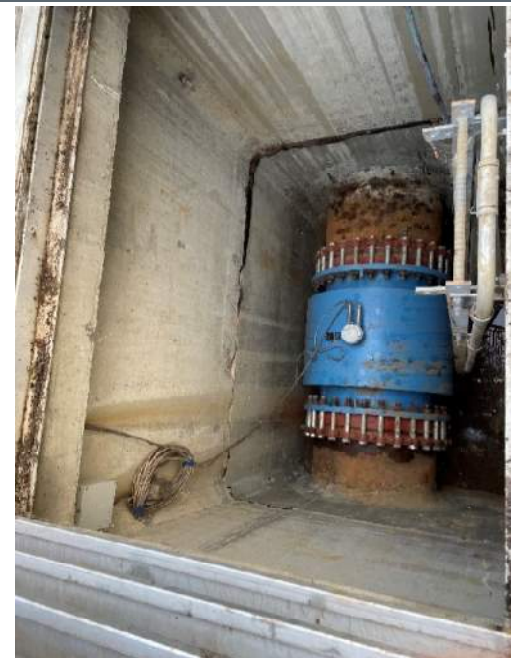
Photo 4-2-4
Broadway – Flow Meter Vault – Standing Water

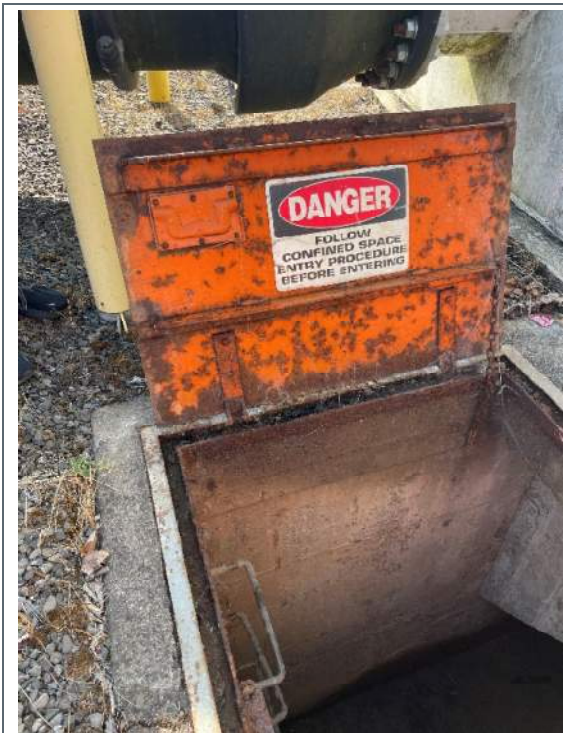
Photo 4-2-5
Maple St – Reservoir Vault - Hatch & Ladder Corrosion

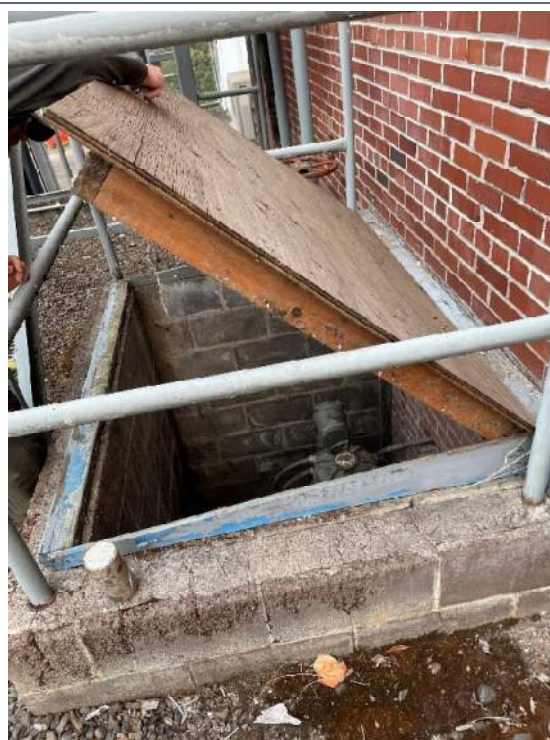
Photo 4-2-8
Vine St - RWPS Valve Vault – Wood Lid

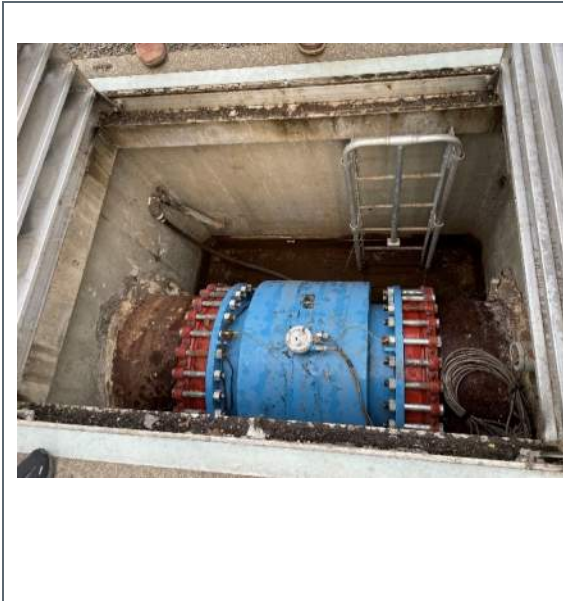
Photo 4-2-9
Vine St – RWPS Meter Vault – Standing Water

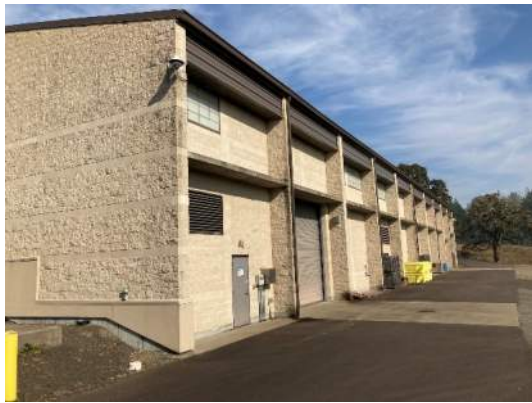
Photo 4-3-7
A&M WTP – Clear Gutters, Clean & Seal CMU Wall

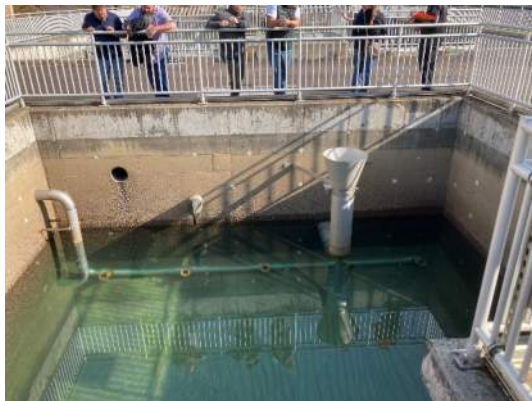
Photo 4-3-9
A&M WTP – Coat Exposed Aggregate in Neutralization Basin

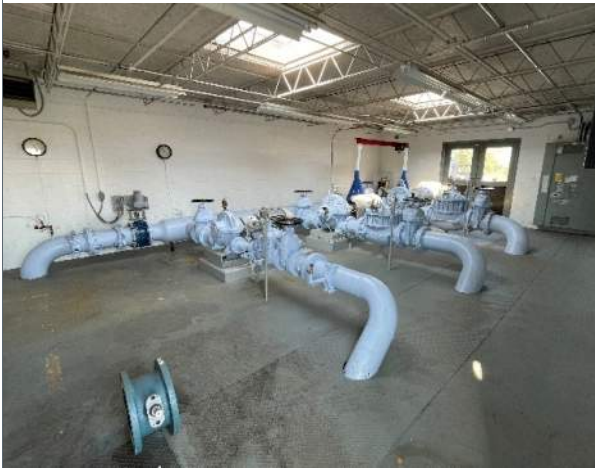
Photo 4-4-1
34th St PS- Piping - Add Pipe Supports

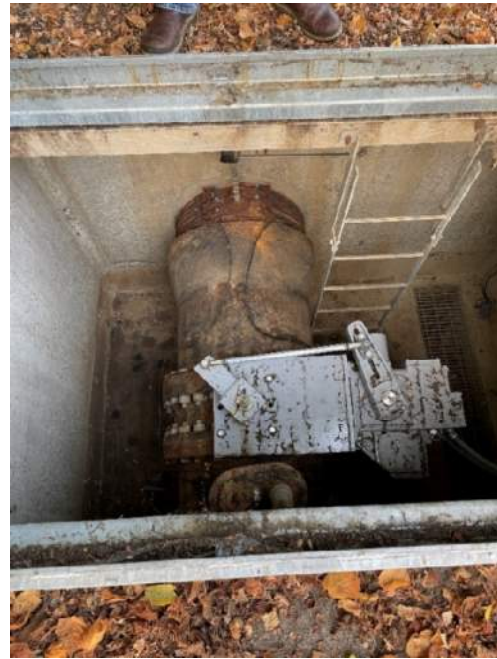
Photo 4-4-2
Broadway – Valve Vault – Rusty Piping

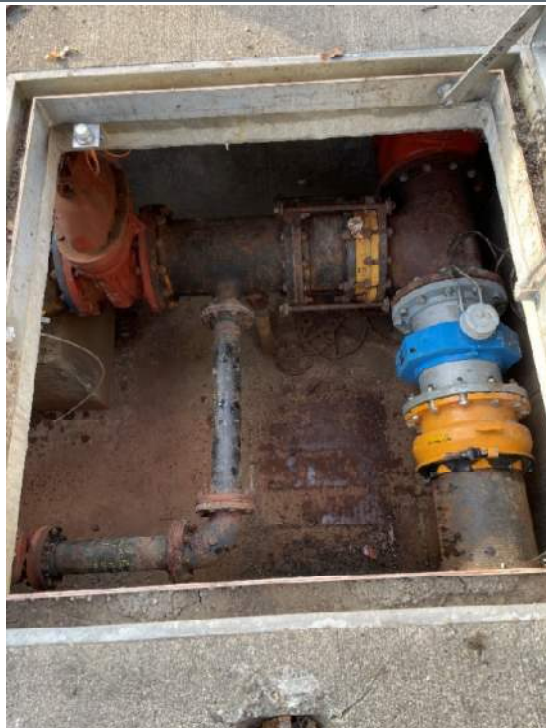
Photo 4-4-3
Gibson Hill – Flow Meter Vault – Rusty Piping

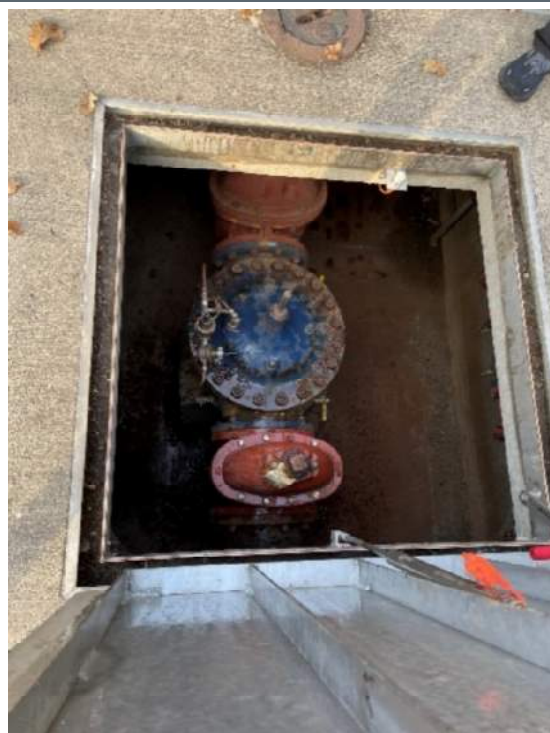
Photo 4-4-4
Gibson Hill – Valve – Rust & Bolts

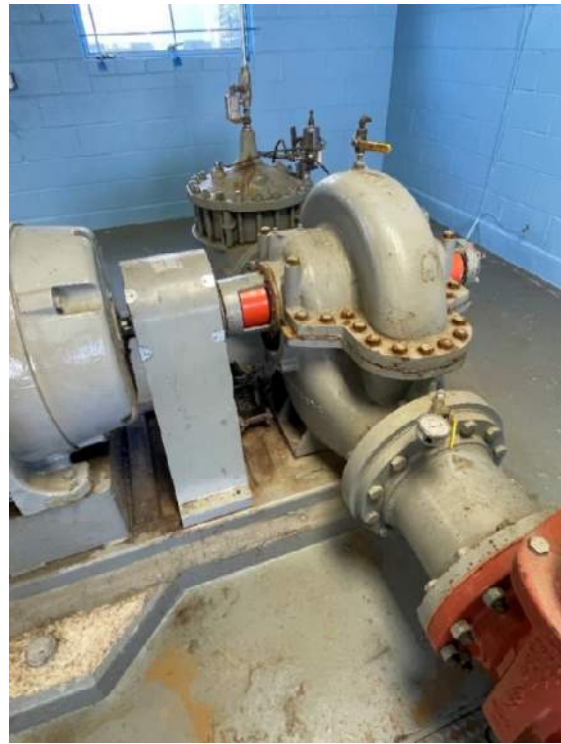
Photo 4-4-5
Maple PS – Pipe - Coating Damage

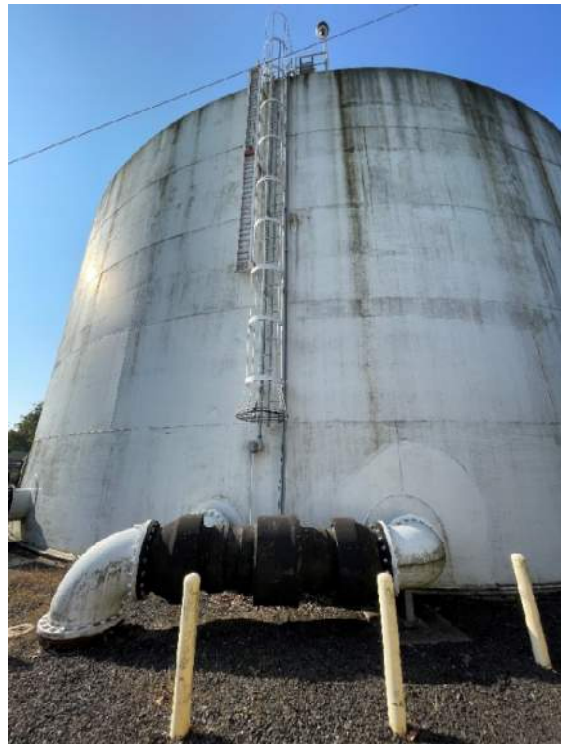
Photo 4-4-6
Maple PS – Reservoir – Worn Coating

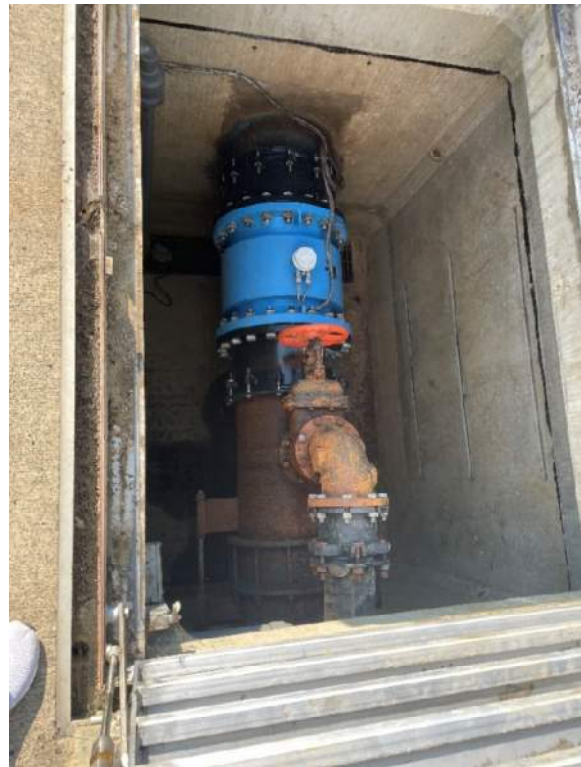
Photo 4-4-7
Maple – Valve Vault – Rusty Piping

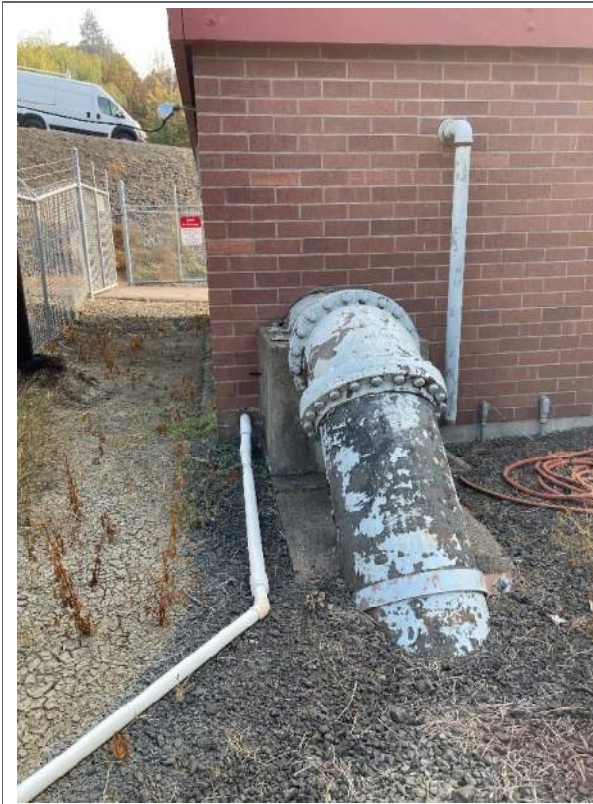
Photo 4-4-8
North Albany – Exterior PS Piping – Chipped Coating

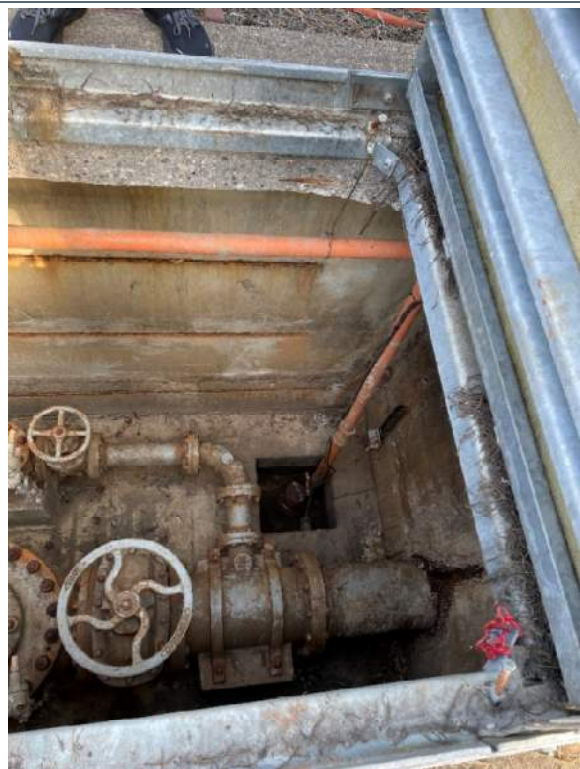
Photo 4-4-9
North Albany – Valve Vault – Rusty Piping

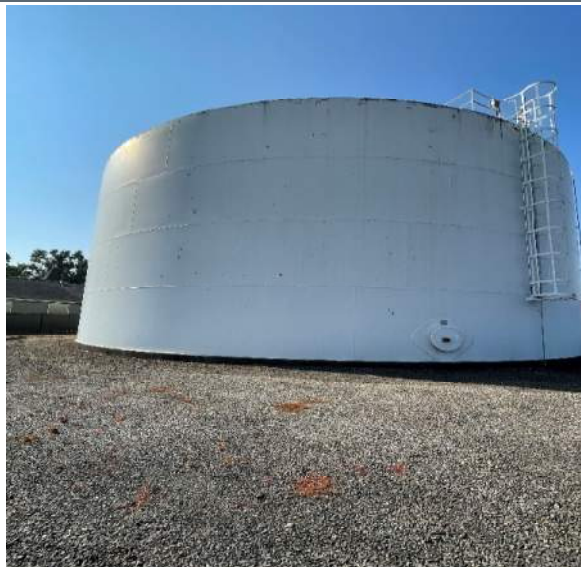
Photo 4-4-10
Queen Ave – Reservoir Paint Chipping

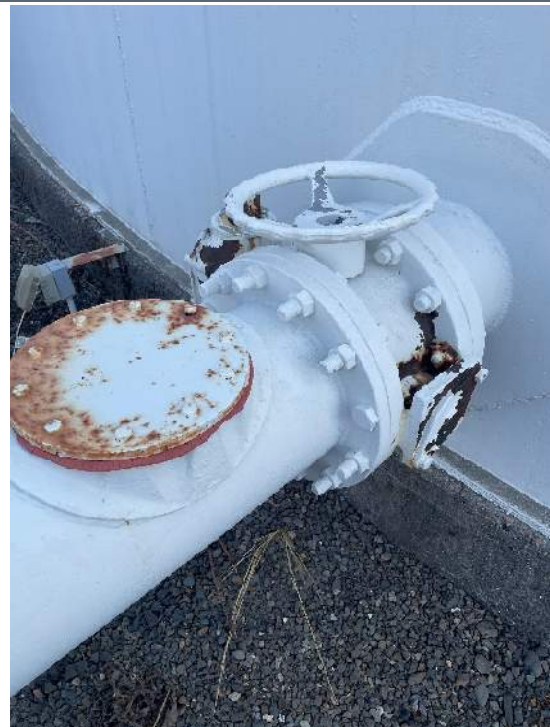
Photo 4-4-11
Queen Ave Reservoir – Rusty Piping

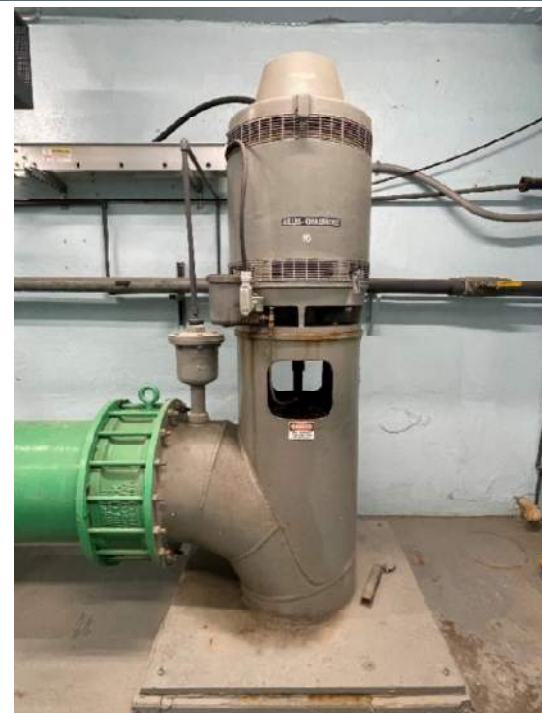
Photo 4-4-14
Vine St – Backwash Pump – Cracked Concrete Base

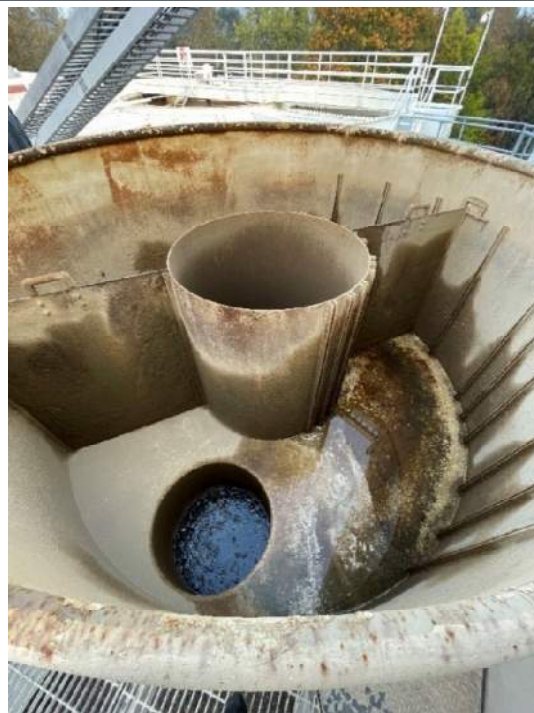
Photo 4-4-15
Vine St – Splitter Box - Rust

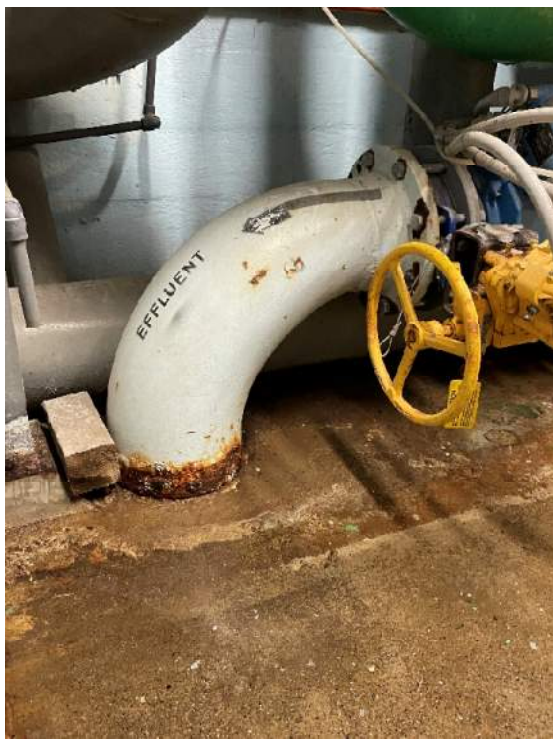
Photo 4-4-16
Vine St – Pipe Gallery – Corrosion & Rust

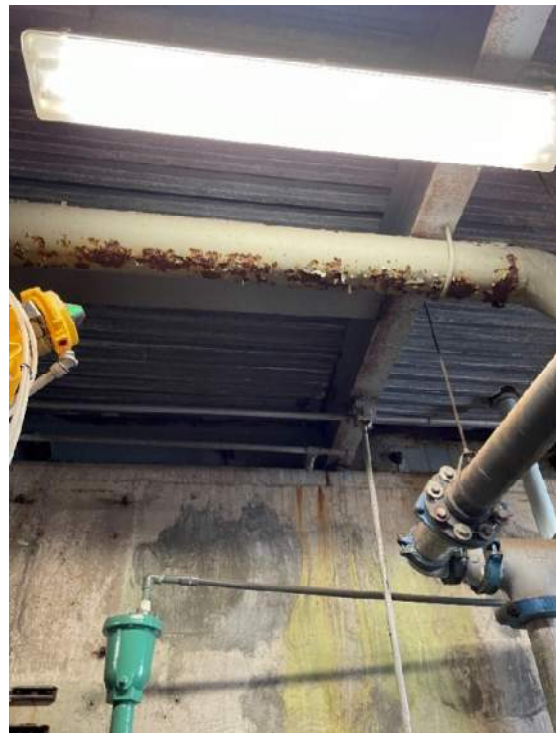
Photo 4-4-17
Vine St – Pipe Gallery – Corrosion & Rust

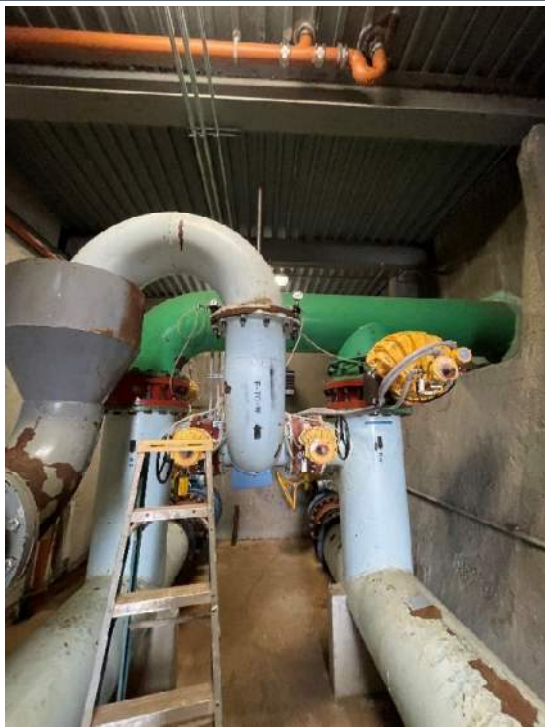
Photo 4-4-18
Vine St – Pipe Gallery – Corrosion & Rust

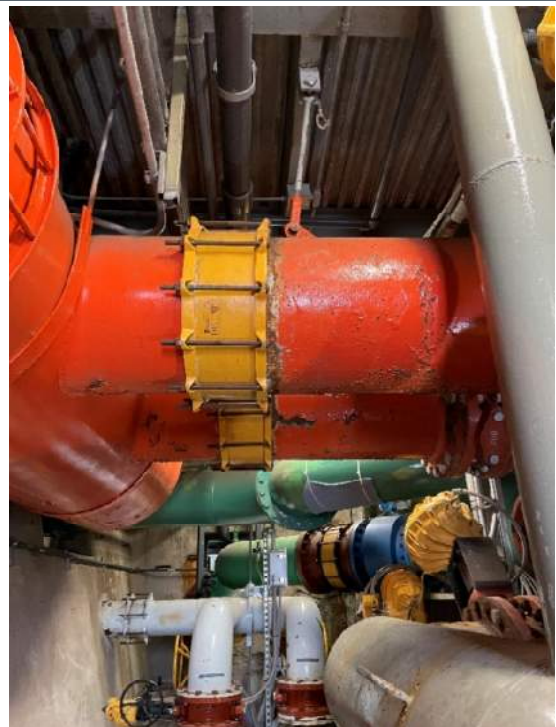
Photo 4-4-19
Vine St – Pipe Gallery – Corrosion & Rust

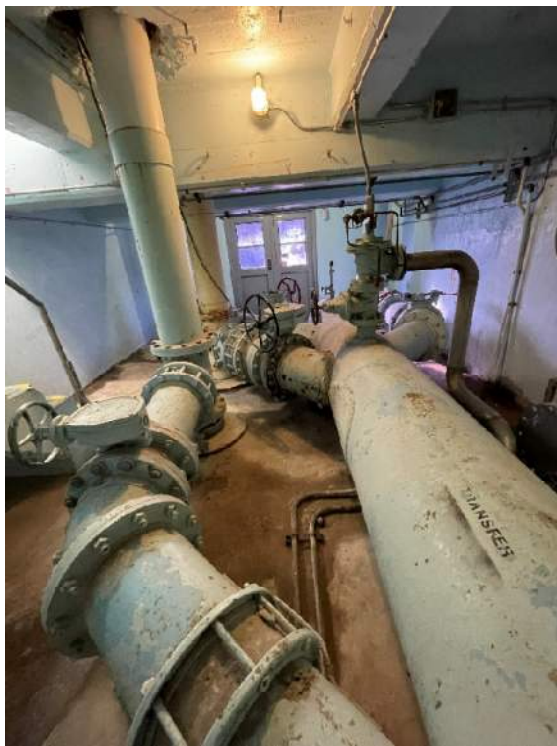
Photo 4-4-20
Vine St – FWPS Pipe Gallery – Corrosion & Rust
