Appendix F

Cheadle Lake Berm TM

Date: October 23, 2023
To: Mel Damewood, III, P.E., Principal Engineer I
West Yost Associates
From: David L. Running, P.E., G.E.
Senior Geotechnical Engineer
Subject: Cheadle Lake Berm Geotechnical Consultation
Project: Albany Water Master Plan
Project No.: 2221130

DATE: March 22, 2024
TO: Ryan Beathe, PE, City of Albany
CC: Ian Jaffe, Brown and Caldwell, PE 99388
FROM: Alan Peck, Brown and Caldwell, PE 16289
and Jon Harper, Brown and Caldwell, PE 70738
REVIEWED BY: Mel Damewood, West Yost, PE 13672
SUBJECT: Condition Assessments - Santiam Albany Canal
Ancillary Facilities

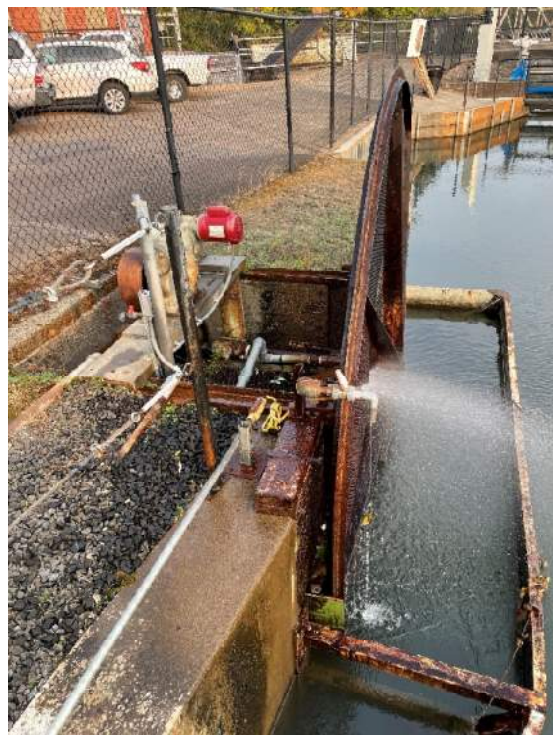
Photo 4-4-21
Vine St – RW Screen – Rust

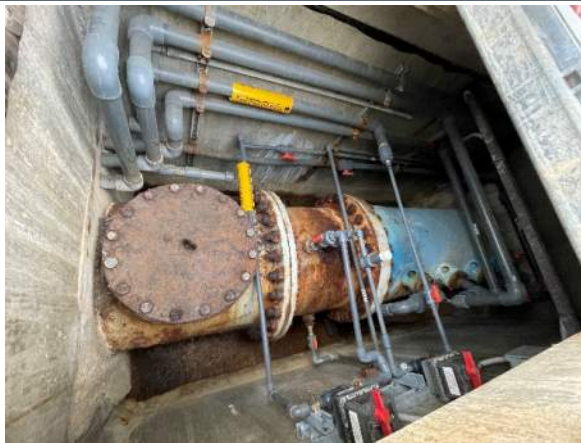
Photo 4-4-22
Vine St – Chemical Injection Vault – Rusty Piping

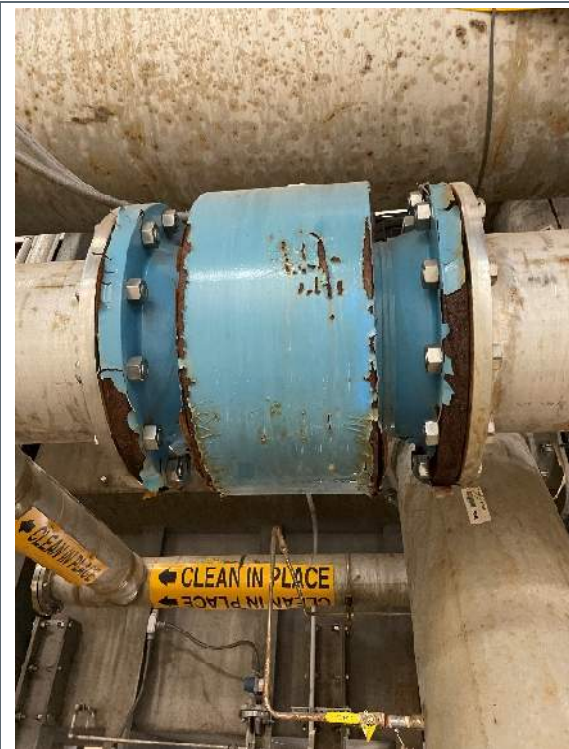
Photo 4-4-24
A&M WTP – Filtrate Flow Meter - Rust

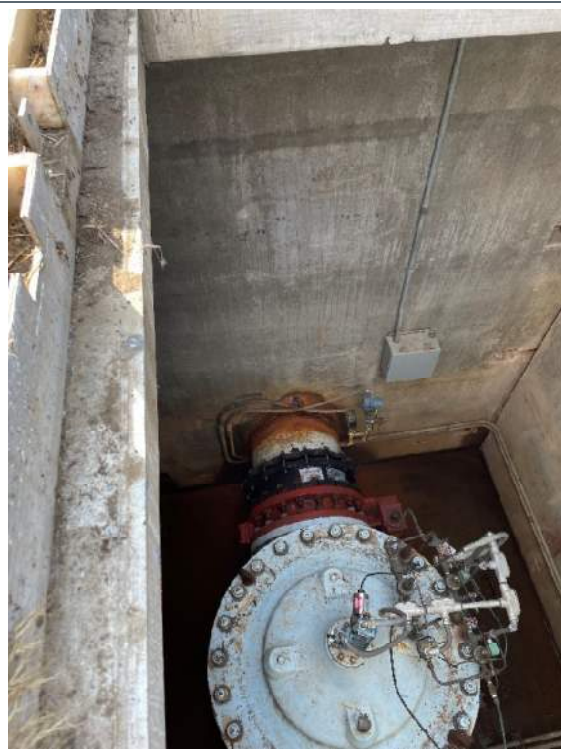
Photo 4-4-25
A&M - Albany Metering Vault – Rusty Piping

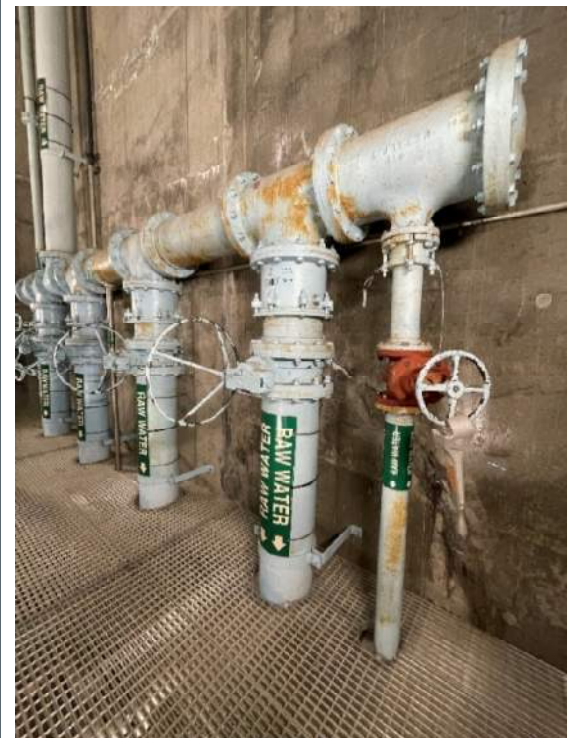
Photo 4-4-26
A&M Intake Structure – Piping Discoloration

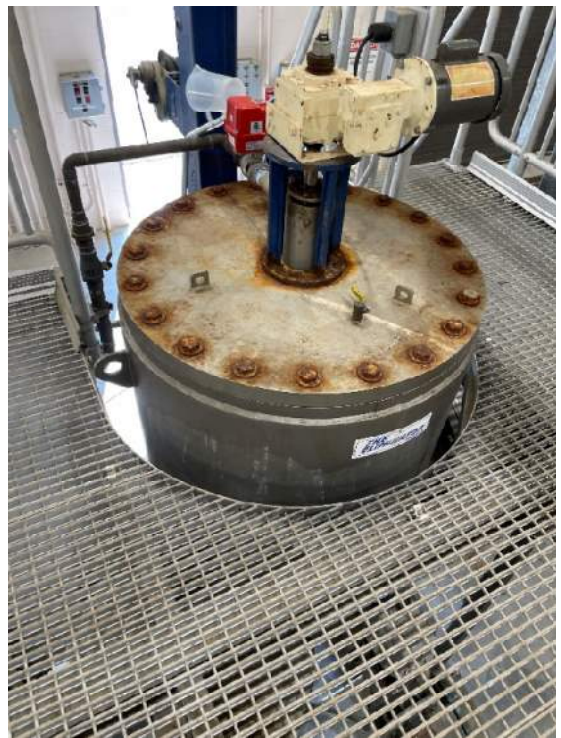
Photo 4-4-27
A&M WTP – Strainers – Rusty Disimilar Metals

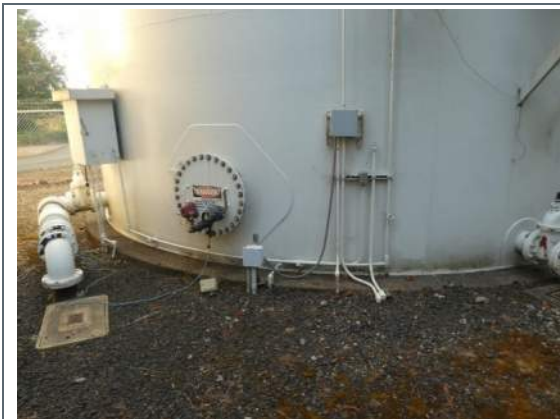
Photo 4-5-9
Valley View – Level Sensor without Heat Trace
