Appendix F

Cheadle Lake Berm TM

Date: October 23, 2023
To: Mel Damewood, III, P.E., Principal Engineer I
West Yost Associates
From: David L. Running, P.E., G.E.
Senior Geotechnical Engineer
Subject: Cheadle Lake Berm Geotechnical Consultation
Project: Albany Water Master Plan
Project No.: 2221130

DATE: March 22, 2024
TO: Ryan Beathe, PE, City of Albany
CC: Ian Jaffe, Brown and Caldwell, PE 99388
FROM: Alan Peck, Brown and Caldwell, PE 16289
and Jon Harper, Brown and Caldwell, PE 70738
REVIEWED BY: Mel Damewood, West Yost, PE 13672
SUBJECT: Condition Assessments - Santiam Albany Canal
Ancillary Facilities

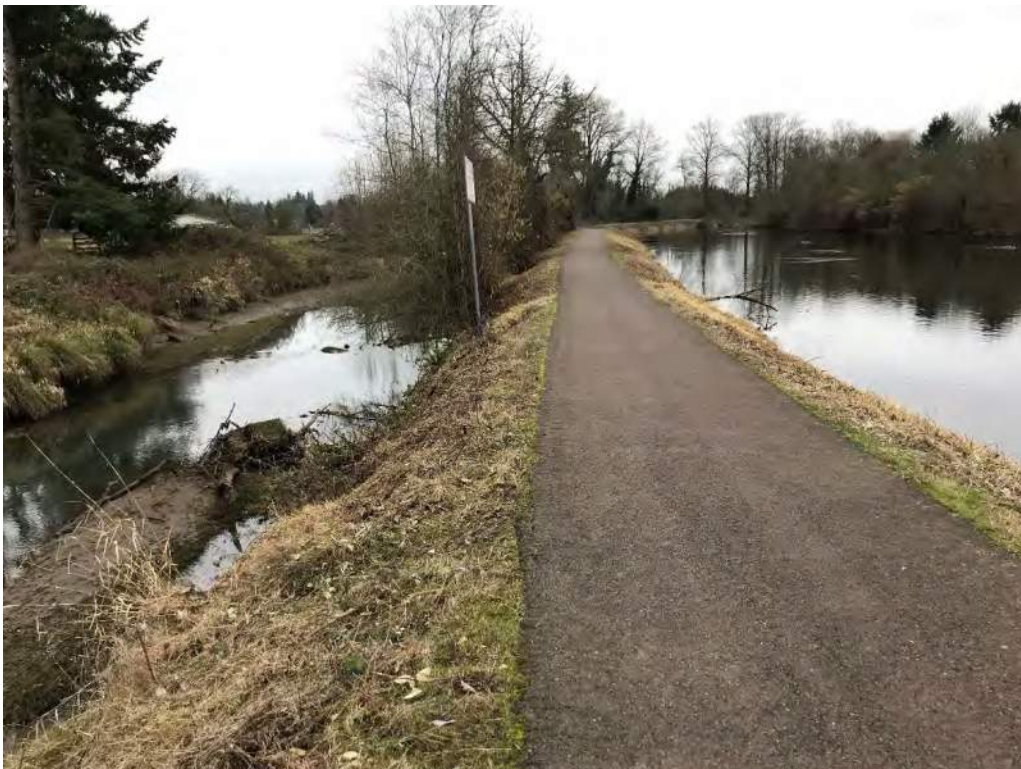
The berm has an ± 8 - to 10-foot-wide asphaltic concrete (AC) paved walking trail on top. Photos 1 through 3 (attached) show the typical conditions along the pathway on the eastern segment of the berm (to the east of Point C in Figure 1). The eastern segment is generally narrower than the western segment. The slopes along the canal side of the berm typically range from $\pm 0.8(H):1(V)$ to $\pm 1.4(H):1(V)$. Photos 4 and 5 show some of the steeper slopes. The side slopes are vegetated with grass, blackberries, weeds, and several small trees. Larger trees up to ± 2 feet in diameter also grow on the berm in some areas. We noted stumps from trees that had been previously cut down. Photo 6 shows a typical tree stump. We also observed a number of leaning trees, which have not been cut down. Photos 7 and 8 show typical leaning trees. Photo 9 shows a tree that had recently been felled into the canal from the opposite bank.

Photo 2. View of berm at Point B (Figure 1) facing southeast.

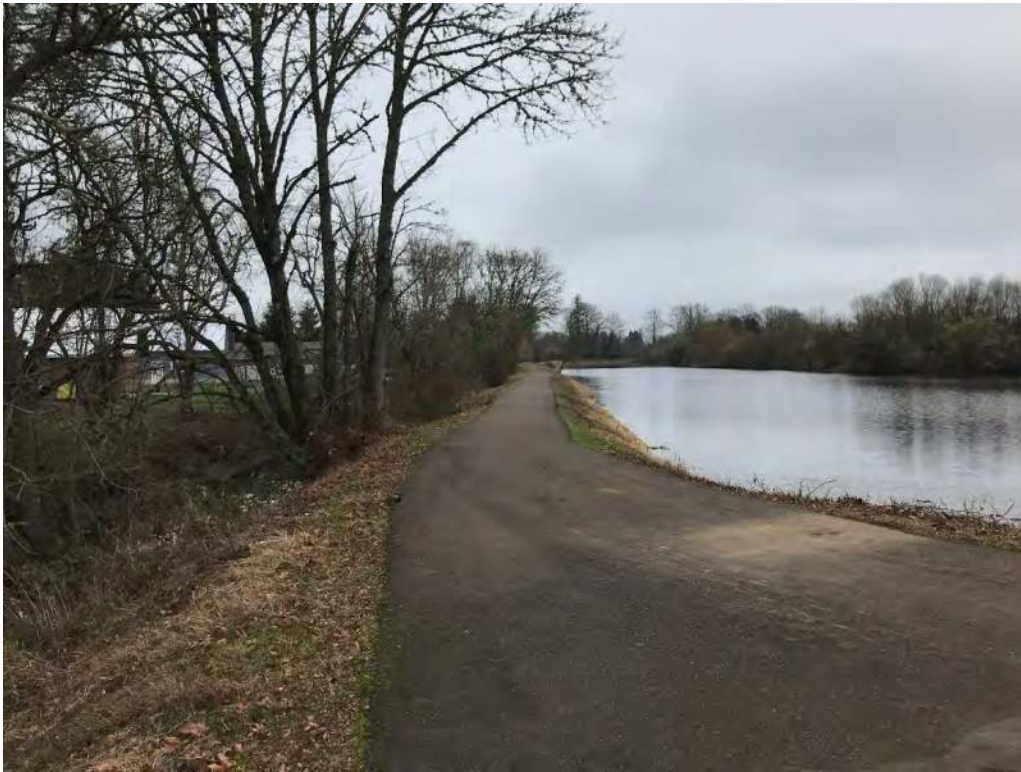
Photo 3. View of berm at Point C (Figure 1) facing southeast.

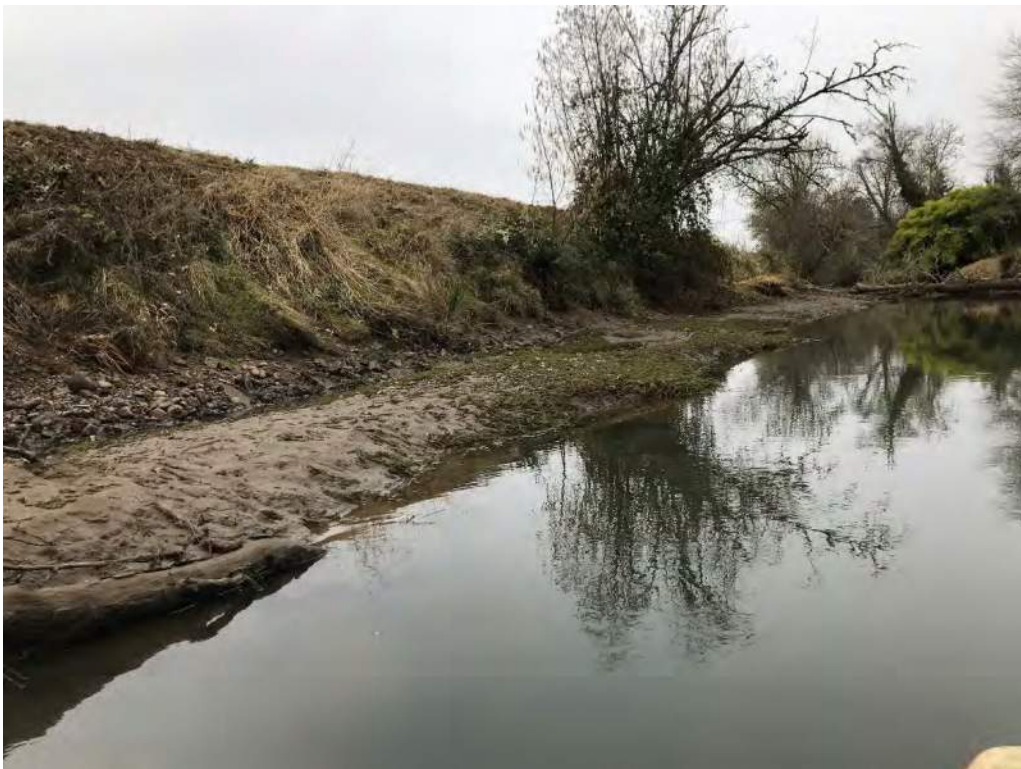
The Cheadle Lake berm is relatively narrow and has side slopes ranging from $\pm 0.8(H):1(V)$ to $\pm 1.4(H):1(V)$. While the slopes do not appear to be currently unstable, these slopes are steeper than would normally be constructed with silty and gravelly soils. Although we have not conducted detailed analysis of the berm stability, we anticipate there is a risk of berm slope instability and breaching during a M_w 9.0 CSZ earthquake. Breaching of the Cheadle Lake berm would release a large volume of water into the canal, which could lead to flooding downstream. We recommend conducting additional geotechnical work including exploratory drilling and analysis to evaluate the stability of the berm for both static and seismic loading conditions.

Photo 4. Typical steep berm slope along canal facing west.

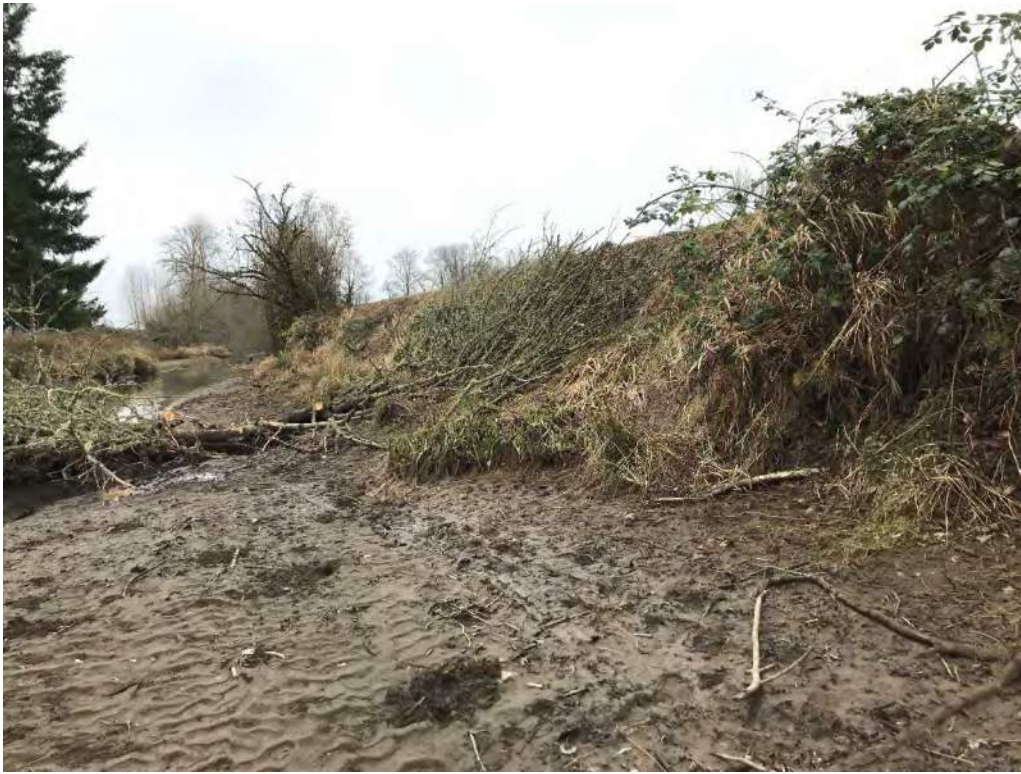
Photo 5. Typical steep berm slope along the canal facing southeast.

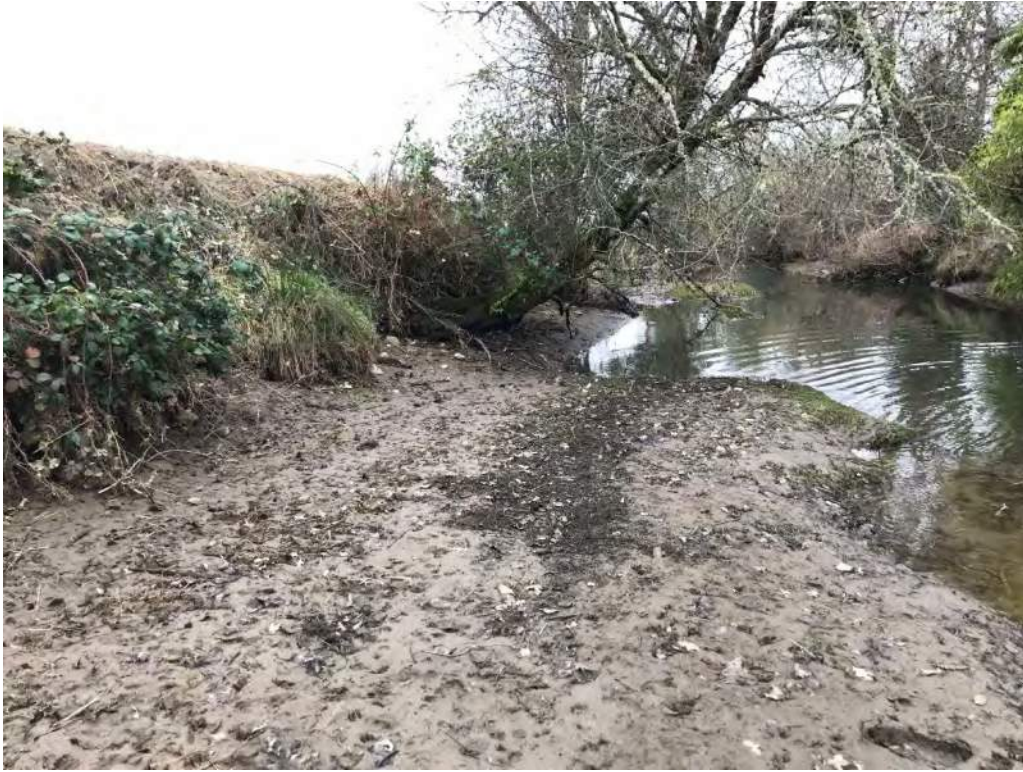
Photo 7. View of a leaning tree facing northwest.

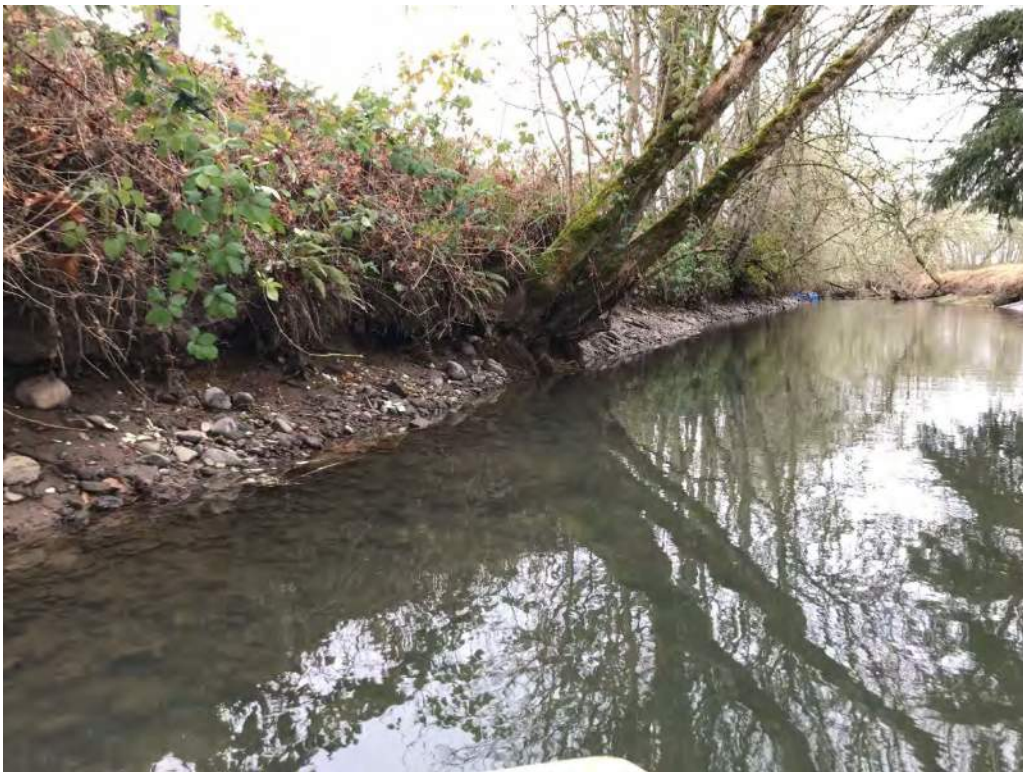
Erosion and vertical slopes are common at the toe of the berm. Undercutting of the banks was also observed in several areas below the vegetation line. Photo 8 and Photos 10 and 11 show typical undercut banks. The soil exposed on the eroded slopes consists of silt and gravel.

Photo 8. View of a leaning tree facing northwest.

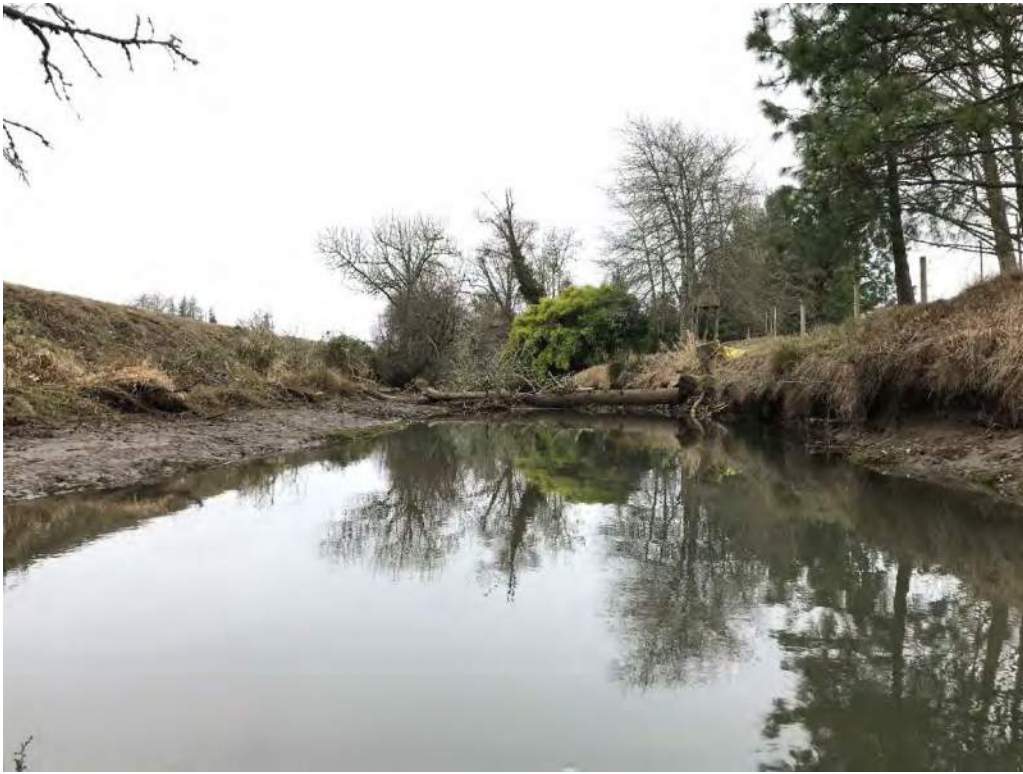
Photo 9. Felled tree facing northwest.

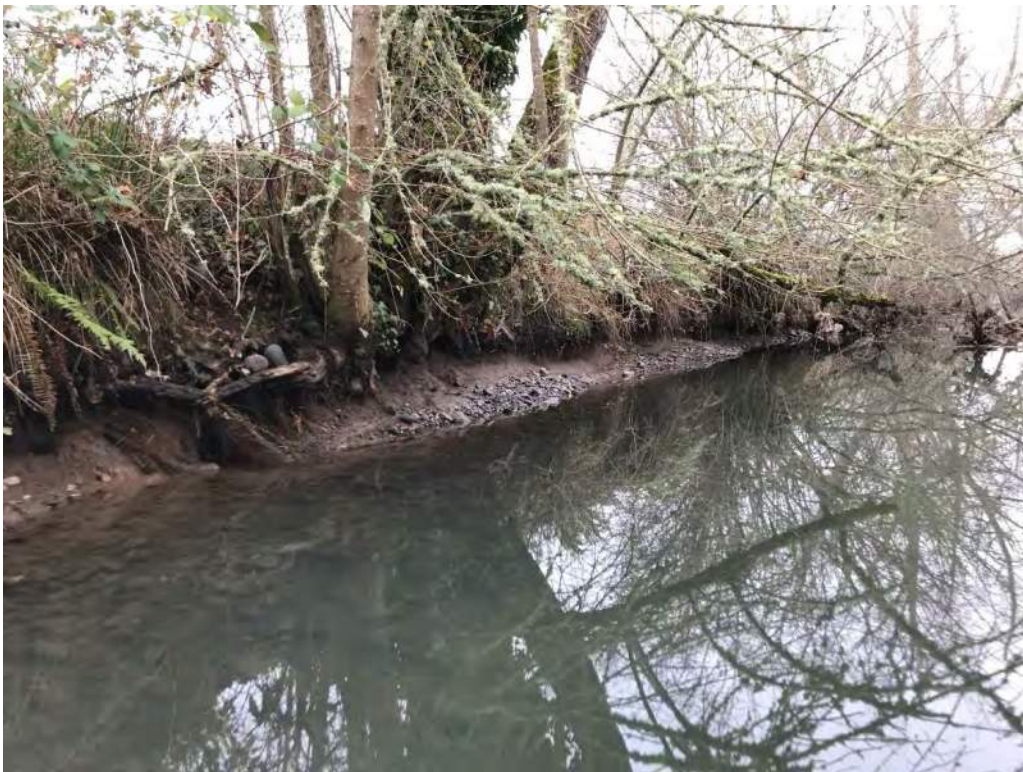
Photo 10. Erosion at the toe of the berm facing northwest.

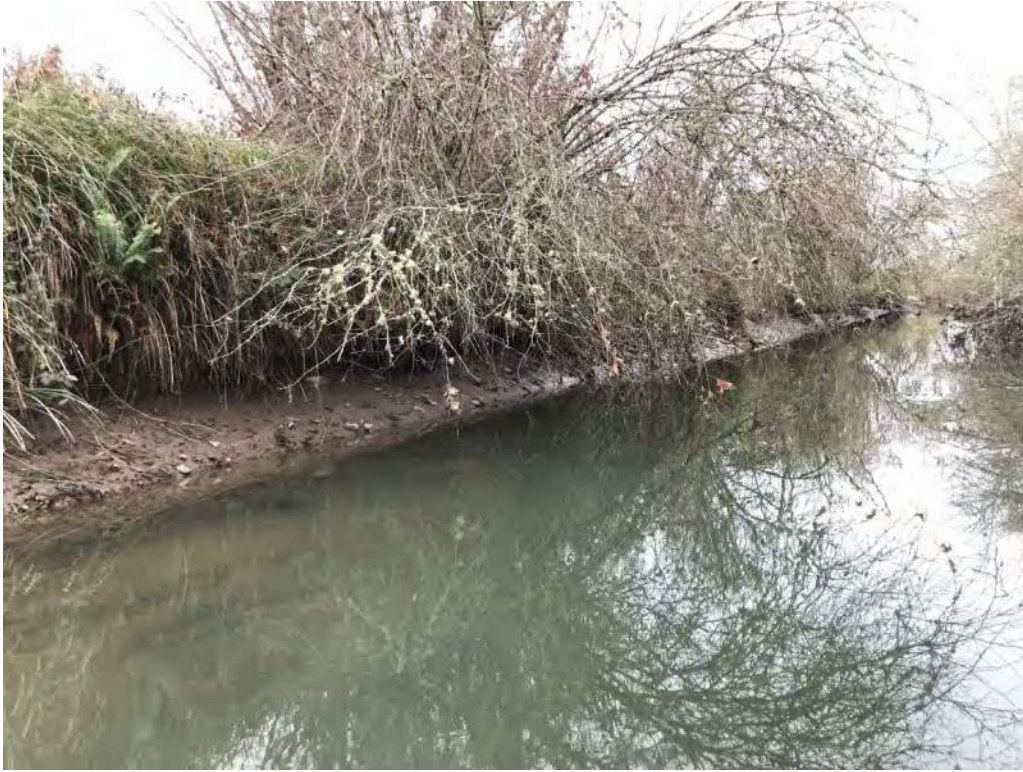
Photo 11. Erosion at the toe of the berm facing northwest.

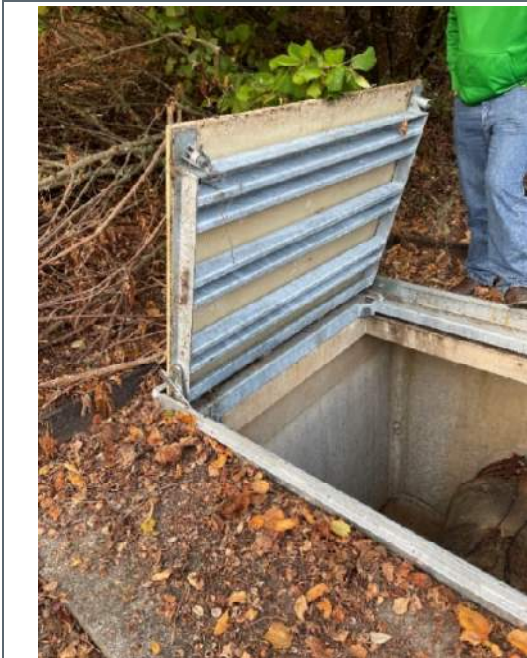
Photo 4-2-3
Broadway – Valve Vault - FRP Hatch

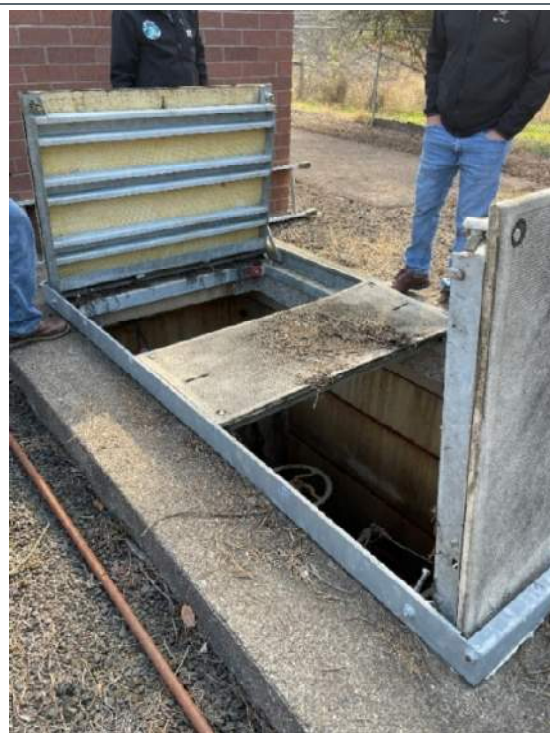
Photo 4-2-6
North Albany – Valve Vault – FRP Hatch

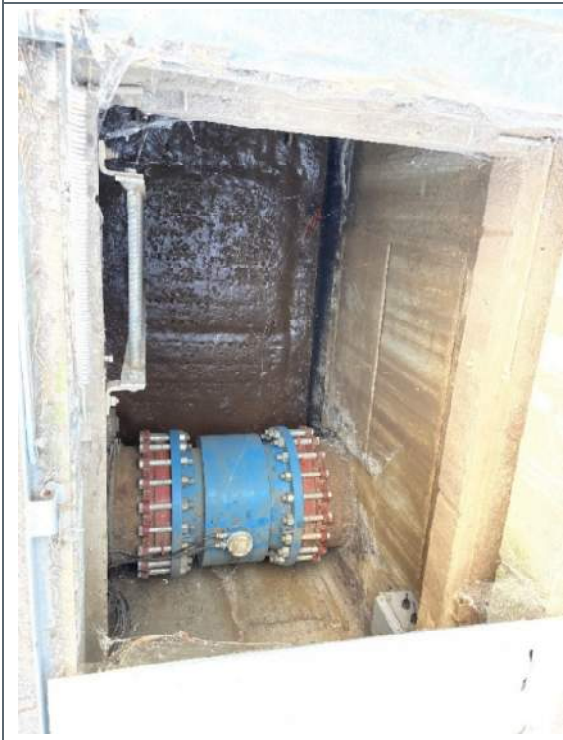
Photo 4-2-7
North Albany - Flow Meter Vault – Mud on Floor

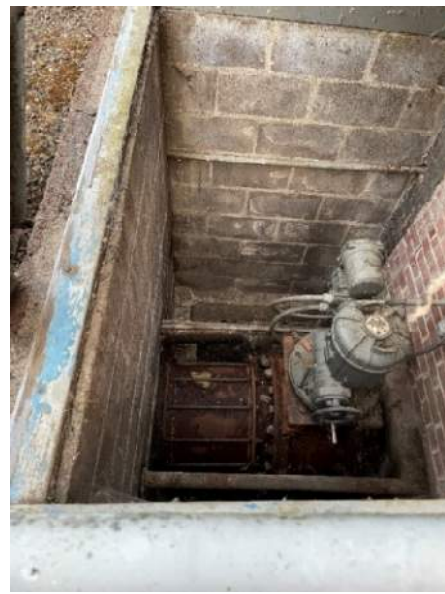
Photo 4-2-10
Vine St – RWPS Valve Vault – Made of CMU

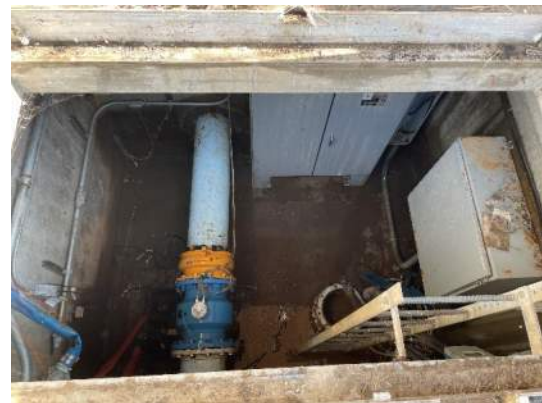
Photo 4-2-12
A&M WTP – Millersburg Meter Vault – Standing Water

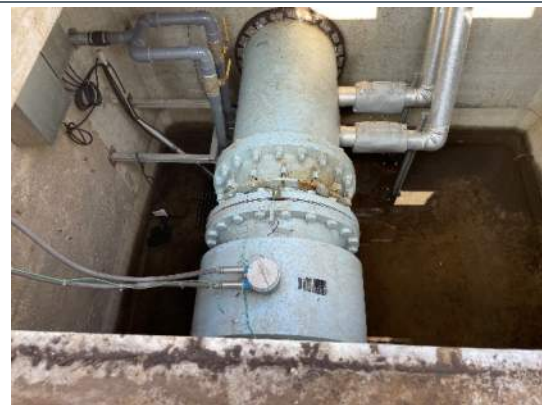
Photo 4-2-13
A&M WTP – ACH & Metering Vault – Standing Water

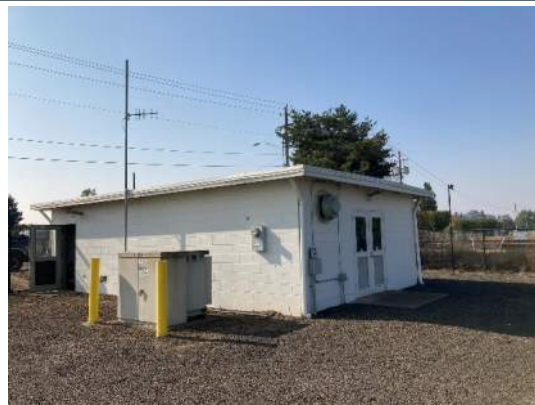
Photo 4-3-23
34th Street Pump Station

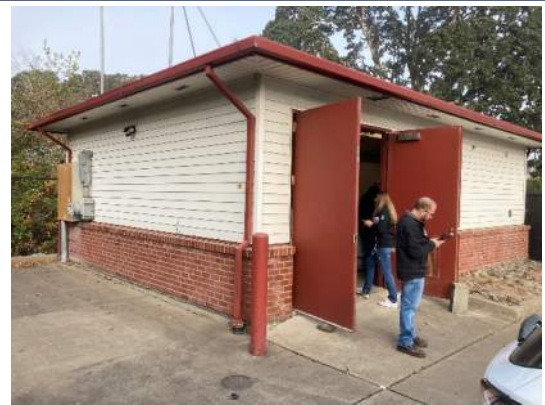
Photo 4-3-24
Gibson Hill Pump Station

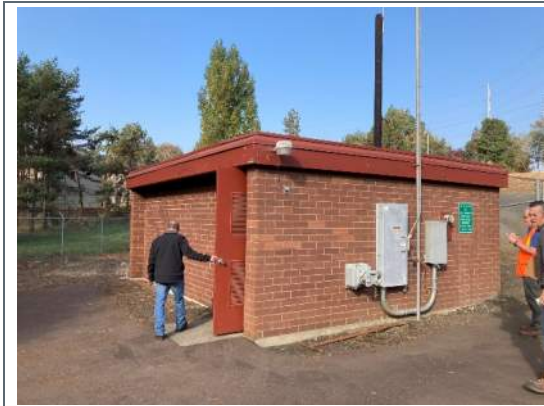
Photo 4-3-25
North Albany Pump Station

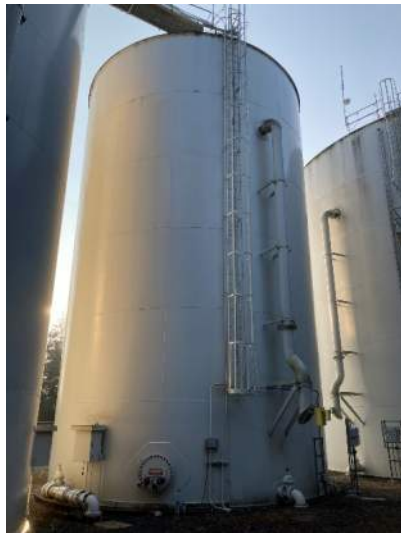
Photo 4-3-27
Valley View Reservoir

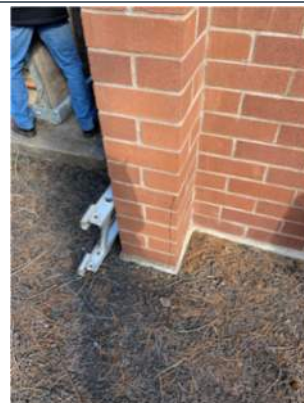
Photo 4-3-30
North Albany Pump Station

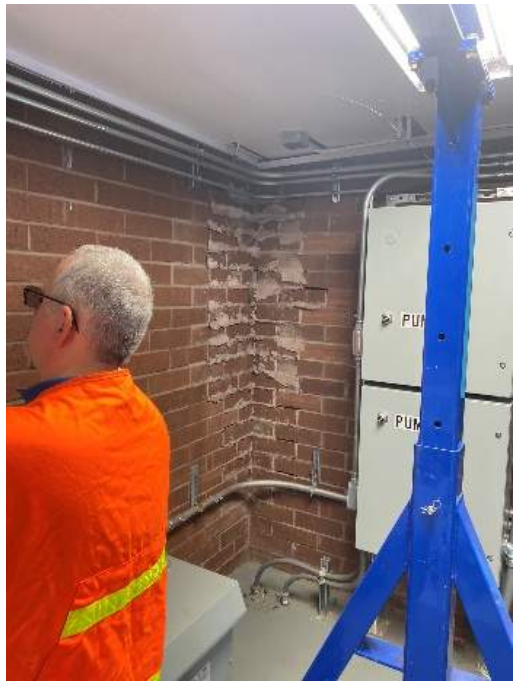
Photo 4-3-31
North Albany Pump Station

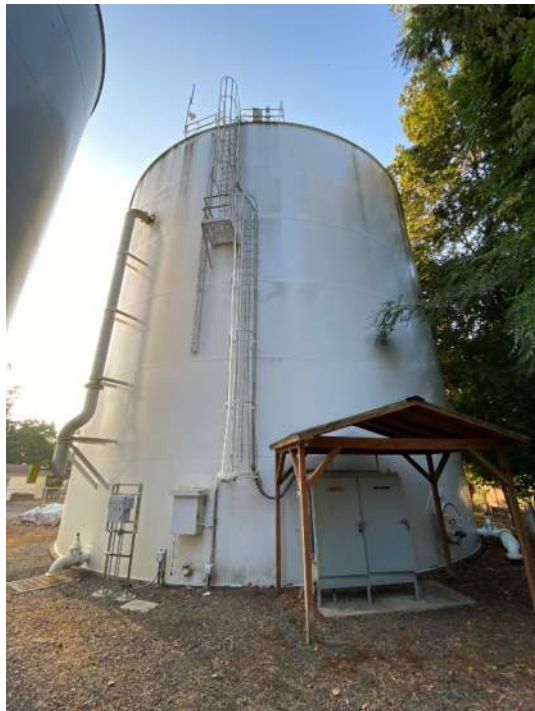
Photo 4-3-33
Valley View Reservoir

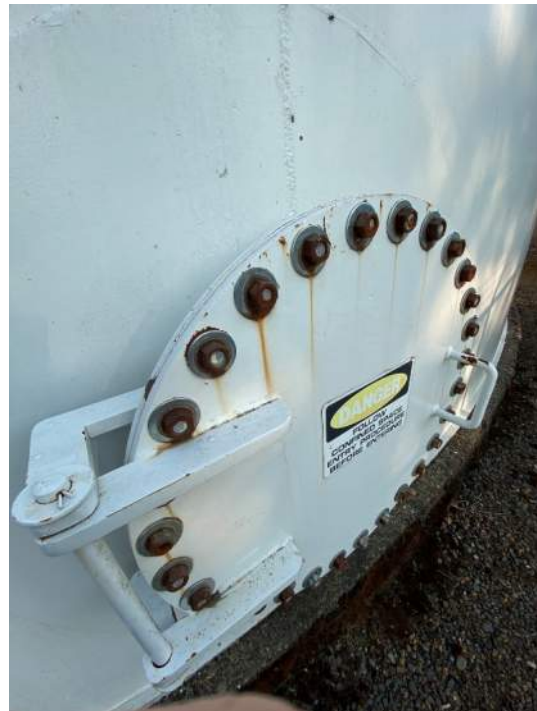
Photo 4-3-34
Valley View Reservoir

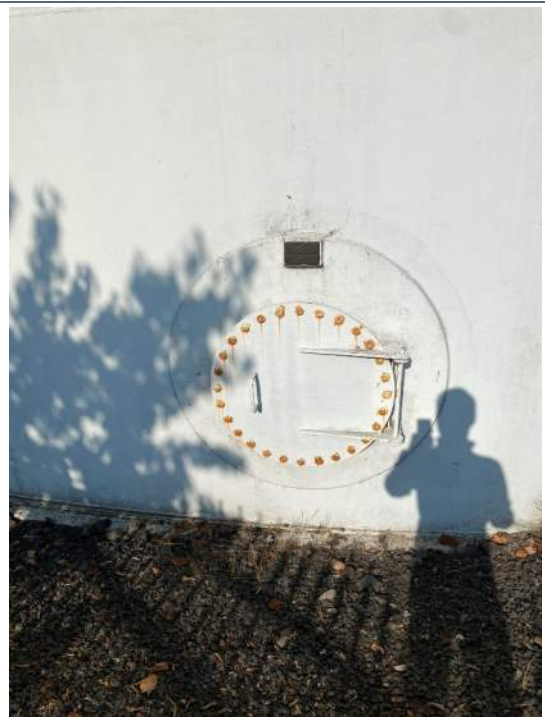
Photo 4-3-36
Maple Street Reservoir

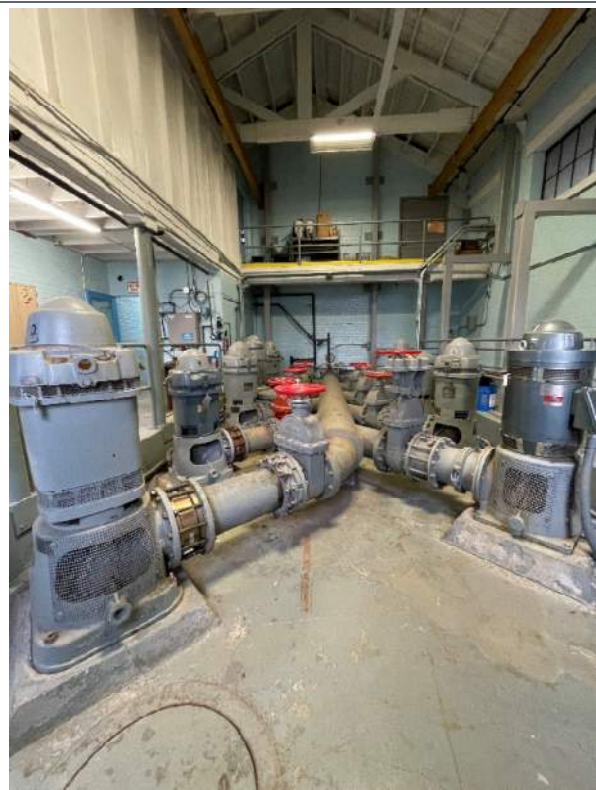
Photo 4-4-13
Vine St – RW Pump Station – Pipe Coating Aged

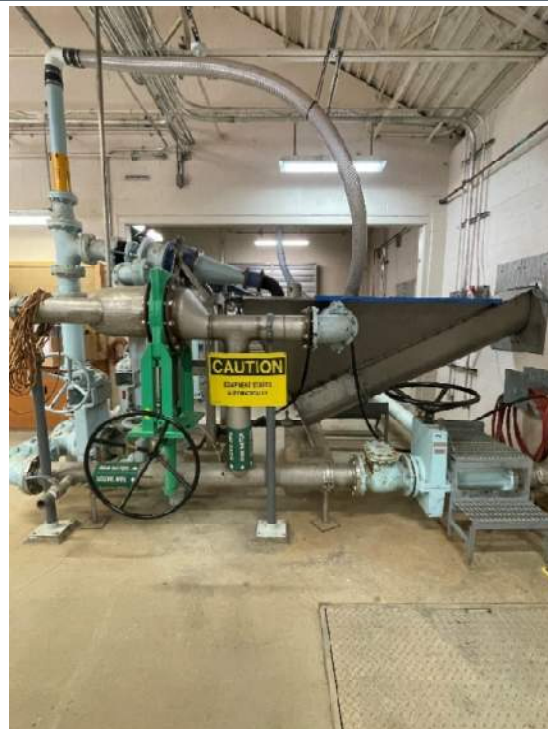
Photo 4-4-23
A&M WTP – RW Intake – Sand Classifier Augers

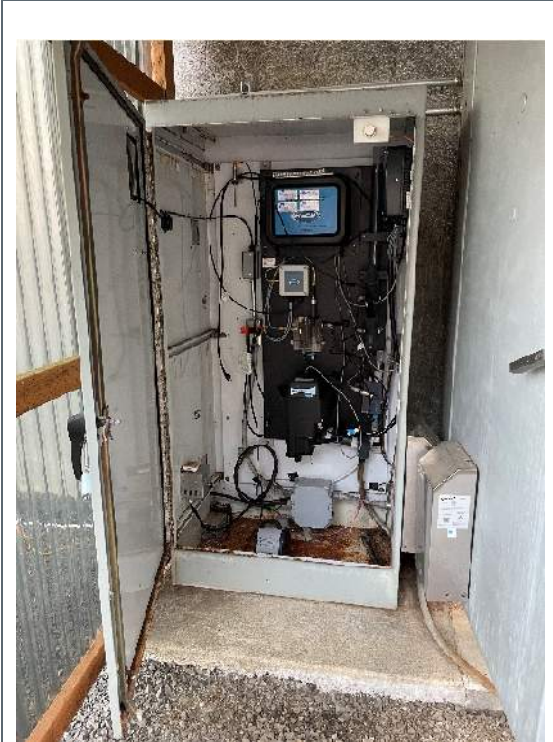
Photo 4-5-3
Broadway - Water Quality Panel

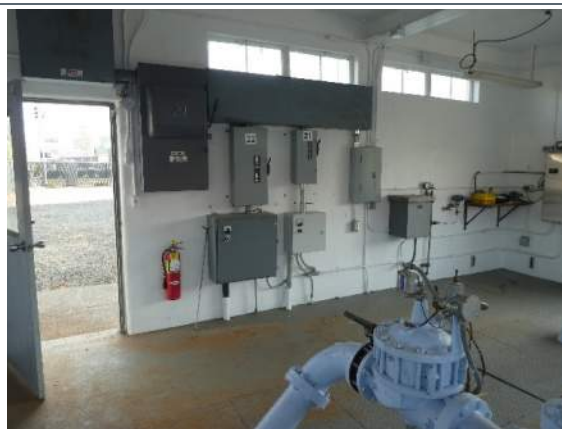
Photo 4-5-6
Queen Ave – MCC NEMA 4

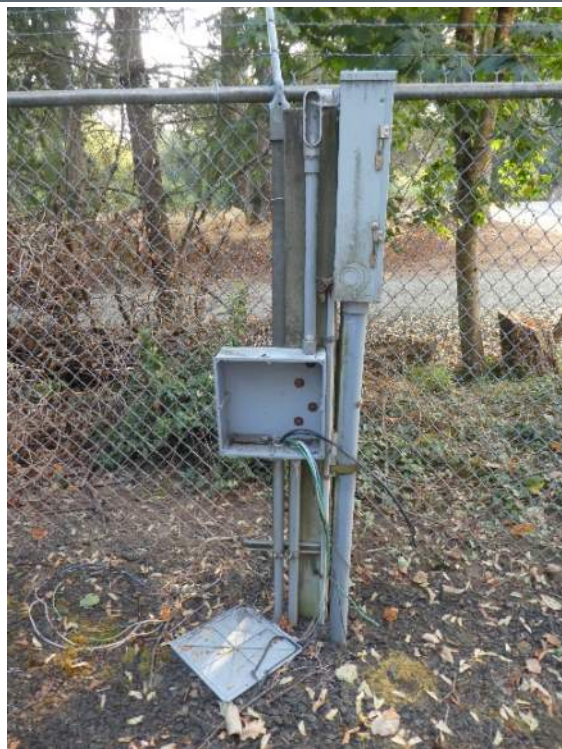
Photo 4-5-8
Valley View – Original 100A Service

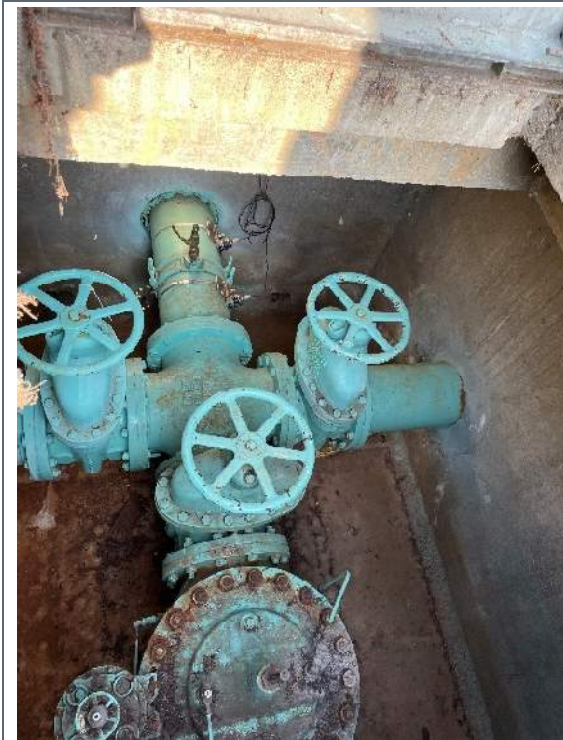
Photo 4-6-1
Wildwood – Ultrasonic Flow Meter

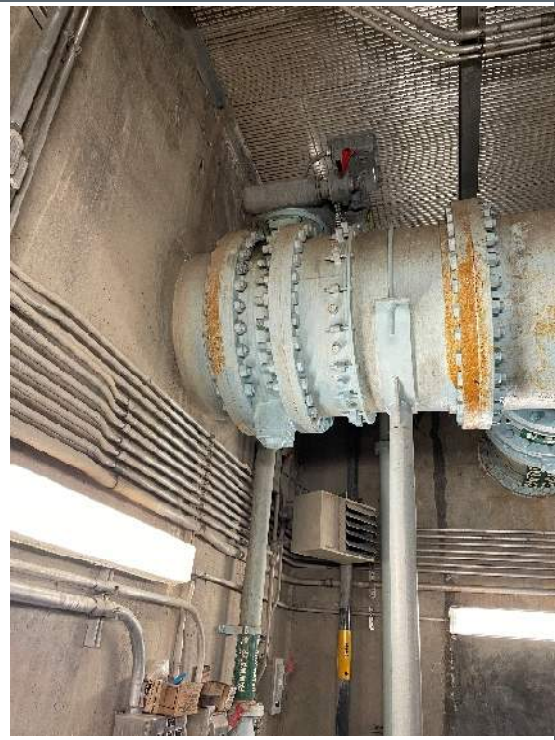
Photo 4-6-2
A&M Intake PS – Low Level Valve

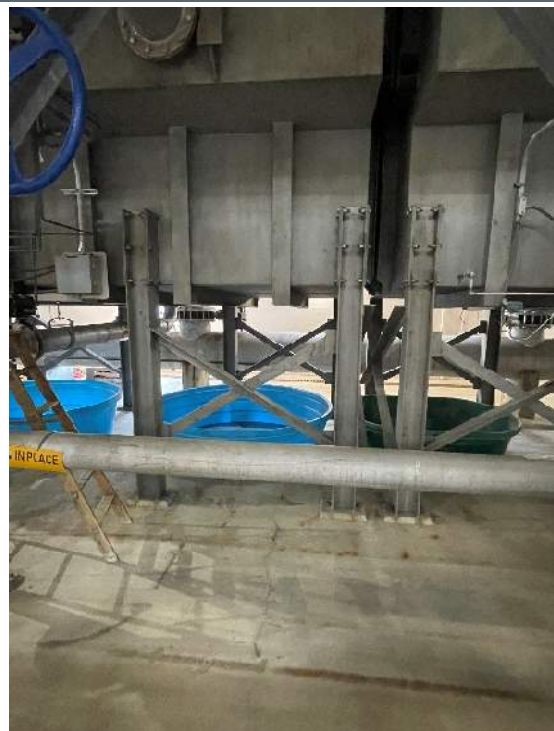
Photo 4-6-3
A&M WTP – Membranes – Plast Blue Pools

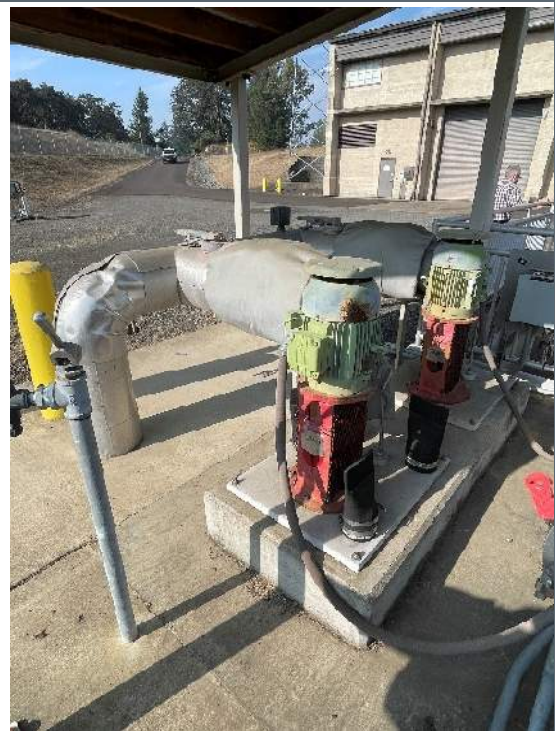
Photo 4-6-4
A&M WTP - Neutralization Basin – Outdoor Pumps

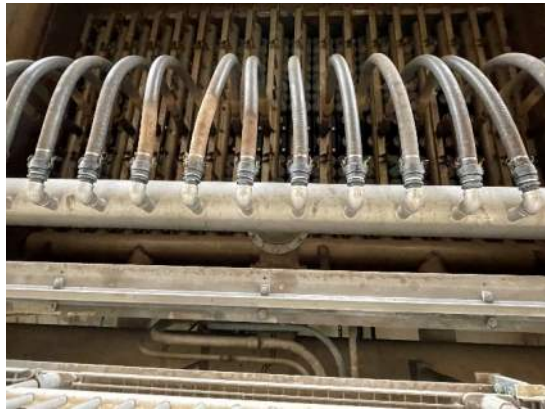
Photo 4-6-5
A&M WTP – Membrane - Hoses

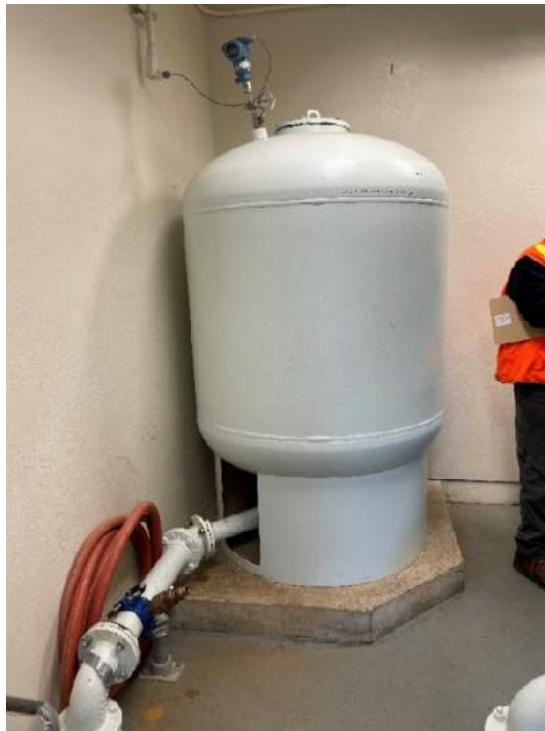
Photo 4-6-7
Valley View PS – Bladder Tank
