## Appendix A

### Pump Station Pump Curves

## Appendix B

### System Validation Results

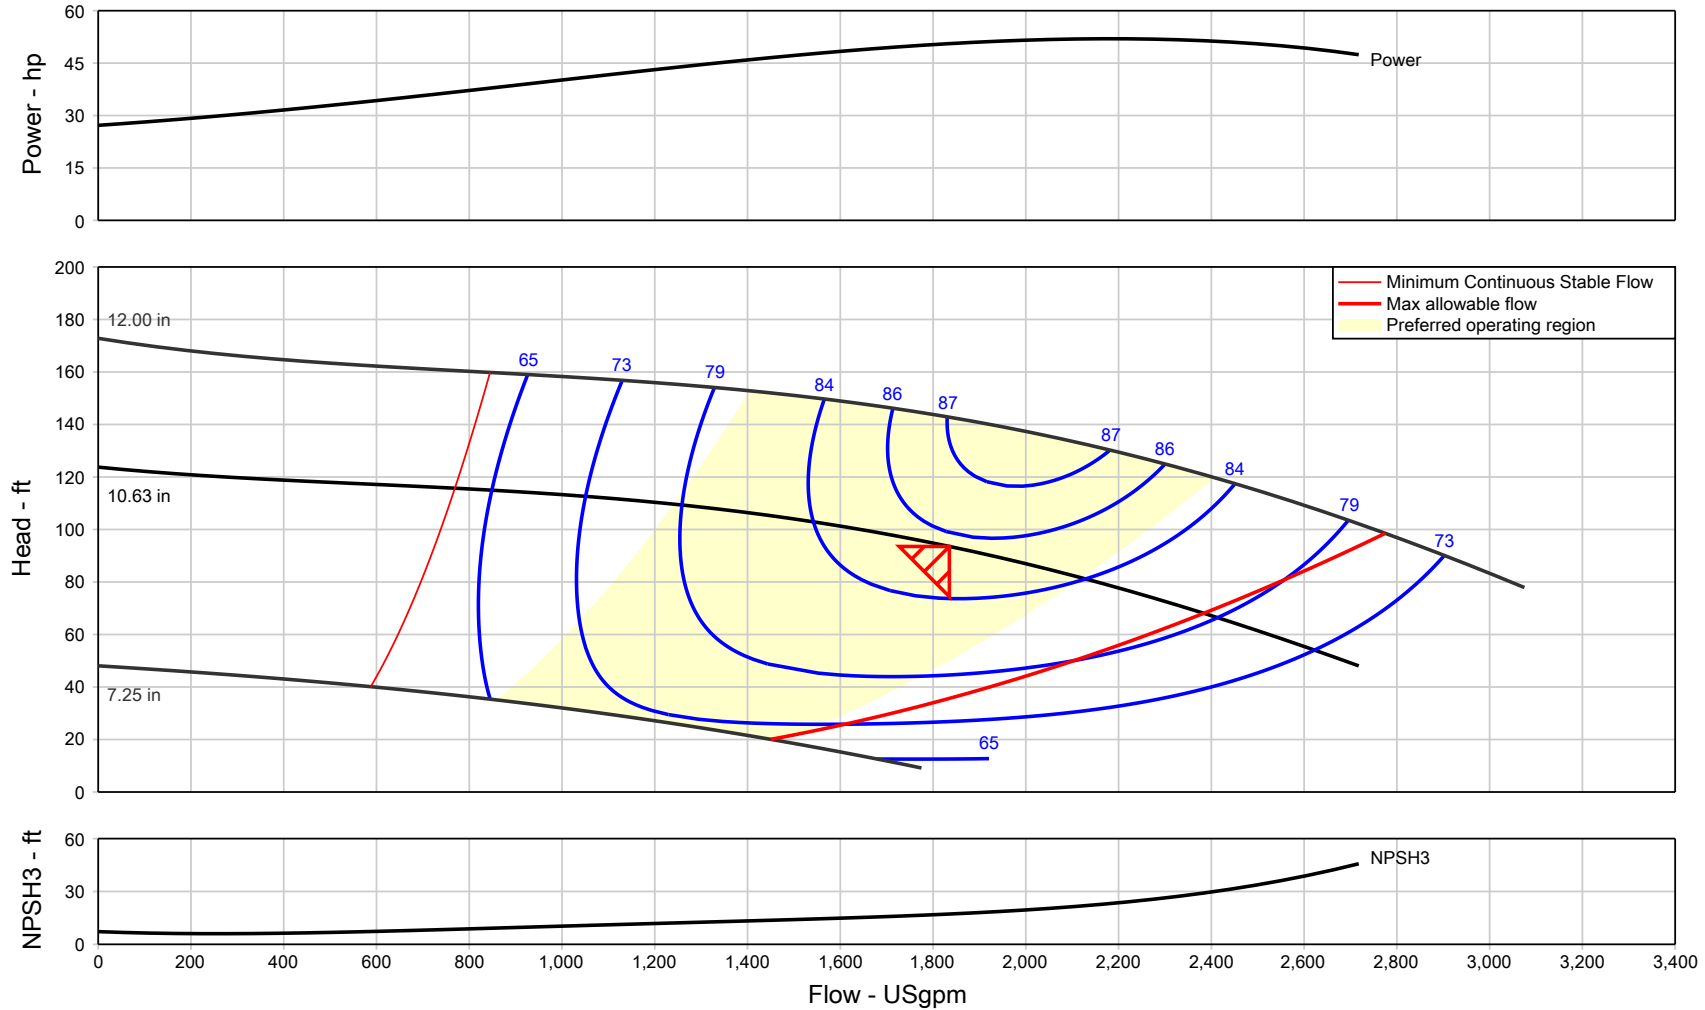
North Albany pumps

Item number	: 012	Size	: 410 - 8x8x11B	Flow, rated	: 1,835.2 USgpm
Service	:	Stages	: 1	Differential head / pressure, rated	: 93.53 ft
Quantity	: 1	Speed, rated	: 1775 rpm	NPSH required	: 17.19 ft
Quote number	: 1048197	Based on curve number	: 14-8x8x11B-1775 Rev	Fluid density, rated / max	: 1.000 / 1.000 SG
Date last saved	: 23 Mar 2020 11:50 AM	Efficiency	: 85.69 %	Viscosity	: 1.00 cP
		Power, rated	: 50.58 hp	Cq/Ch/Ce/Cn [ANSI/HI 9.6.7-2010]	: 1.00 / 1.00 / 1.00 / 1.00

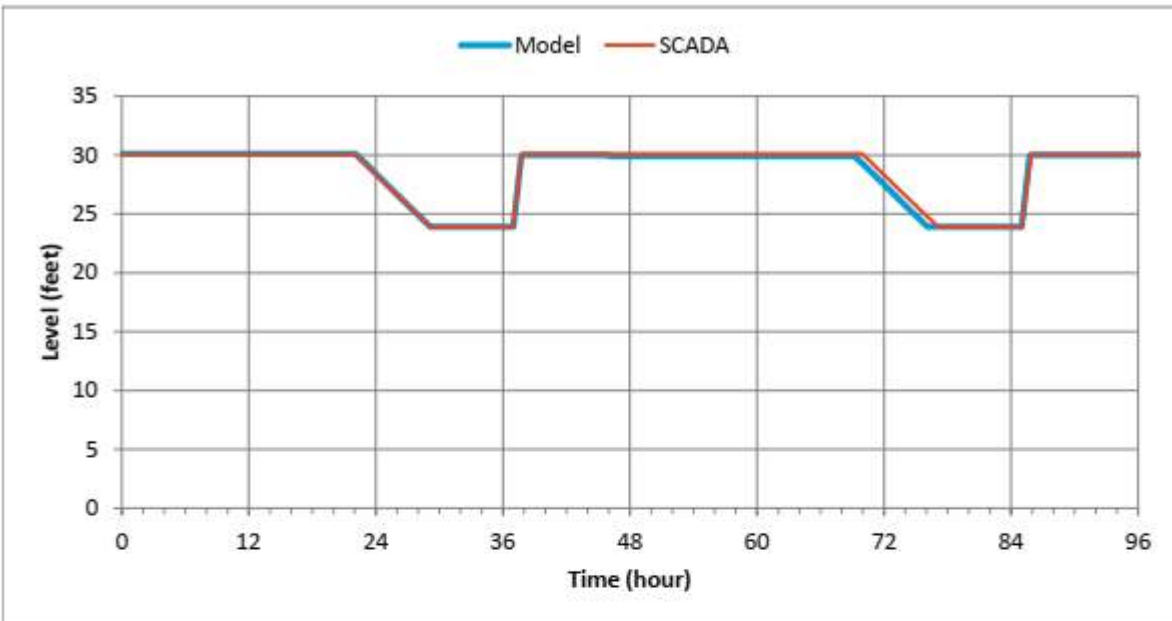
Figure B-3. Queen Level

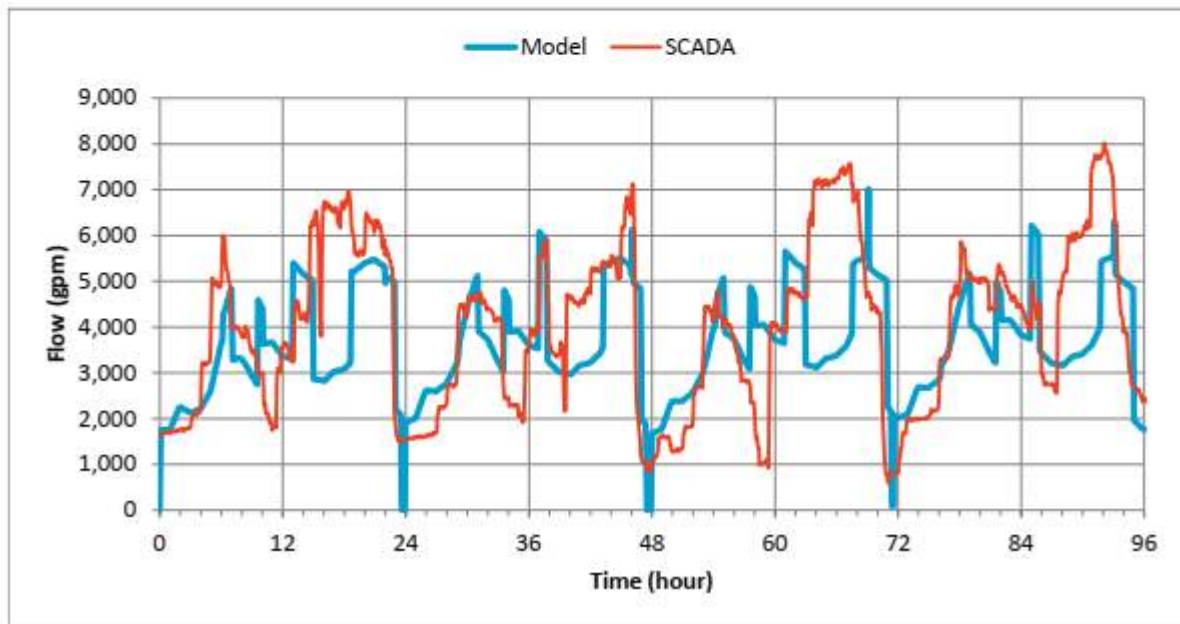
Figure B-6. Albany Flow Meter

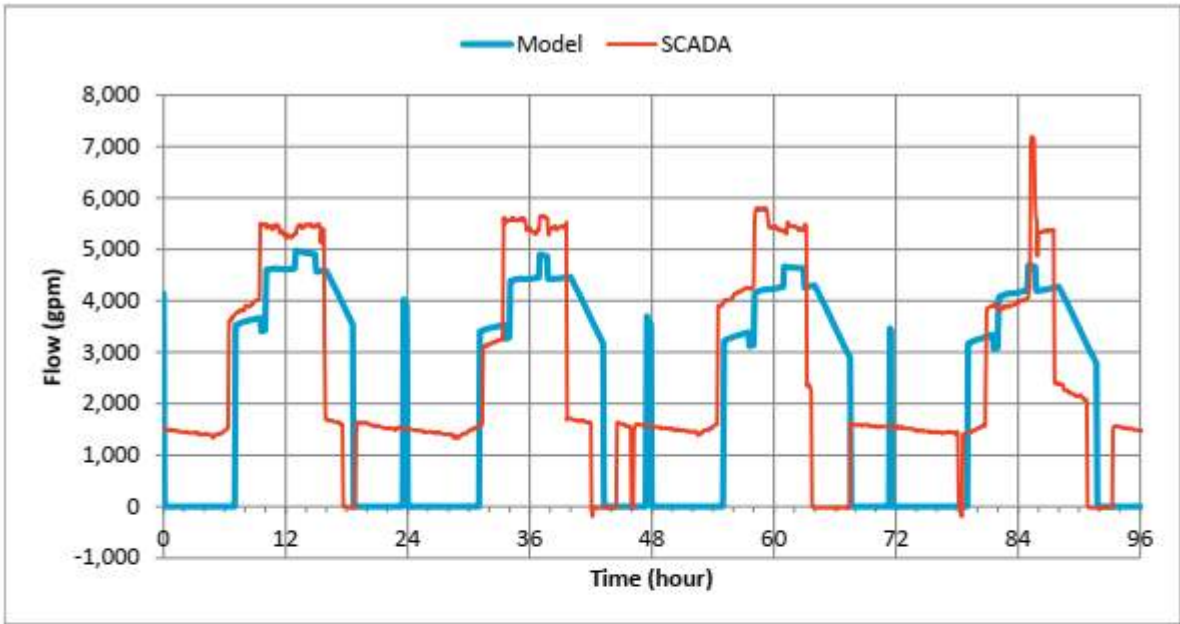
Figure B-9. Vine net production

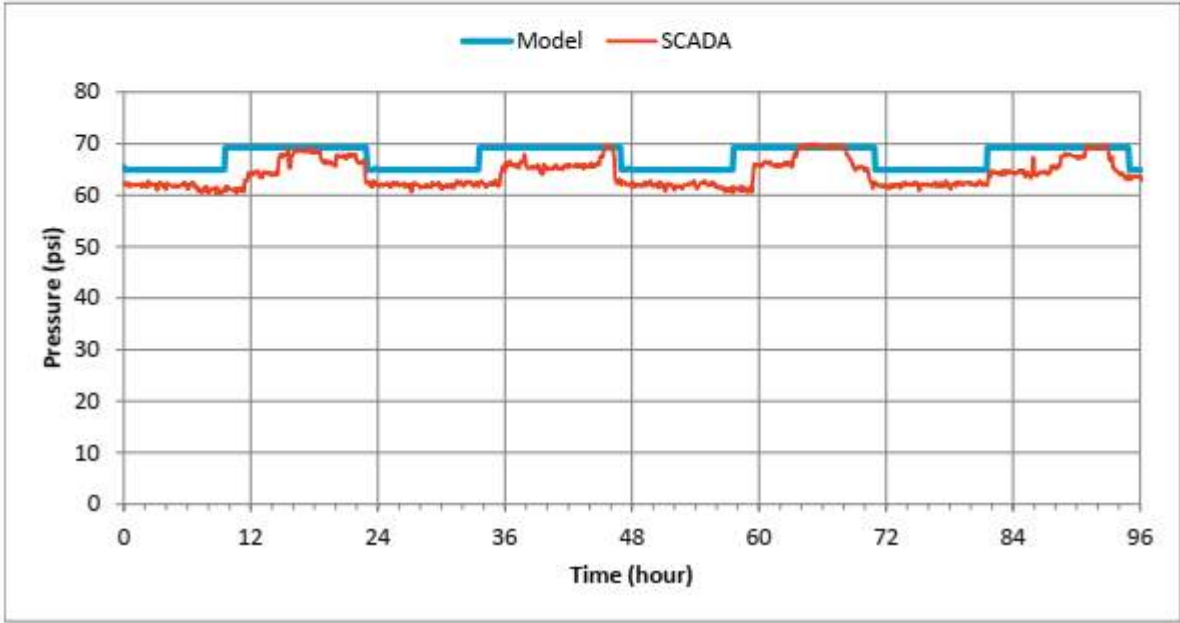
Figure B-10. Albany Metering Pipe Downstream Pressure

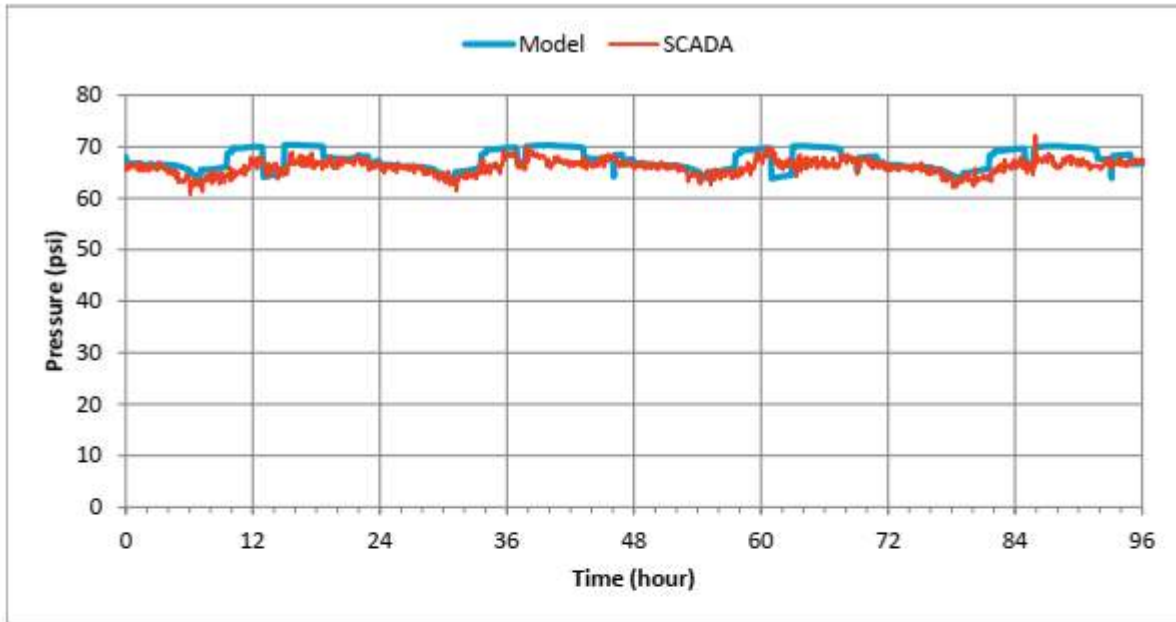
Figure B-11. College Green LS Distribution Pressure

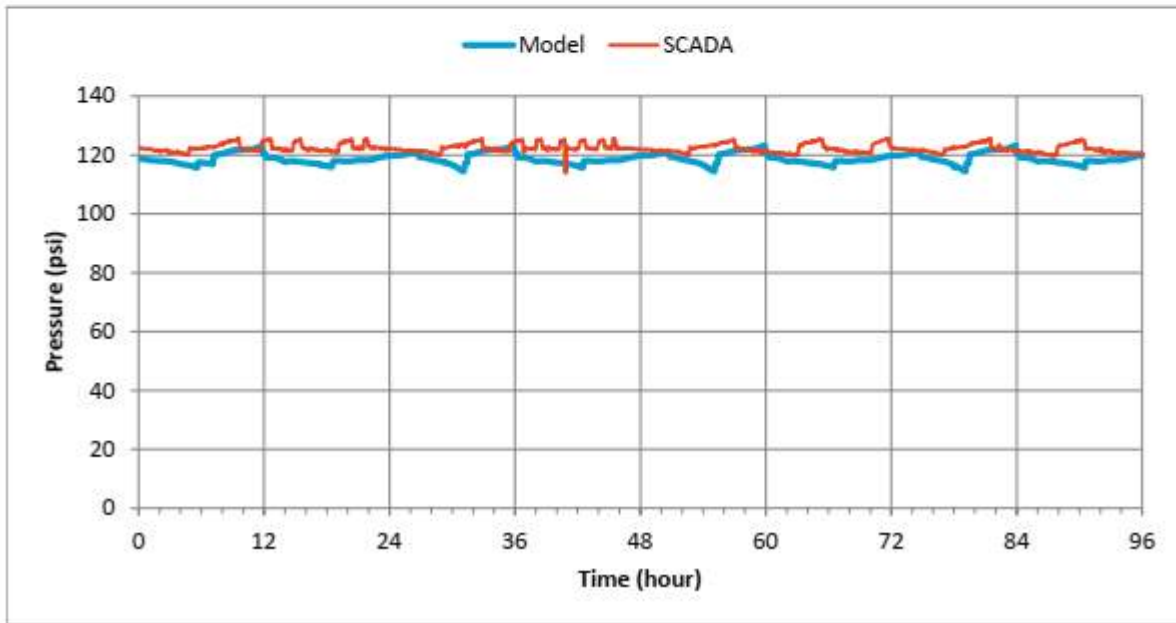
Figure B-12. Gibson Hill PS Discharge Pressure

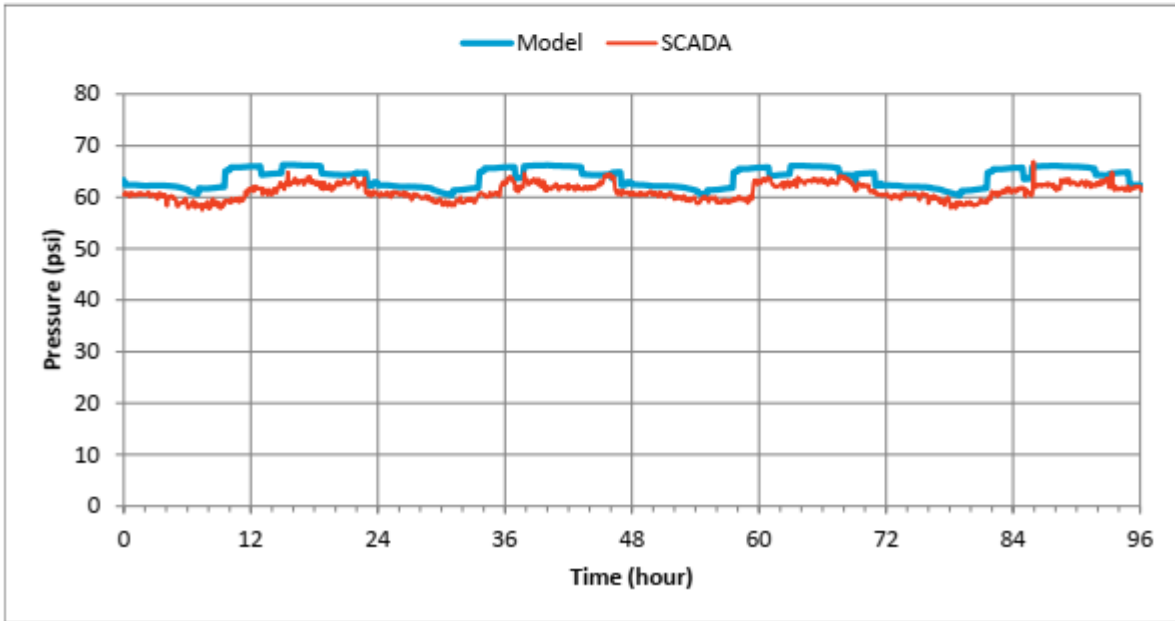
Figure B-14. Lawndale Distribution Pressure

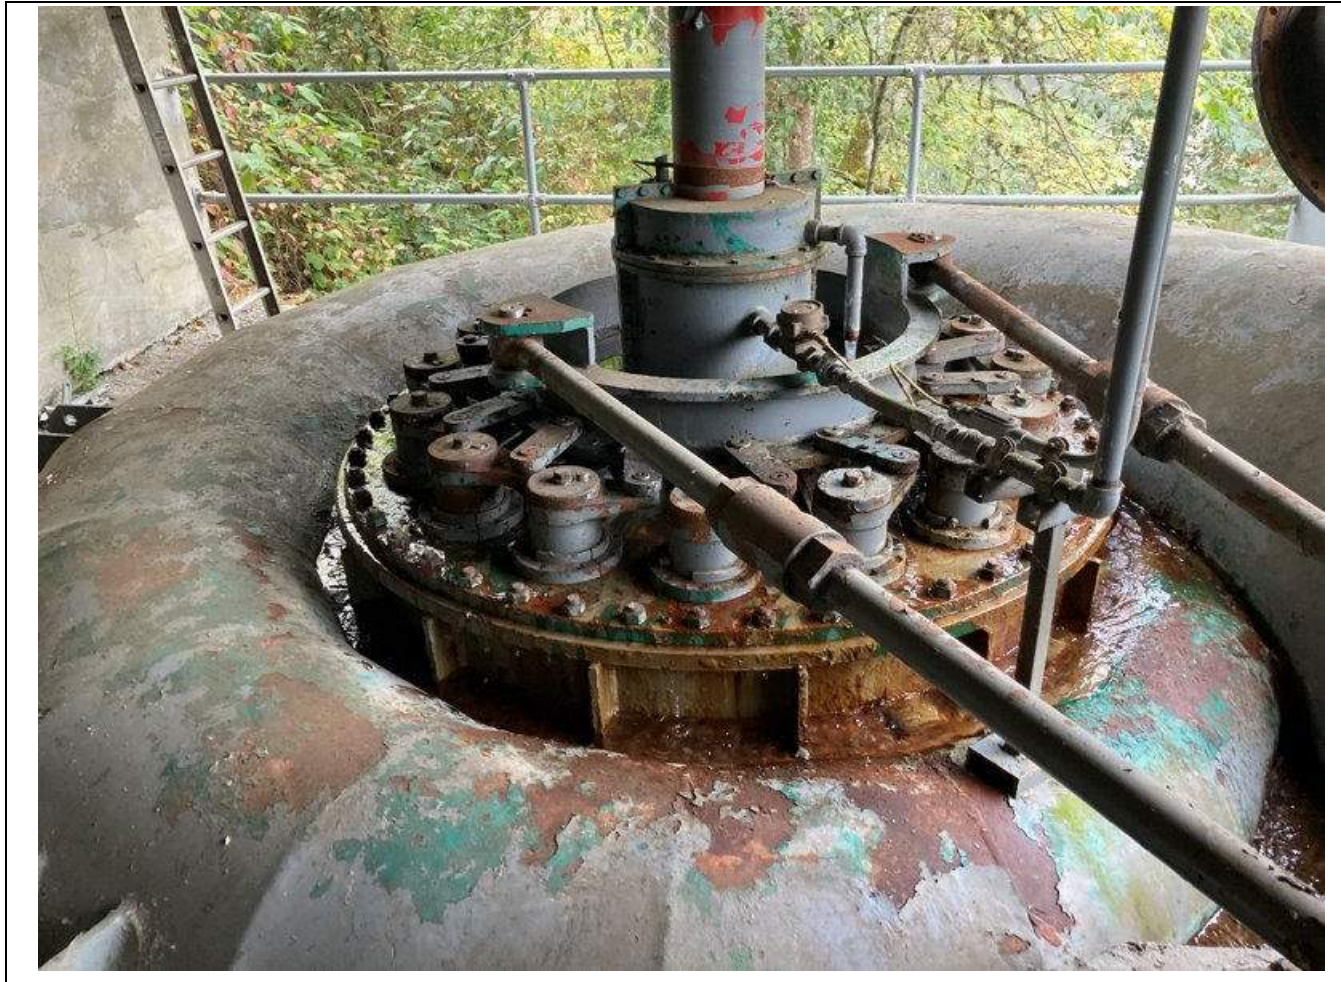
Preliminary evaluation indicates that the combined turbine system efficiency can be improved anywhere from 4.3 percent to 26.5 percent with a newly designed runner and wicket gates. Additional analysis is recommended to determine the root causes of turbine down time when canal flow would otherwise allow for generation.

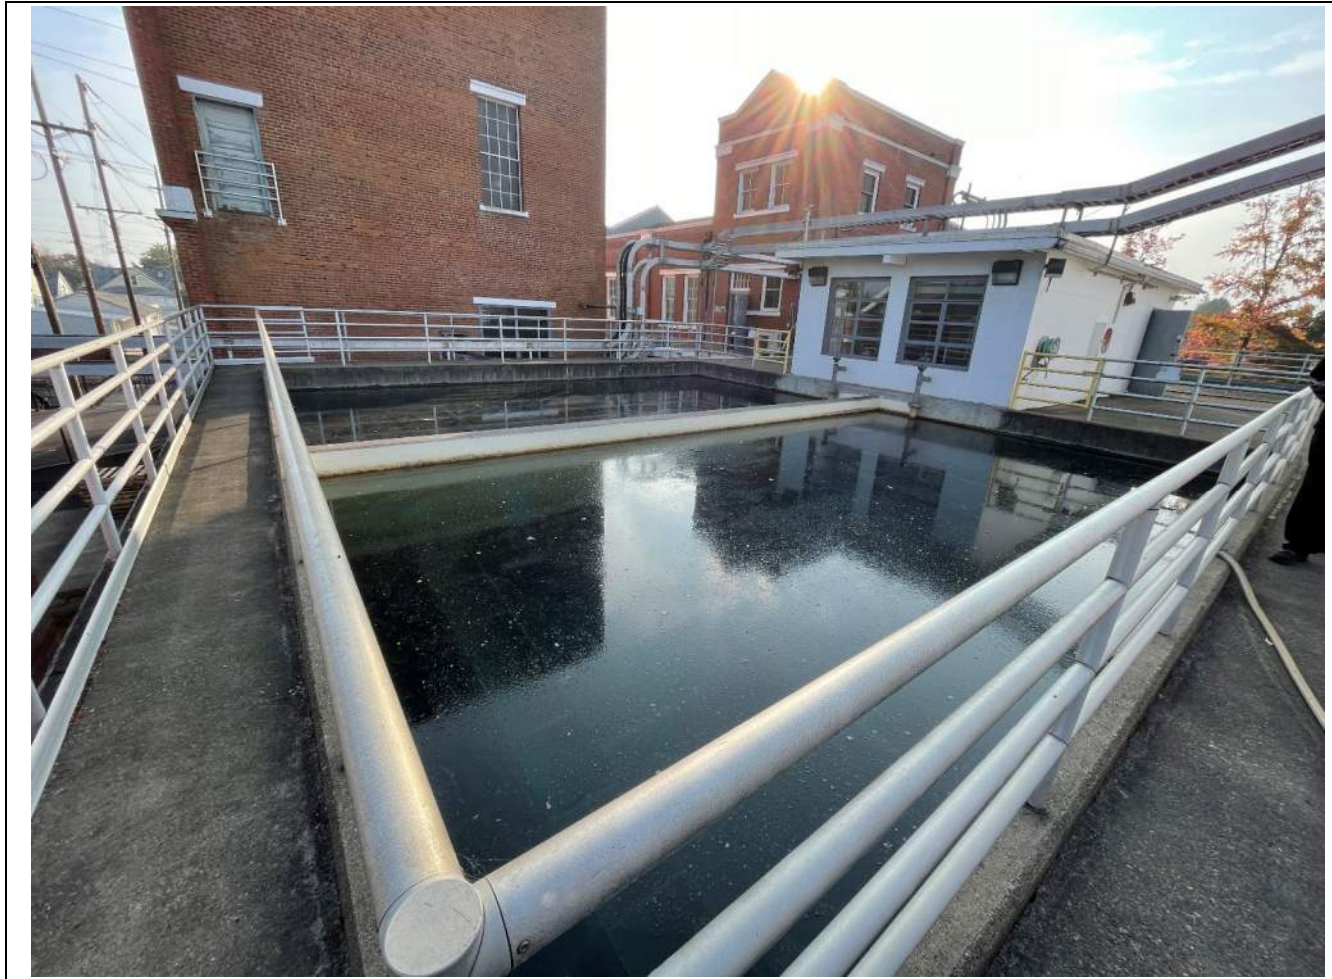
In 2019, it was determined that Vine St WTP Filters #7 and #8 do not include silica media. The next time the anthracite media is replaced, it is recommended to consider adding silica sand to Filters #7 and #8.

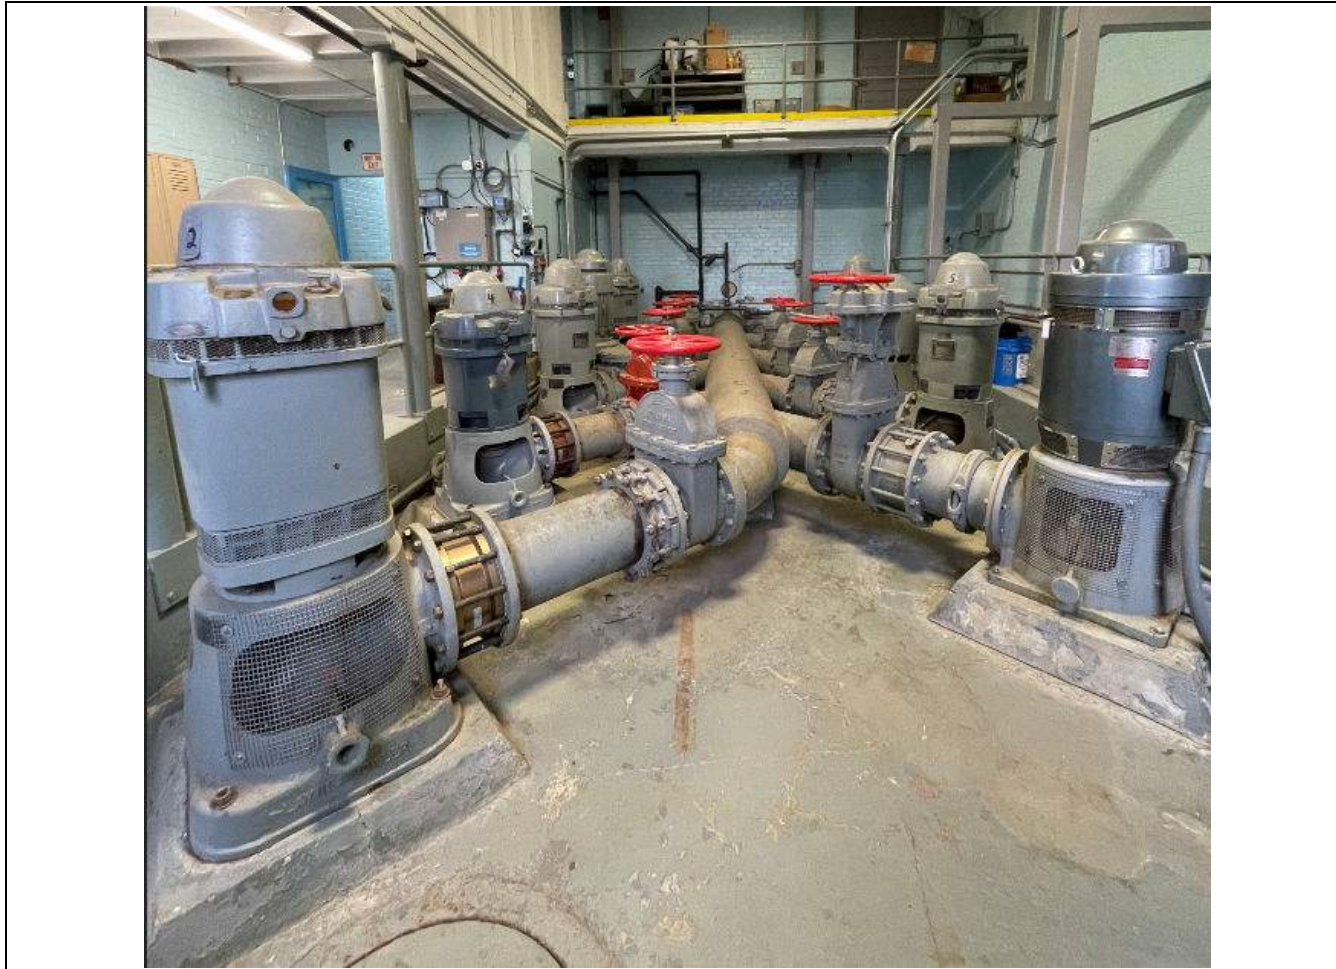
The existing Raw Water Pump Station pipes are chipping and need recoating.

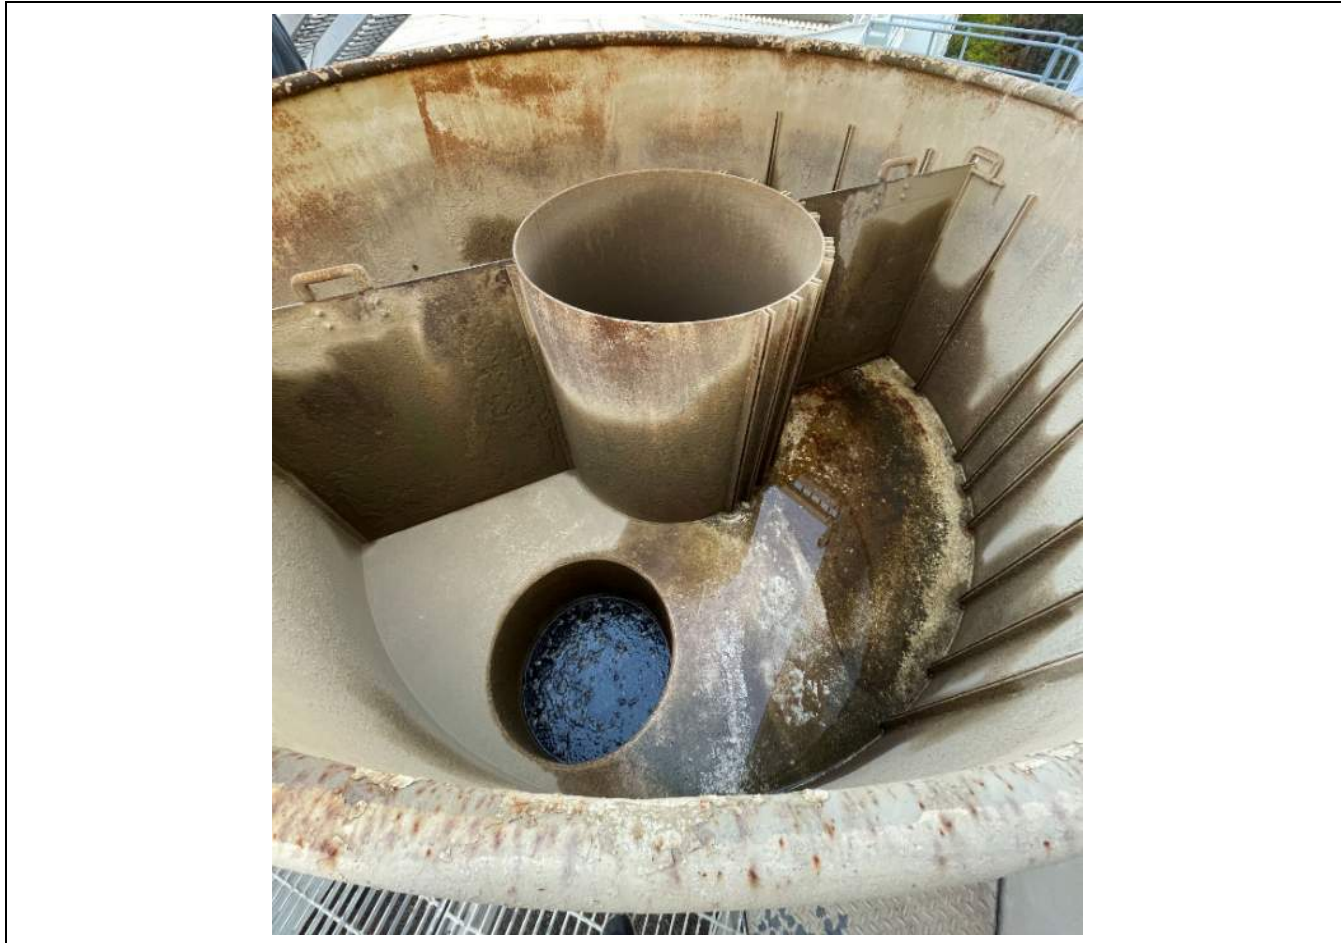
The raw water splitter is rusted. It is recommended to coat it.

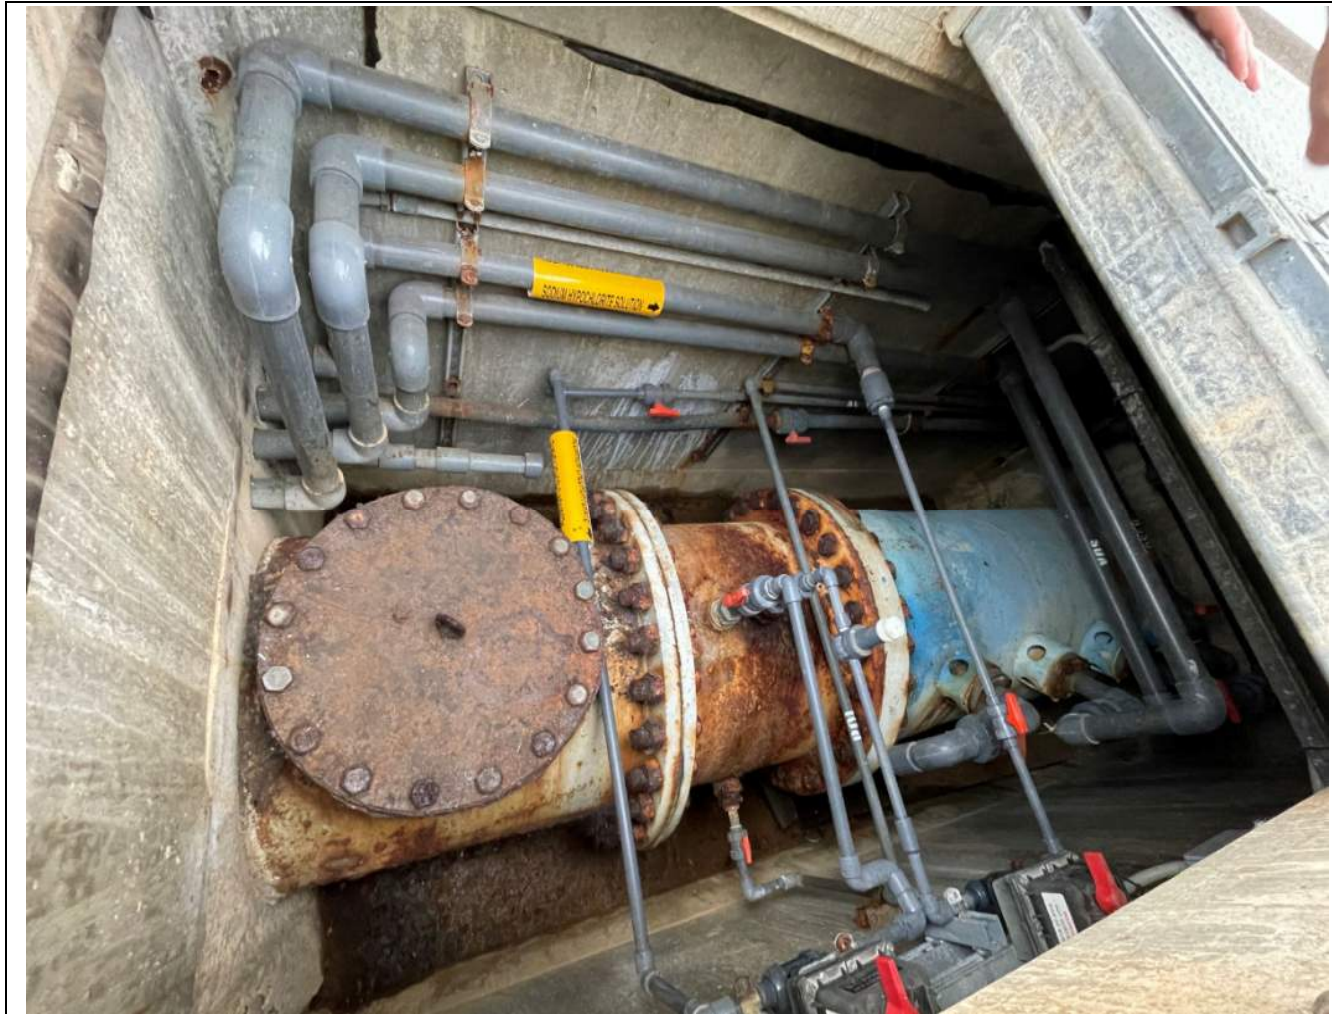
Vine St WTP Chemical Injection Vault piping, bolts, and pipe supports have rust. Measure pipe thickness. Replace or recoat. Replace bolts. Replace pipe supports, as necessary.

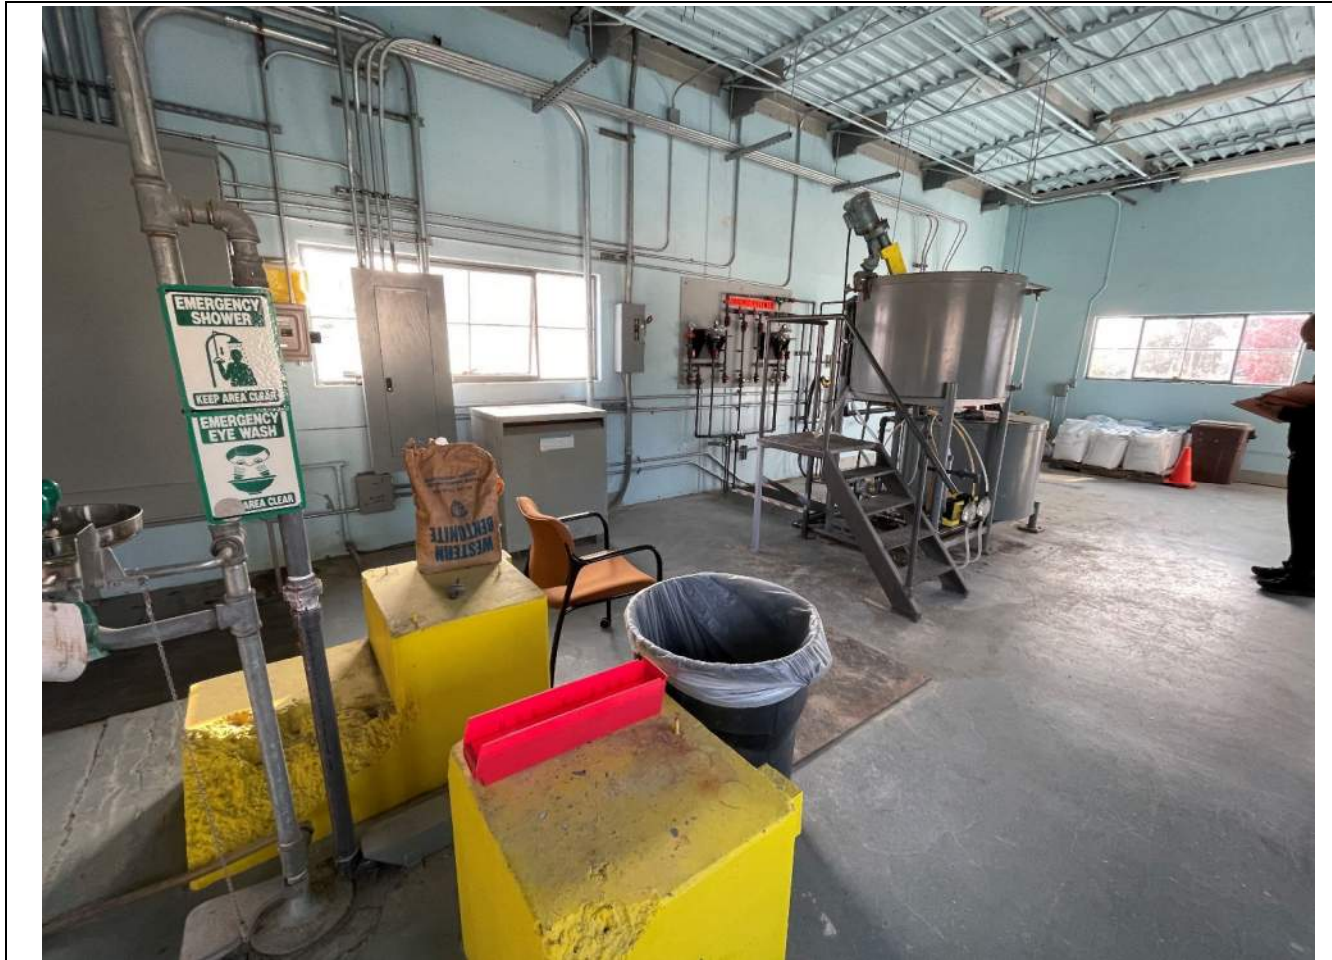
The Vine St WTP Control Building/ Chemical Storage Building reinforcing bar details do not comply with recommended standards. A seismic retrofit to address the shortcomings identified by the ASCE/SEI 41-17 checklist would be very difficult to perform.

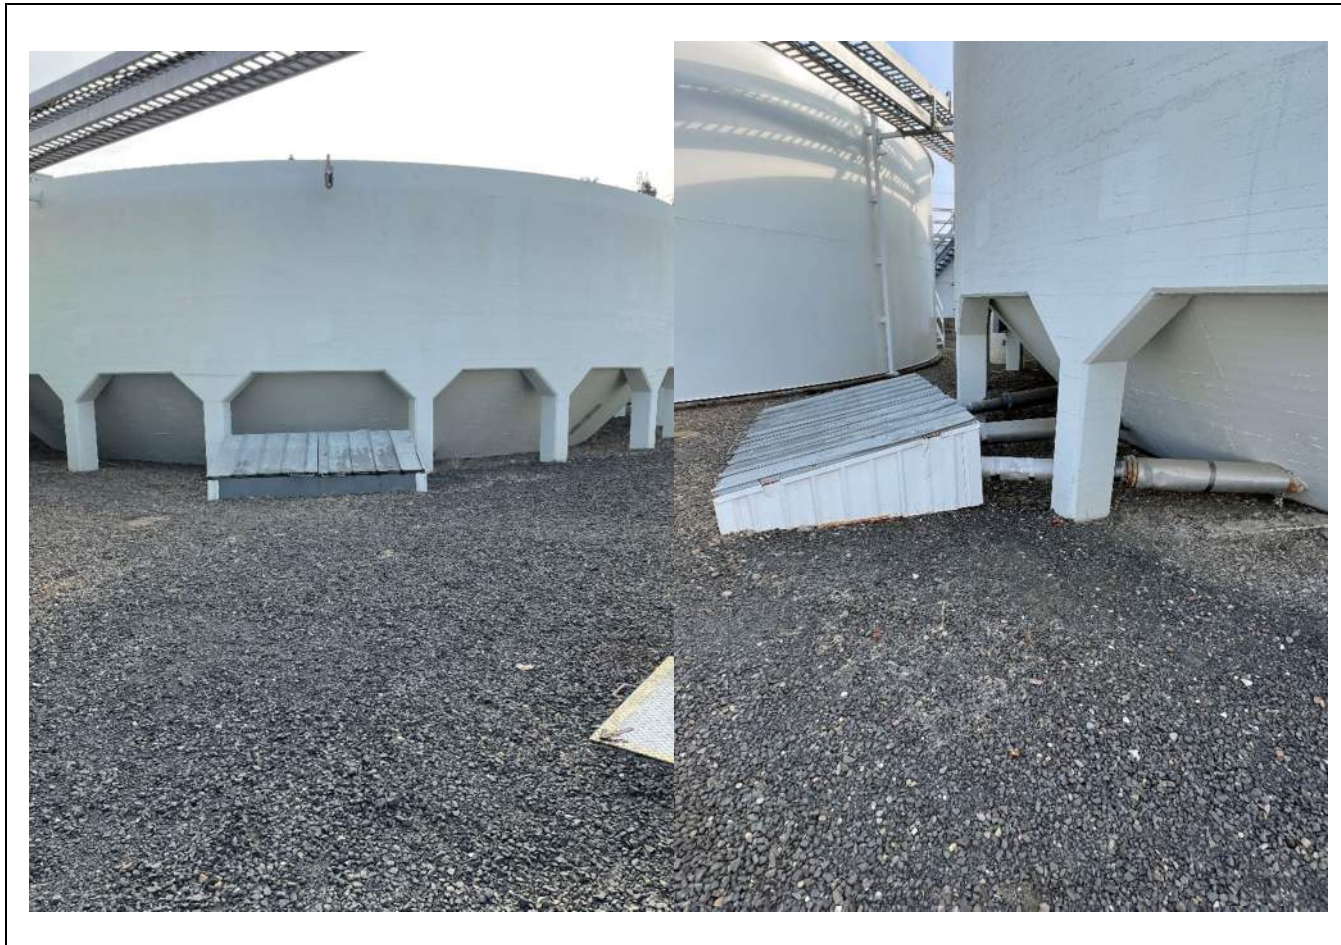
At Vine St WTP, the perimeter columns below the exterior walls of Accelerator 1 create a vertical irregularity and weak lateral force resisting system at the base. Infill between the existing columns with a concrete wall footing to eliminate the vertical irregularity. Tie the foundations together. If executed, the construction cost of this project is estimated at \$286,000. If this structure is planned for future decommissioning due to the new WTP, the City may choose not to implement this project.

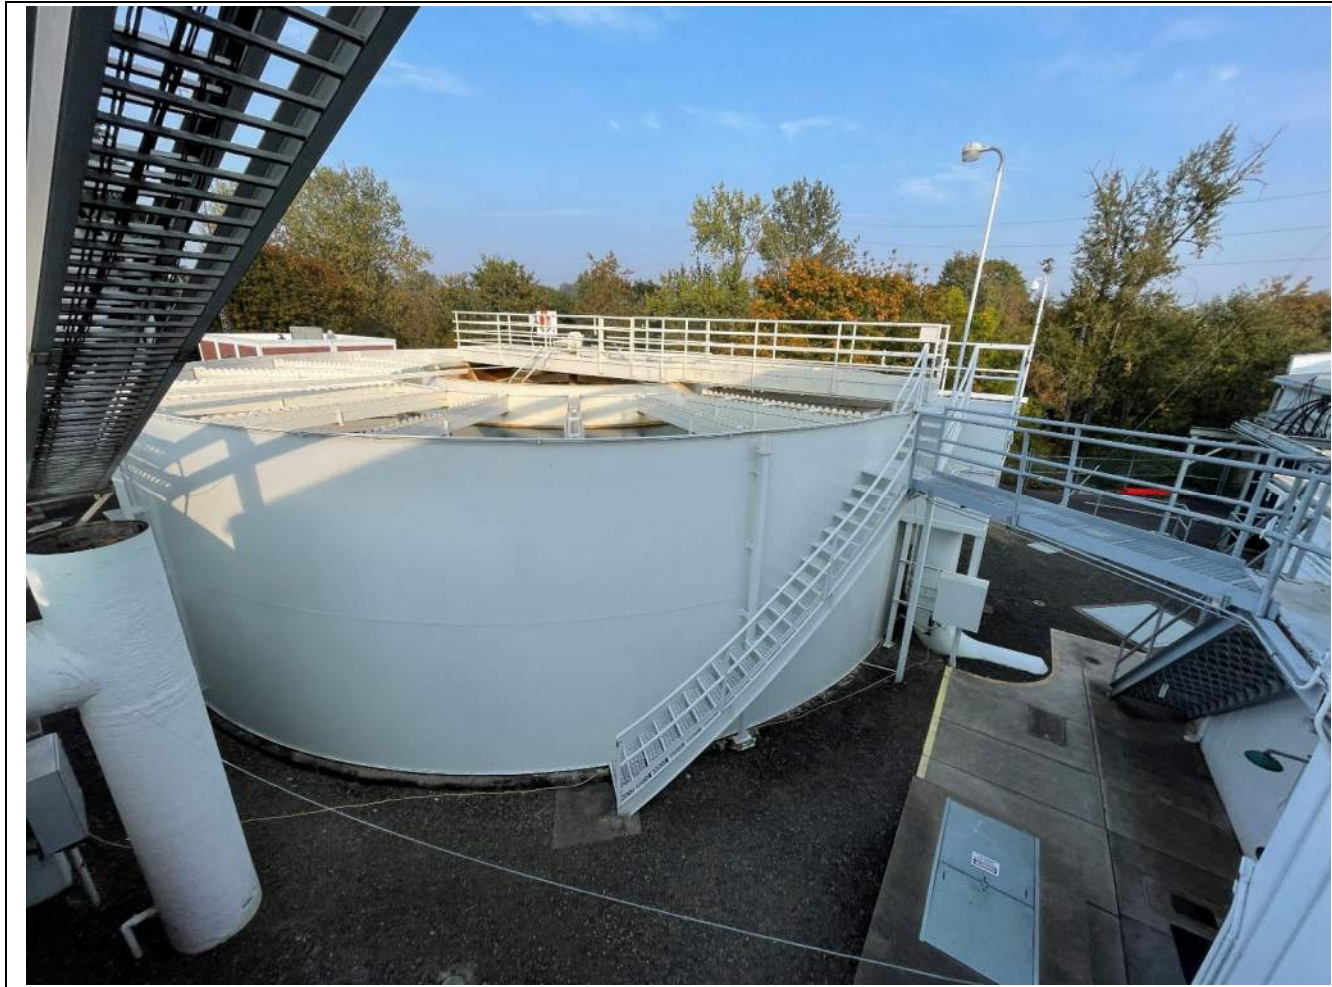
The Vine St WTP Accelerator 2 is not bolted to the foundation and relies on friction between the steel and concrete. Maintenance of steel wall is recommended. Consider adding anchor bolts capable of resisting uplift and sliding seismic forces. Clean and remove moss, mold and rust then maintain tank coating. If executed, the construction cost of this project is estimated at \$603,000. If this structure is planned for future decommissioning due to the new WTP, the City may choose not to implement this project.

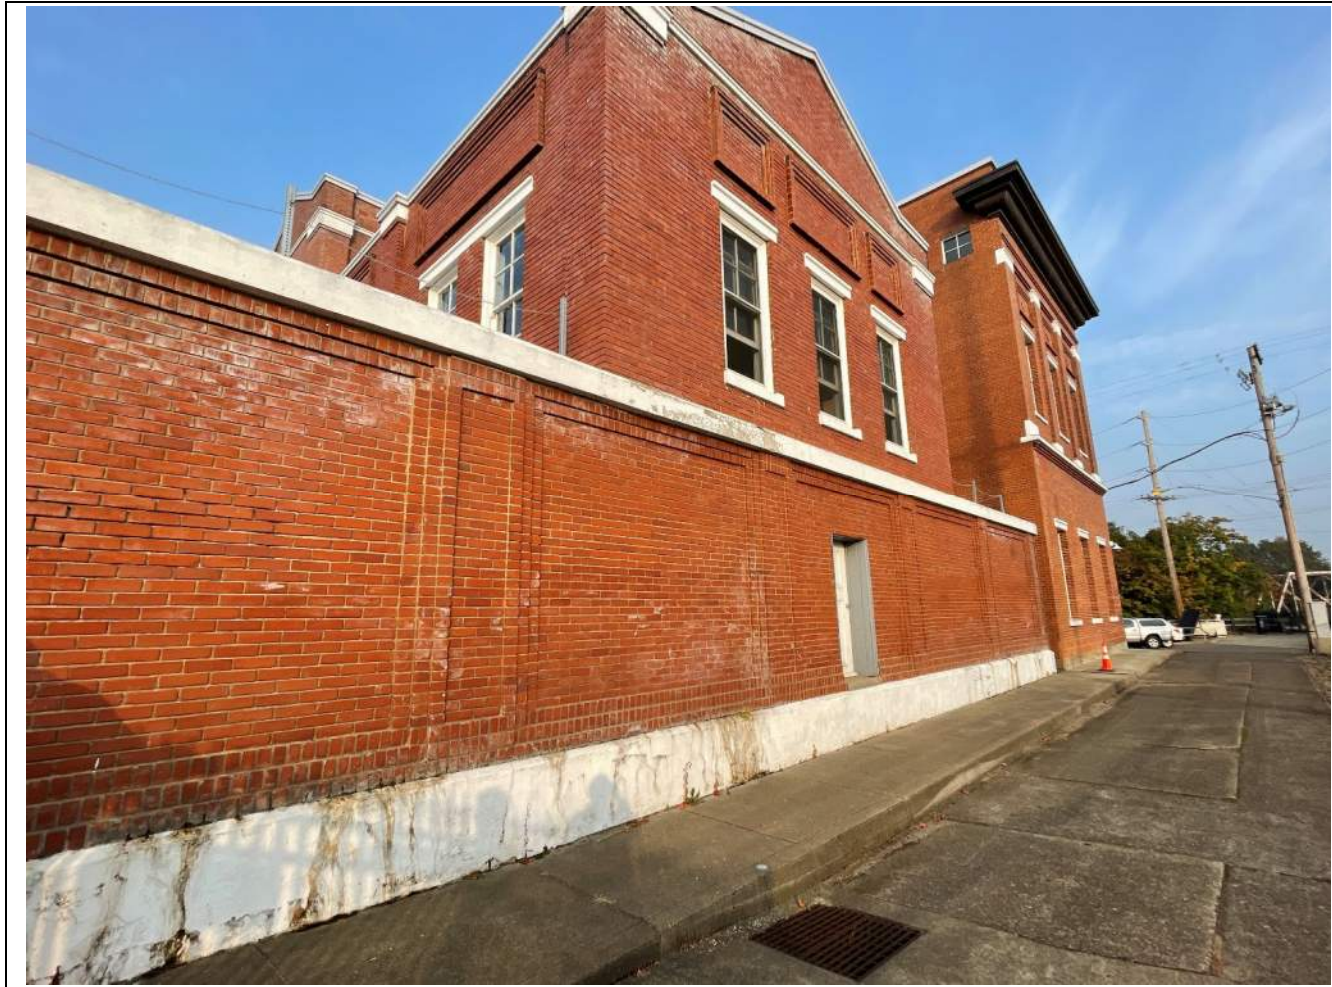
There are multiple structures at Vine St WTP that have an unreinforced brick parapet wall elements, which project above the roof, present a falling hazard during a seismic event particularly when located over areas of egress. The structures include the Raw Water Pump Station, Hydroelectric Building, Soda Ash Building, and Filters 1-6. It is recommended that the unreinforced brick parapets be removed so that the walls do not project above the roof, or they should be laterally braced to the roof framing for seismic & wind forces.

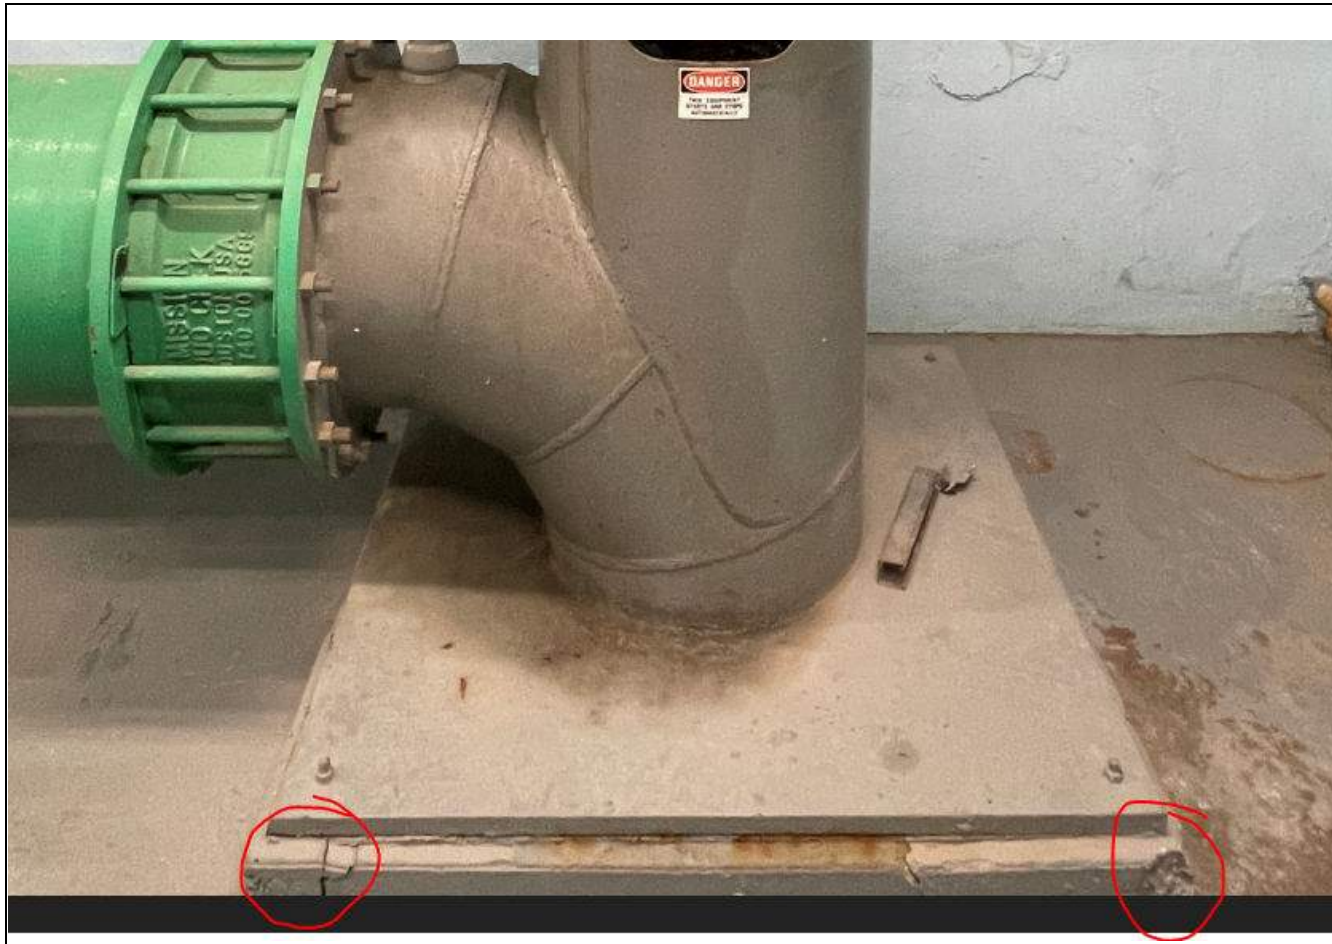
The Vine St WTP large backwash pump has a cracked base. Confirm pump anchorage is secure or replace concrete pad under pump base.

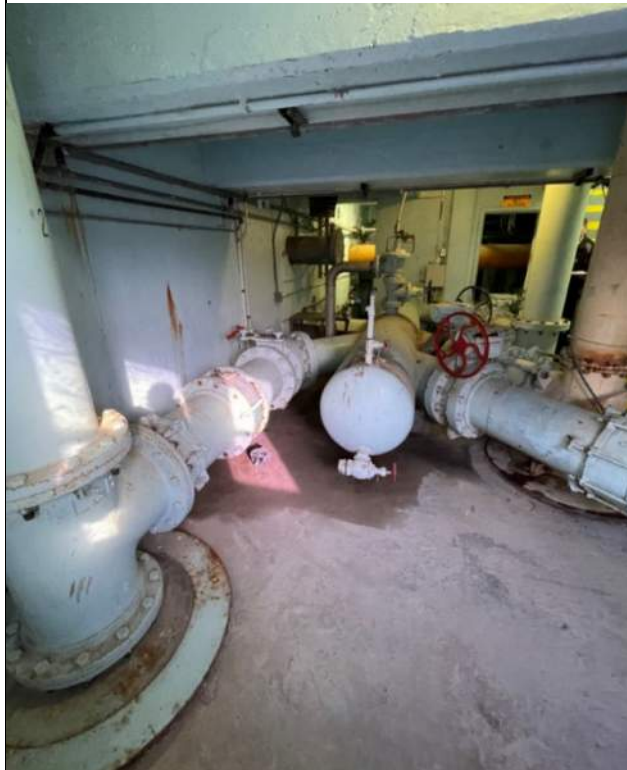
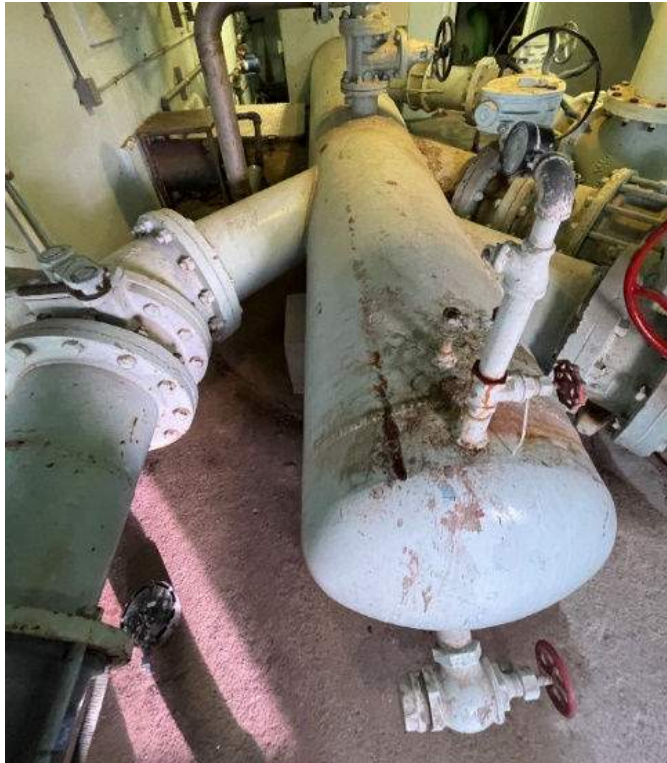
The Vine St WTP Transfer Water PS piping has rust. Appears to have no check valves. May need more pipe supports including lateral supports, may need more dismantling joints. Measure pipe thickness and recoat or replace pipes, as necessary. Add pipe supports within 2 feet of changes of direction, where practical. Add check valves and dismantling joints where practical.

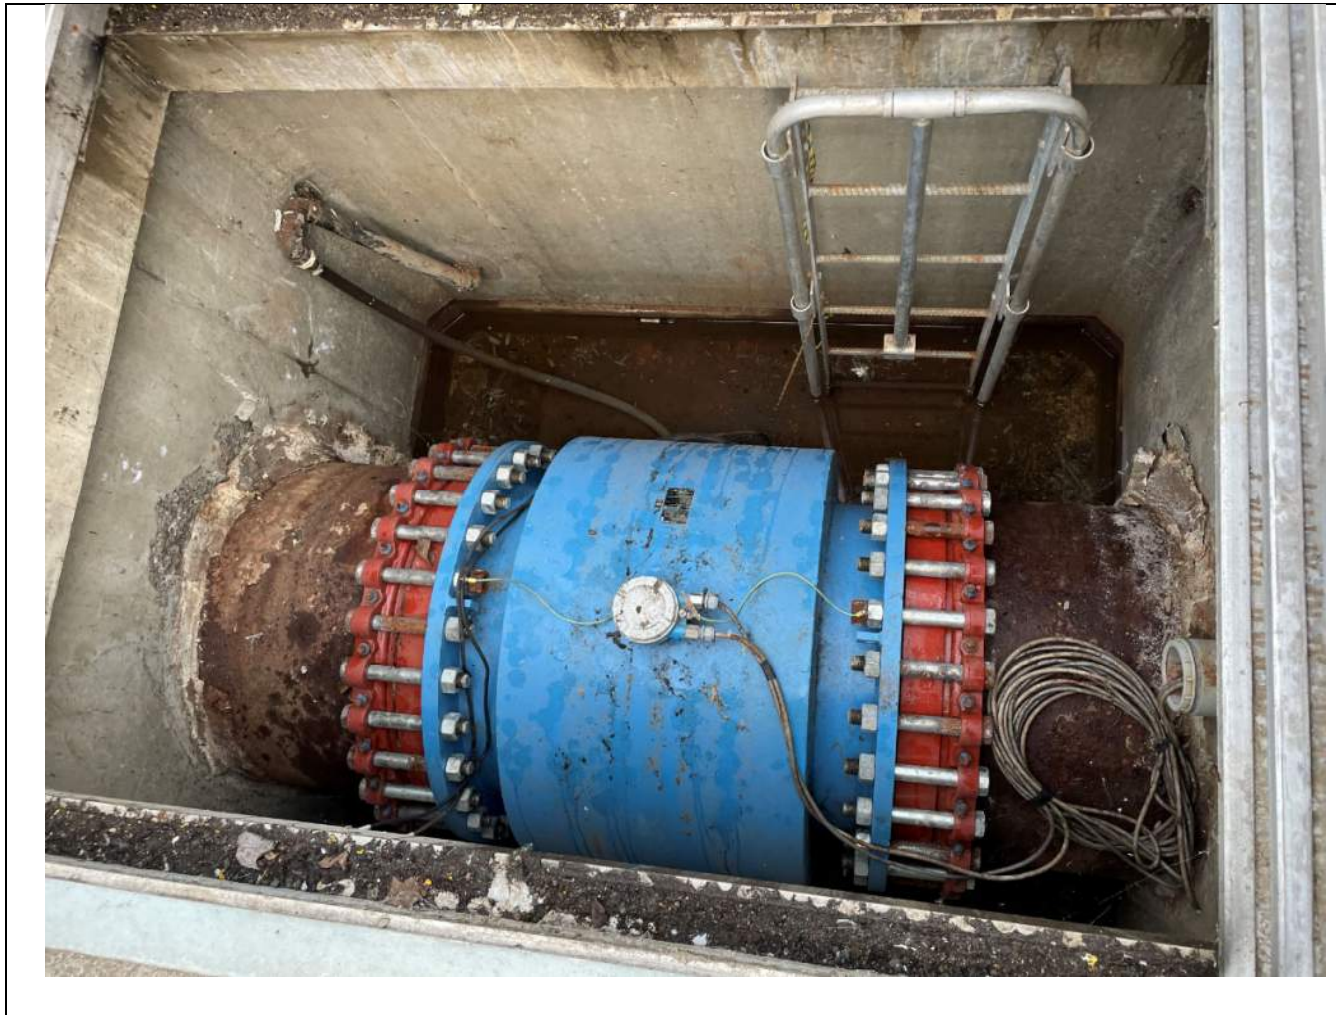
The Vine St RWPS Flow Meter Vault piping has rust. Measure pipe thickness. Replace or recoat.
