## Appendix A

### Pump Station Pump Curves

## Appendix B

### System Validation Results

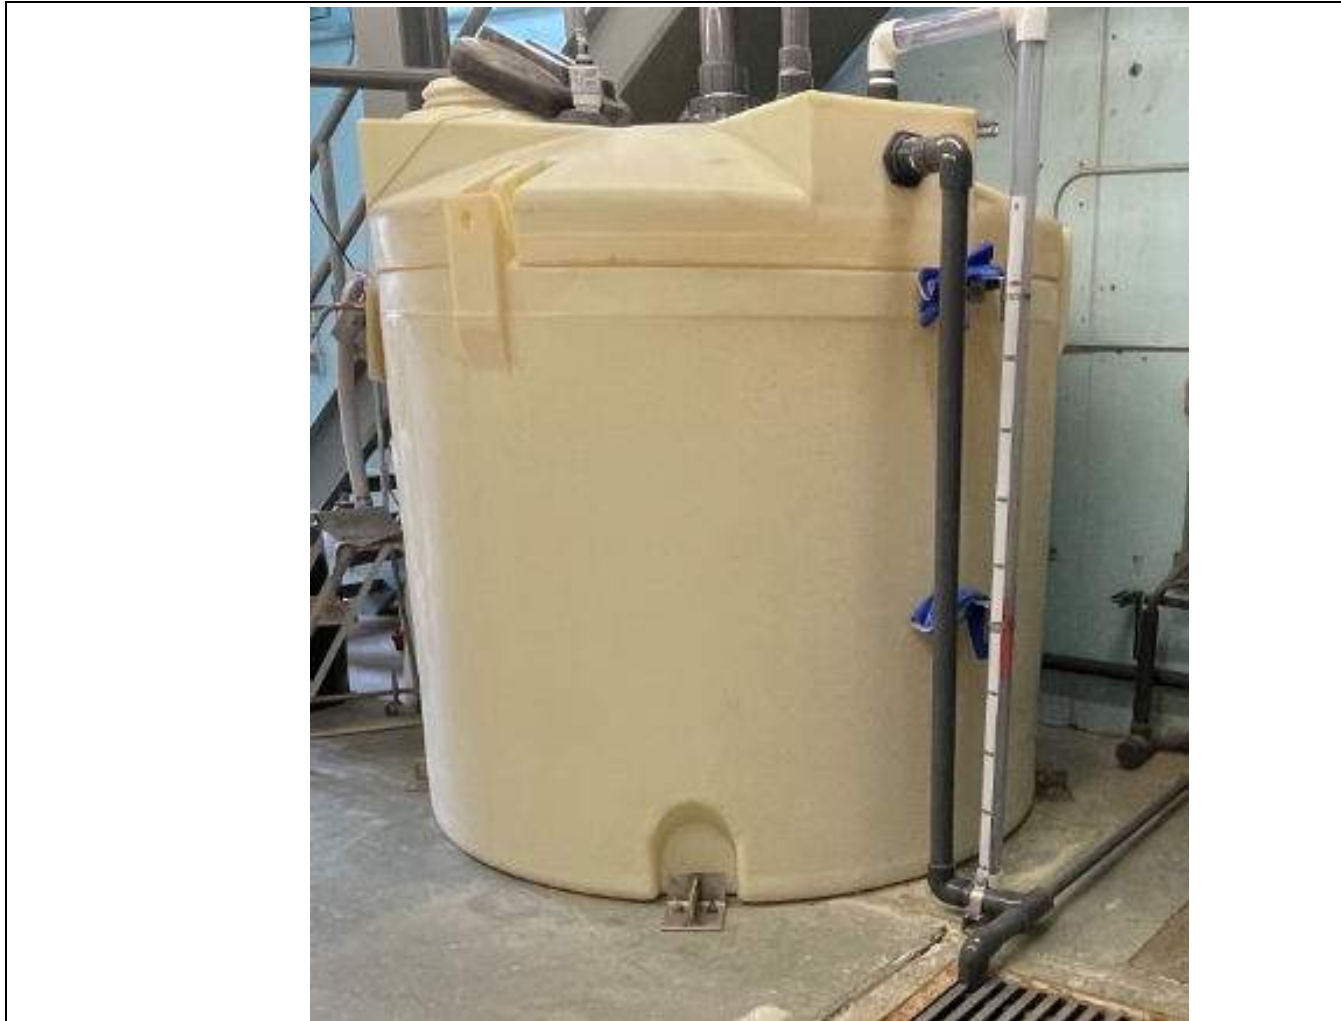
Liquid chemical room tanks may need more anchorage. Provide added tank anchorage as needed. Add MSDS on tanks as needed.

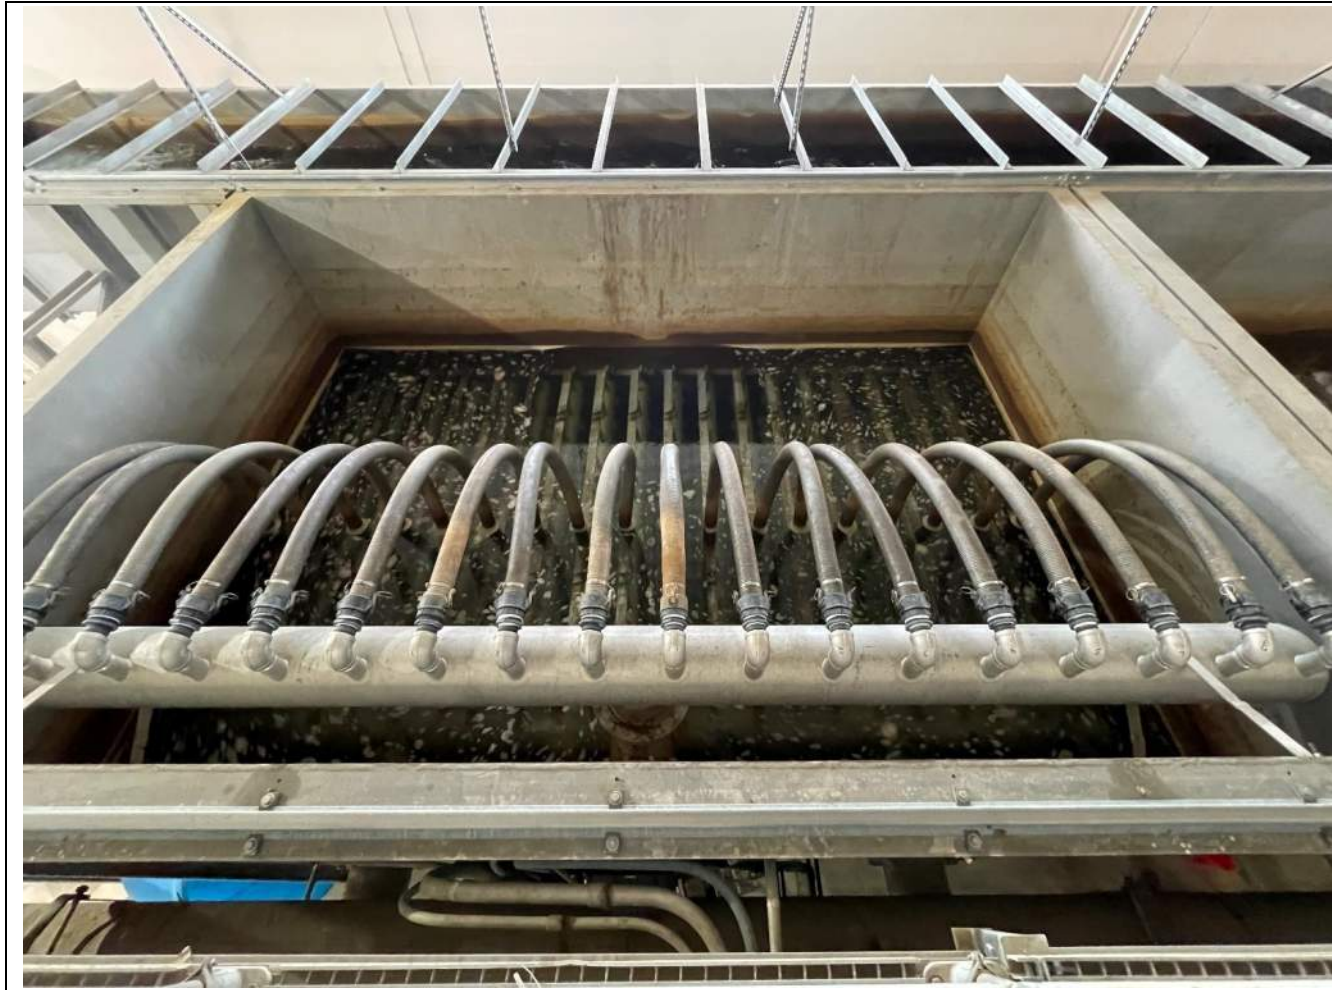
## AM WTP Replace Filter Cell Header Pipes

The existing header pipes for the filter cells have cracked and failed multiple times. It is thought that the pipe thickness may need to be thicker. It is recommended to replace the cell header pipes and consider a thicker pipe and stronger connection.

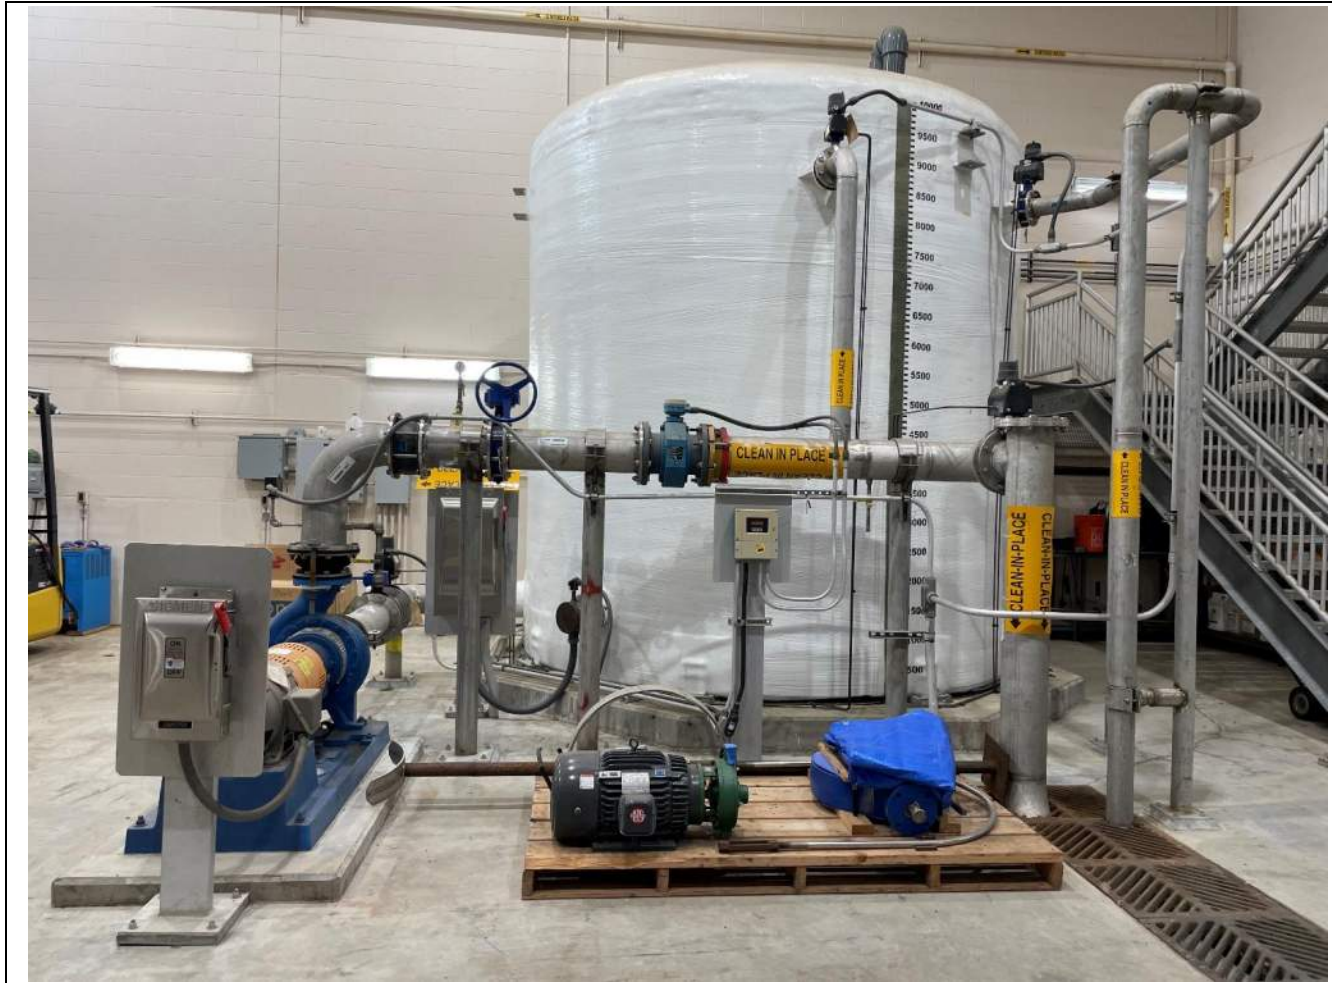
# AM WTP Clean in Place Pump

There is only one existing clean-in-place pump used to clean AM WTP filter membranes. It is recommended to install a second pump for redundancy.

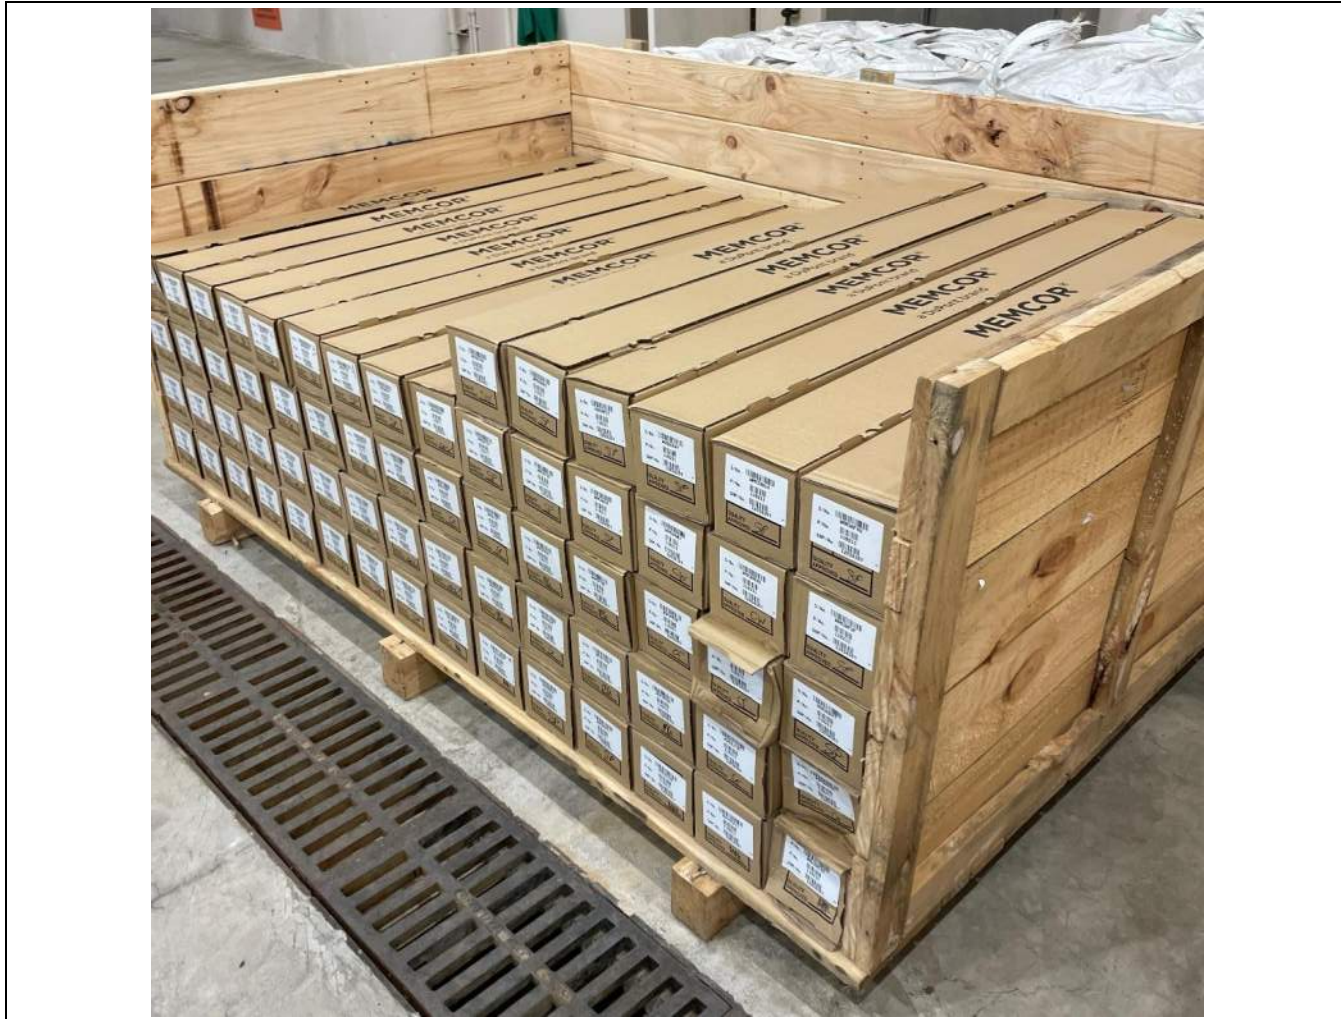
# AM WTP Membrane Replacement

Membrane lifespan is 10 years and the next replacement cycle is 2026-2028. The City plans to increase the number of membranes to the maximum 648 membranes per cell at that point which is recommended to achieve full capacity.

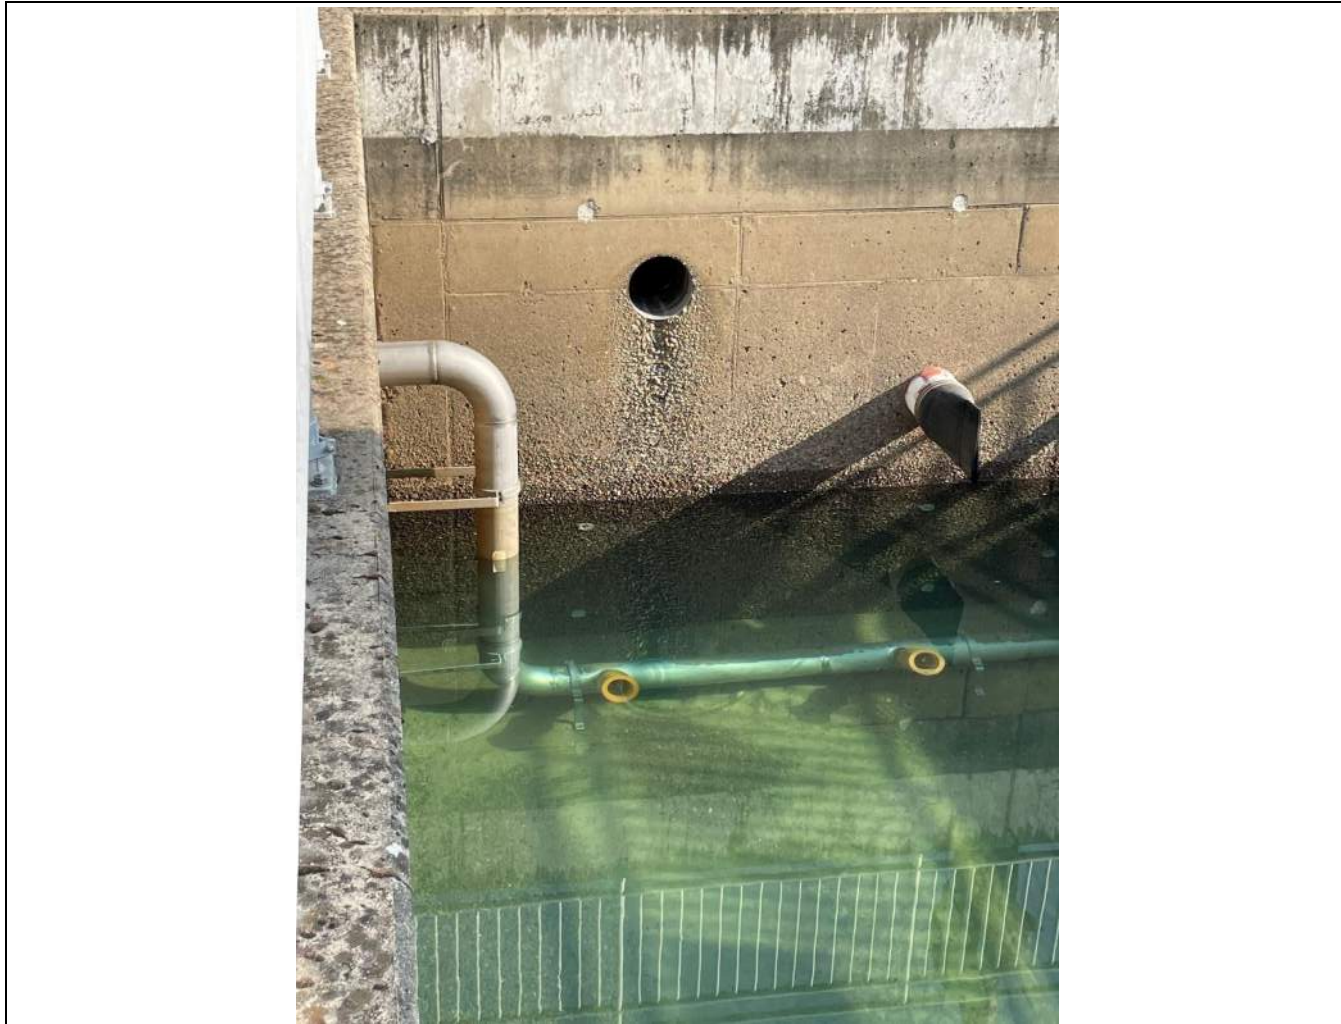
# AM WTP Neutralization Basin Concrete Repair

The AM WTP Neutralization Basin concrete wall has exposed aggregate near the inlet and below the waterline. Clean and provide a coating repair for the concrete with significant surface loss and exposed aggregate to prevent further loss of wall thickness.

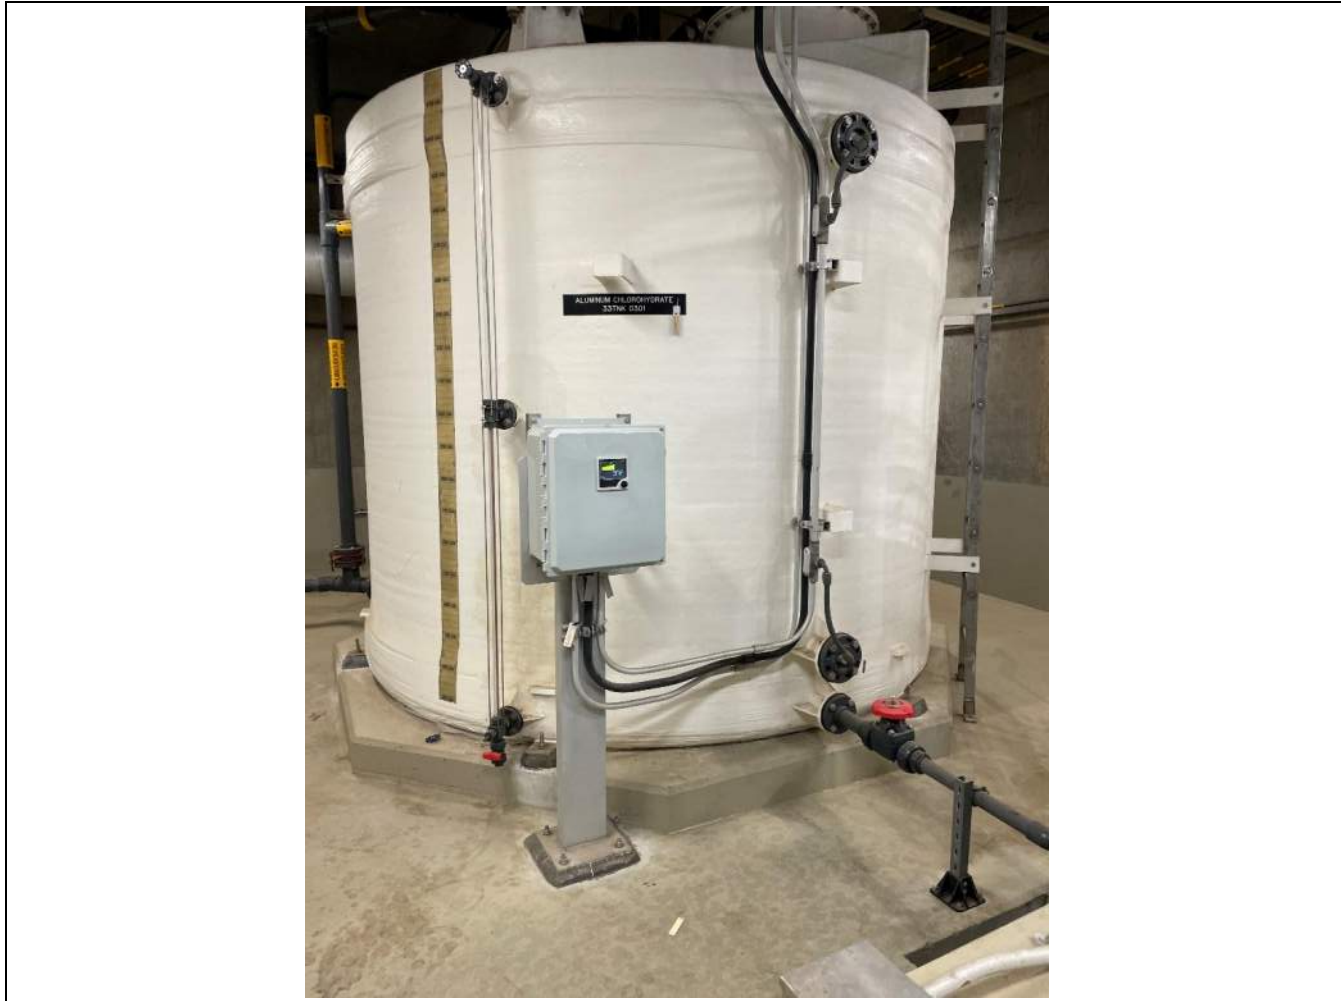
## AM WTP Chemical Tanks Seismic Straps

A&M WTP Chemical Tanks appear to have no seismic straps. Consider adding seismic straps.

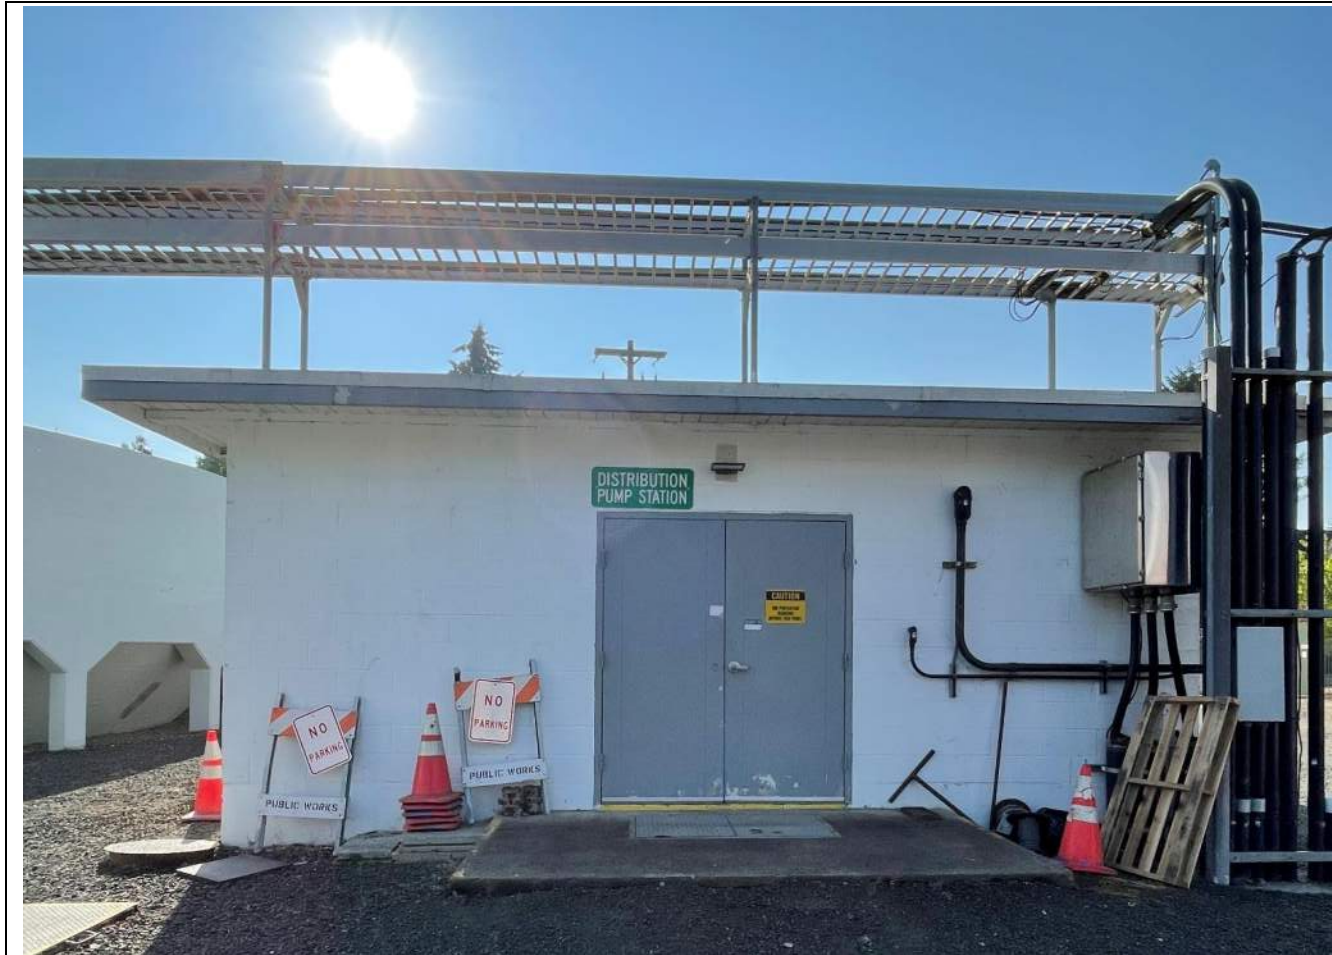
# Maple St Pump Station Roof Connection

The Maple St PS roof to wall connection may not be adequate to resist all seismic forces. During a maintenance re-roofing project for this building, upgrade the roof to wall connection. If executed, the construction cost of this project is estimated at \$288,000. If this structure is planned for future decommissioning, the City may choose not to implement this project. It is recommended that this project be re-evaluated during the next WMP update.

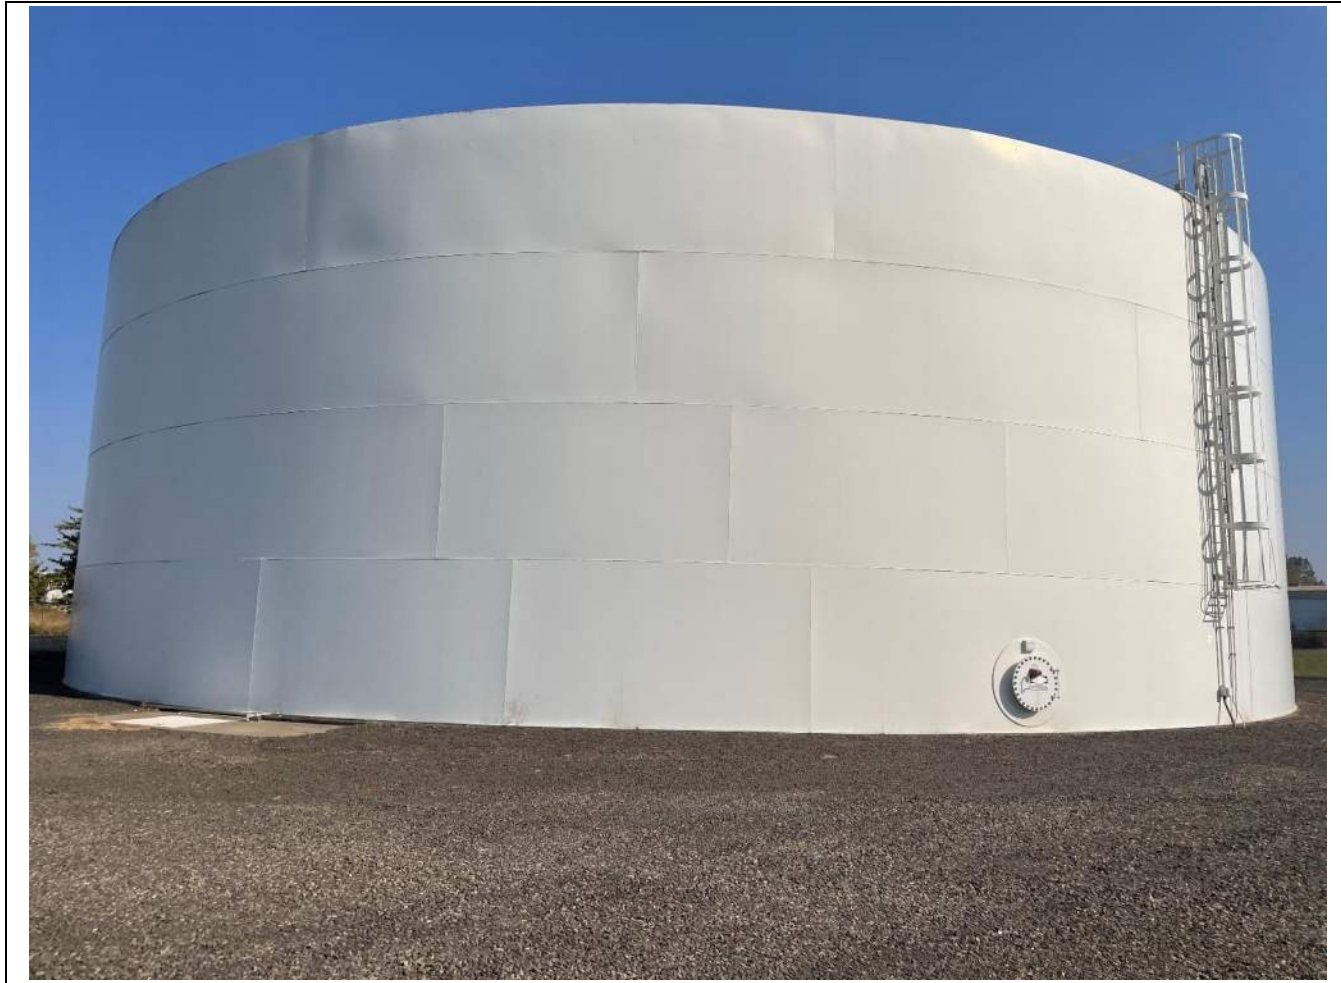
# 34<sup>th</sup> St Reservoir Anchor Bolts

The 34th St Reservoir is not bolted to the foundation and relies on friction between the steel & concrete. Maintenance of steel wall is recommended. Consider adding anchor bolts capable of resisting uplift and sliding seismic forces. Clean and remove moss, mold and rust then maintain tank coating.

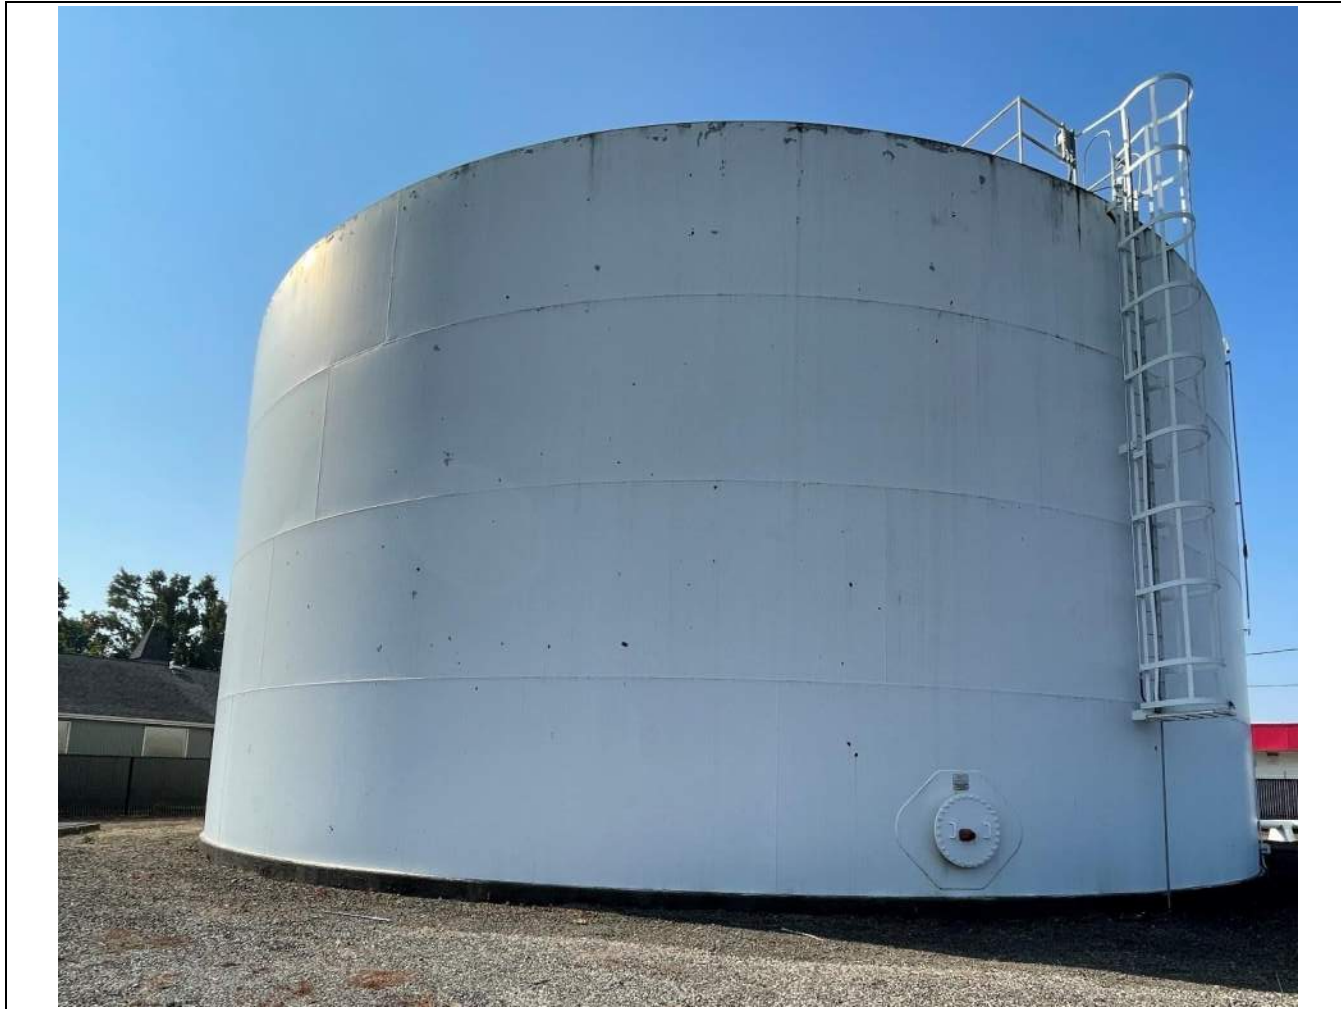
# Queen Ave Reservoir Anchor Bolts

The Queen Ave Reservoir is not bolted to the foundation and relies on friction between the steel and concrete. Maintenance of steel wall is recommended. Consider adding anchor bolts capable of resisting uplift and sliding seismic forces. Clean and remove moss, mold and rust then maintain tank coating.

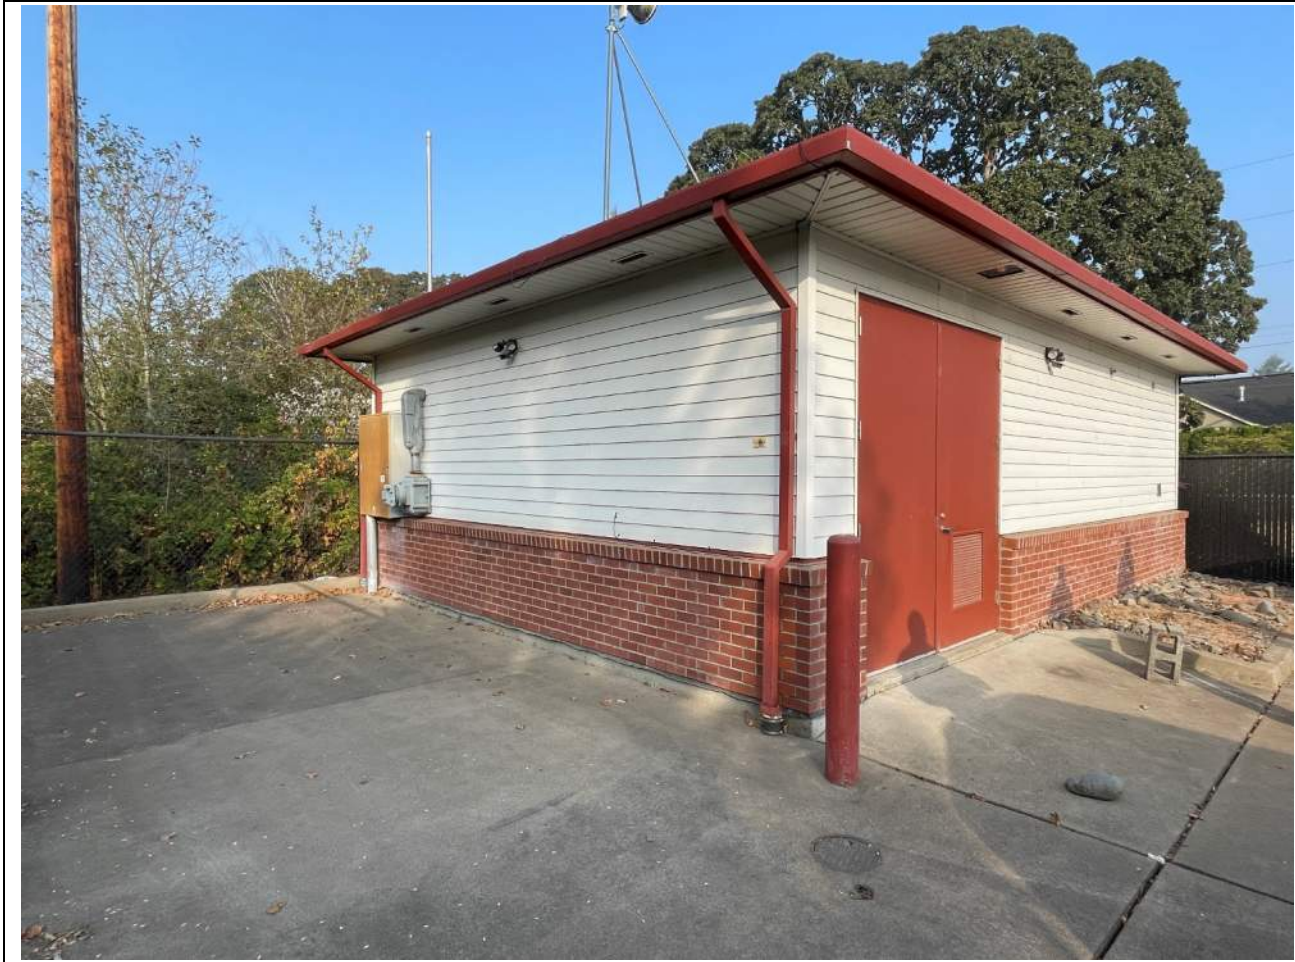
No hold down hardware and anchor bolts are visible or shown on the existing drawings. Remove finishes and provide appropriate hold down anchors. If these connections are not present, provide the appropriate hold downs and sill bolts.

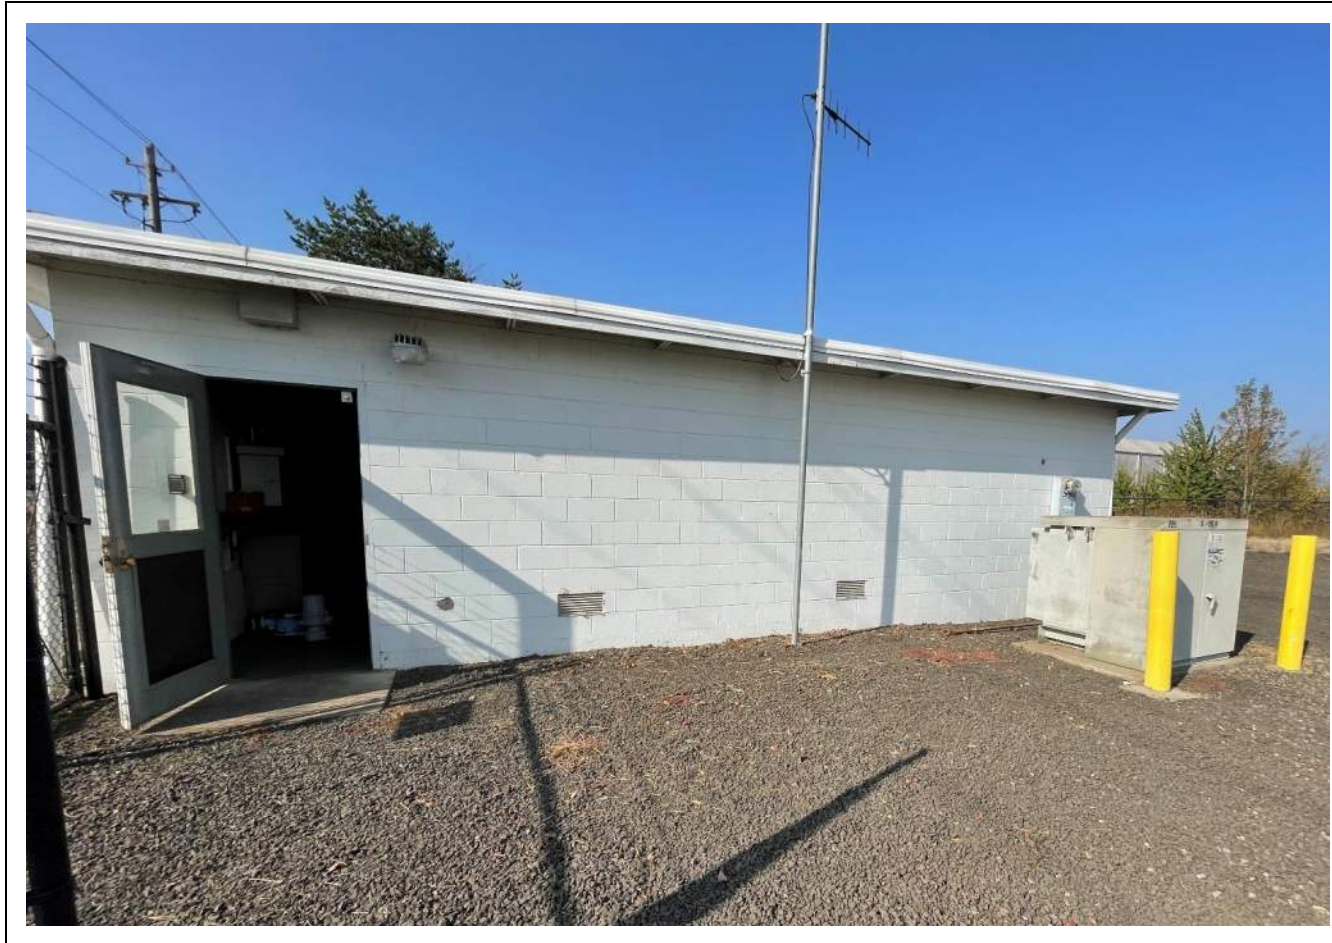
## 34<sup>th</sup> St Pump Station Roof Connection

The 34th St Pump Station roof to wall connection of the Pump Station is non-compliant. During a maintenance re-roofing project for this building, upgrade the roof to wall connection.

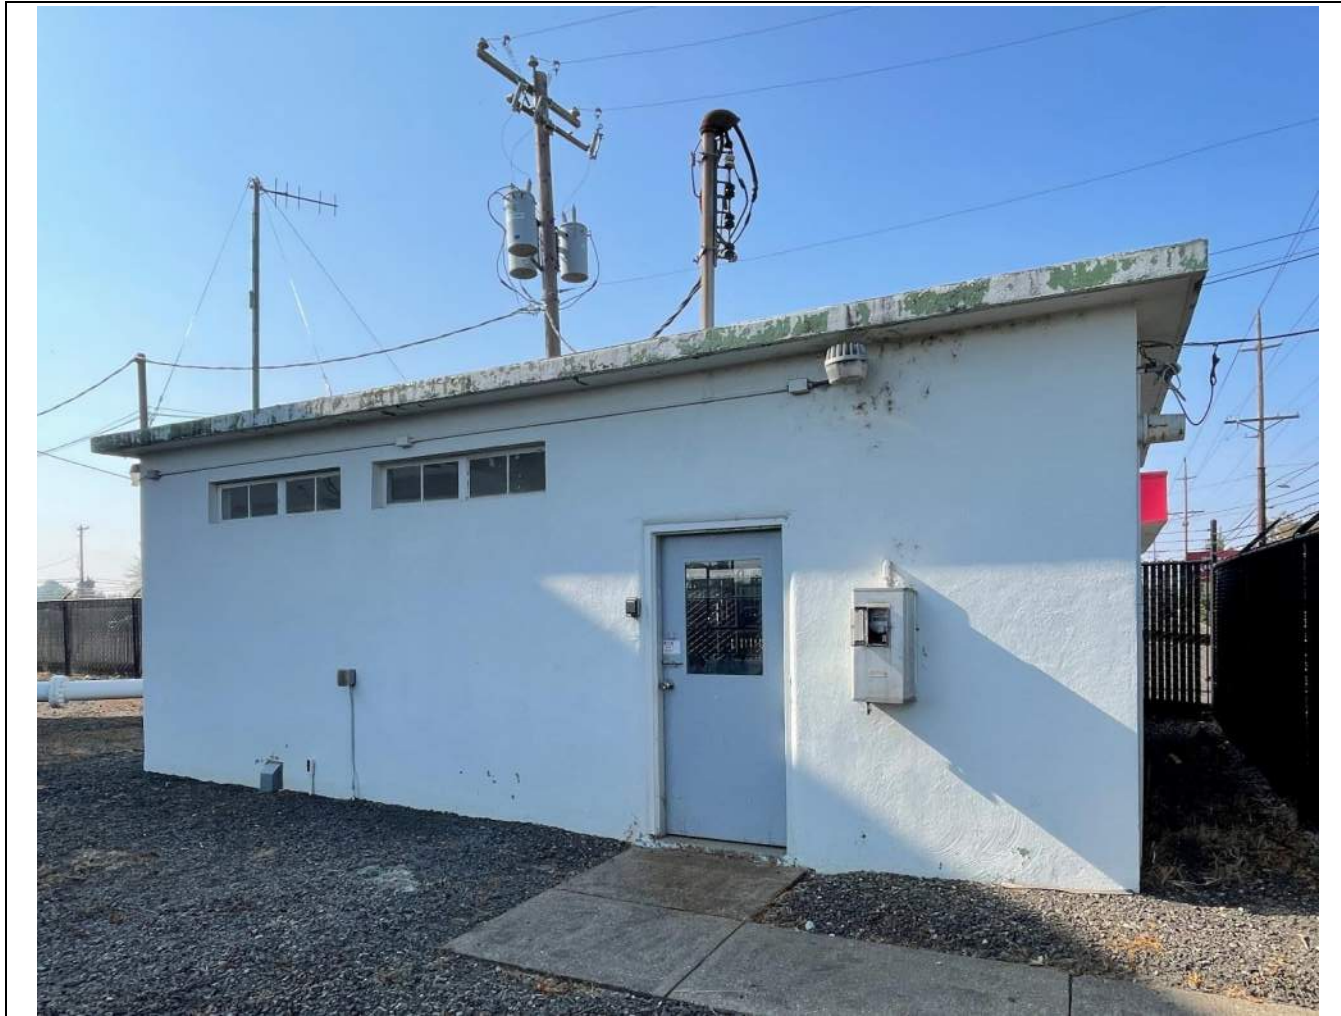
# Queen Ave Pump Station Roof Connection

The Queen Ave Pump Station roof to wall connection of the Pump Station is non-compliant. During a maintenance re-roofing project for this building, upgrade the roof to wall connection.

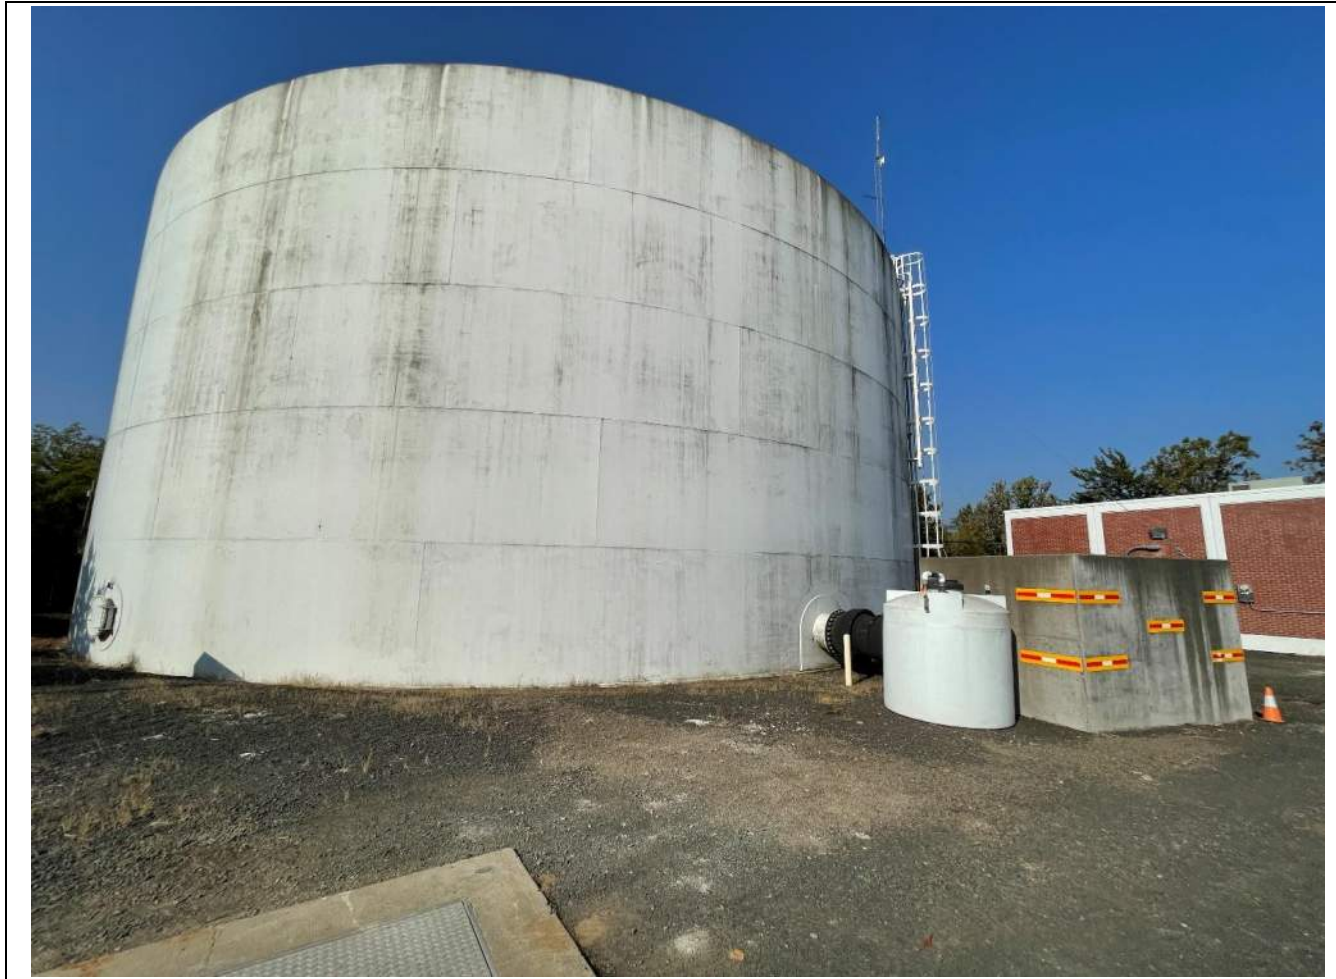
# Maple St Reservoir Anchor Bolts

The Maple St Reservoir is not bolted to the foundation and relies on friction between the steel & concrete. Maintenance of steel wall is recommended. Consider adding anchor bolts capable of resisting uplift and sliding seismic forces. Clean and remove moss, mold and rust then maintain tank coating.

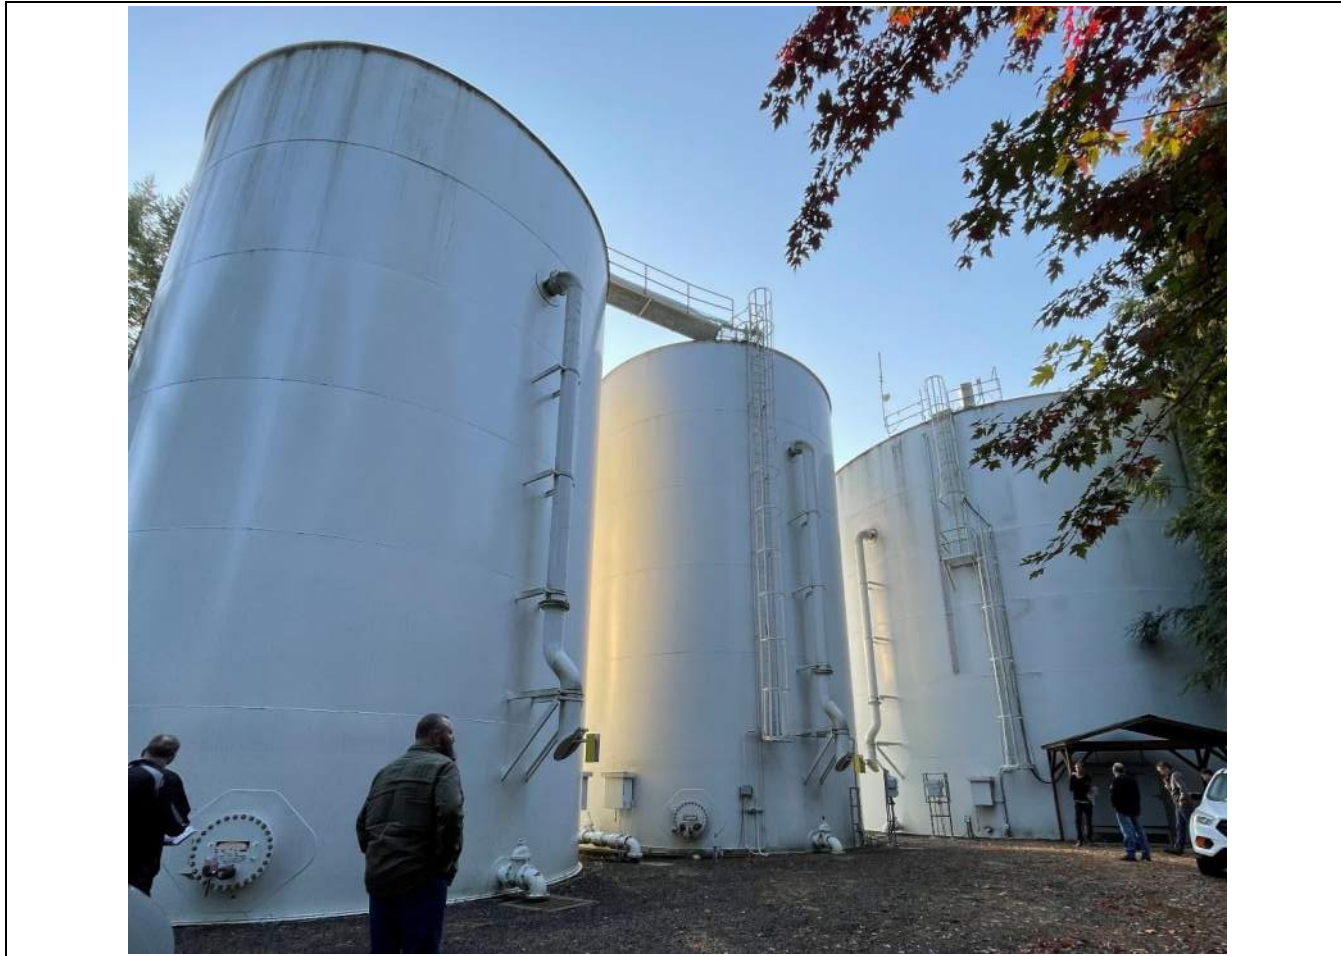
# Valley View Reservoirs Anchor Bolts

The Valley View Reservoirs are not bolted to the foundation and relies on friction between the steel & concrete. Maintenance of steel wall is recommended. Consider adding anchor bolts capable of resisting uplift & sliding seismic forces. Clean and remove moss, mold and rust then maintain tank coating.

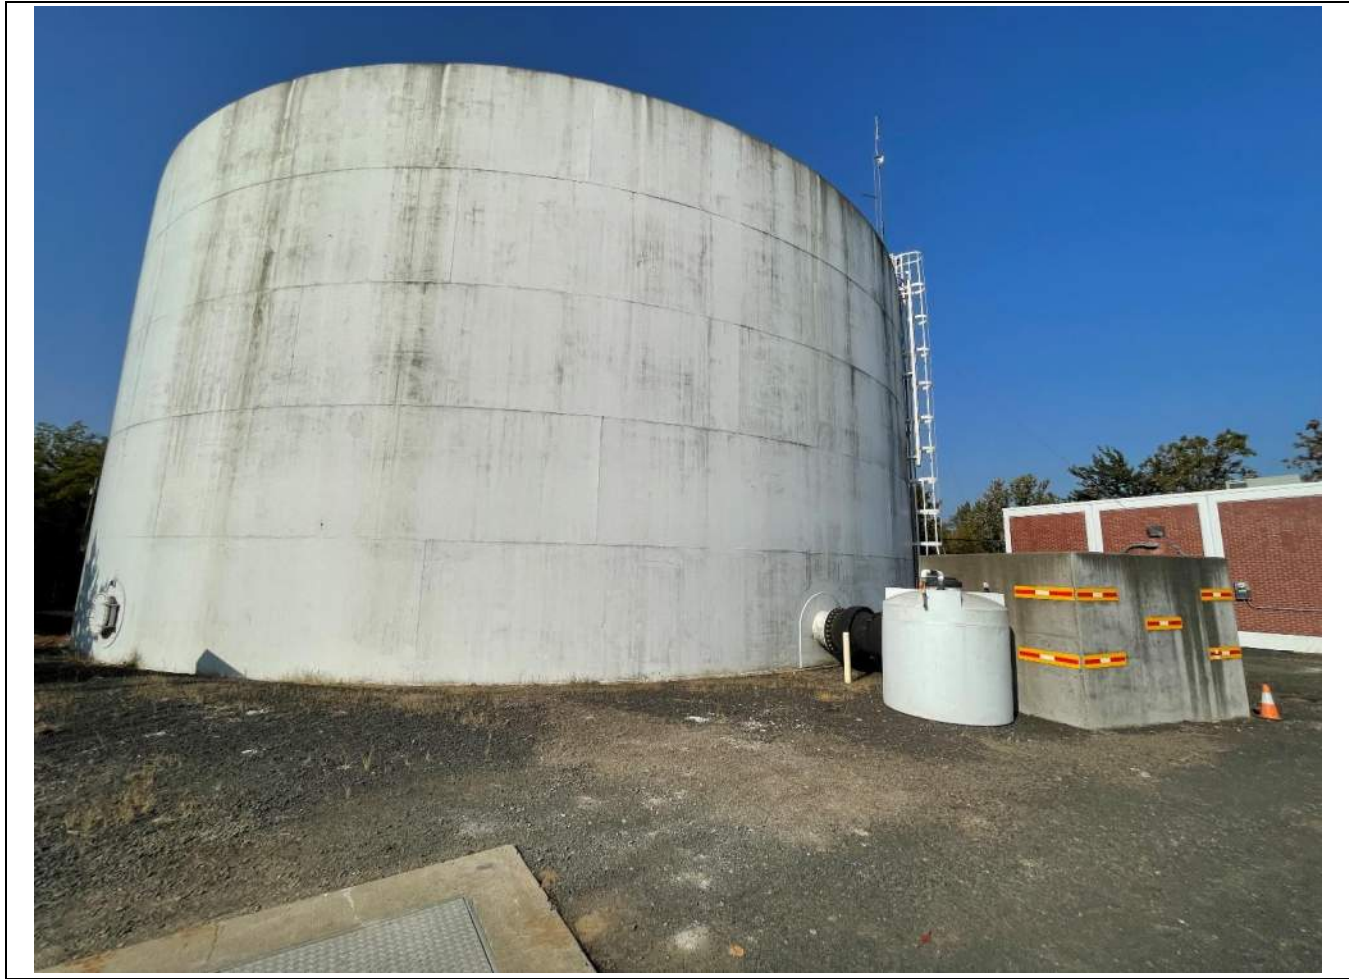
# Maple St Reservoir Coating

This is an existing project the City is currently planning for 2024, and is listed here for reference. The City can't pressure wash the existing Maple St Reservoir coating because it can chip the coating and expose the orange coating underneath which may contain lead. Recoat Reservoir. The City estimates a capital cost of \$500,000 when combined with Vine St Hydropower Penstock Coating. The price for the reservoir coating is assumed to be half, , \$250,000. This project cost is not included in the WMP CIP budget because it is already included in the City budget for 2024-2028 CIP projects.

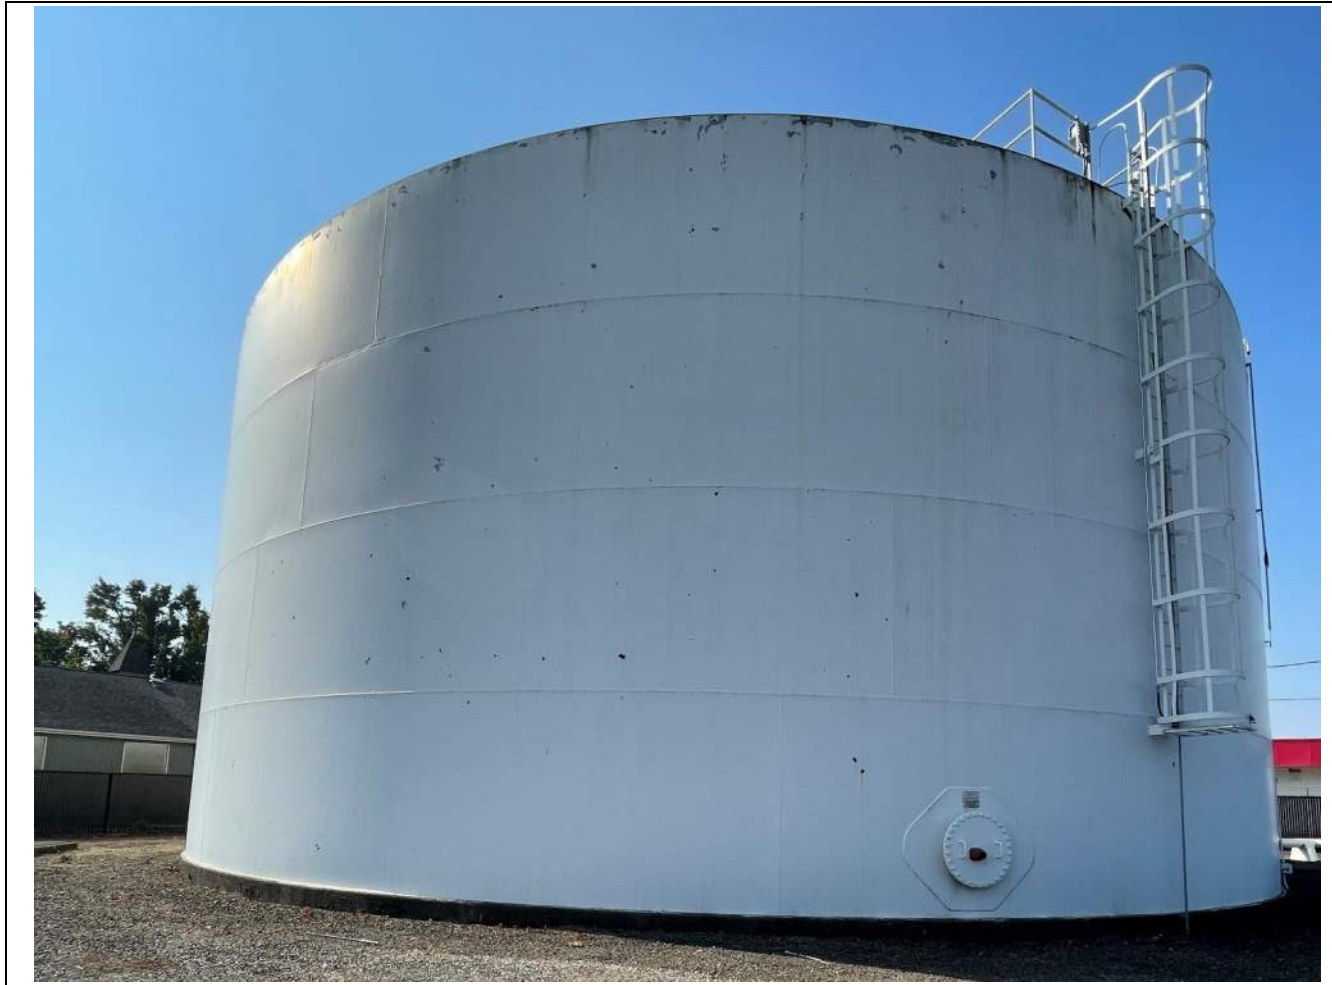
## Queen Avenue Reservoir Coating

This is an existing project the City is currently planning for 2024, and is listed here for reference. The Queen Ave Reservoir paint is chipping. Recoat reservoir. The City estimates a capital cost of \$200,000. This project cost is not included in the WMP CIP budget because it is already included in the City budget for 2024-2028 CIP projects.
