## Appendix A

### Pump Station Pump Curves

## Appendix B

### System Validation Results

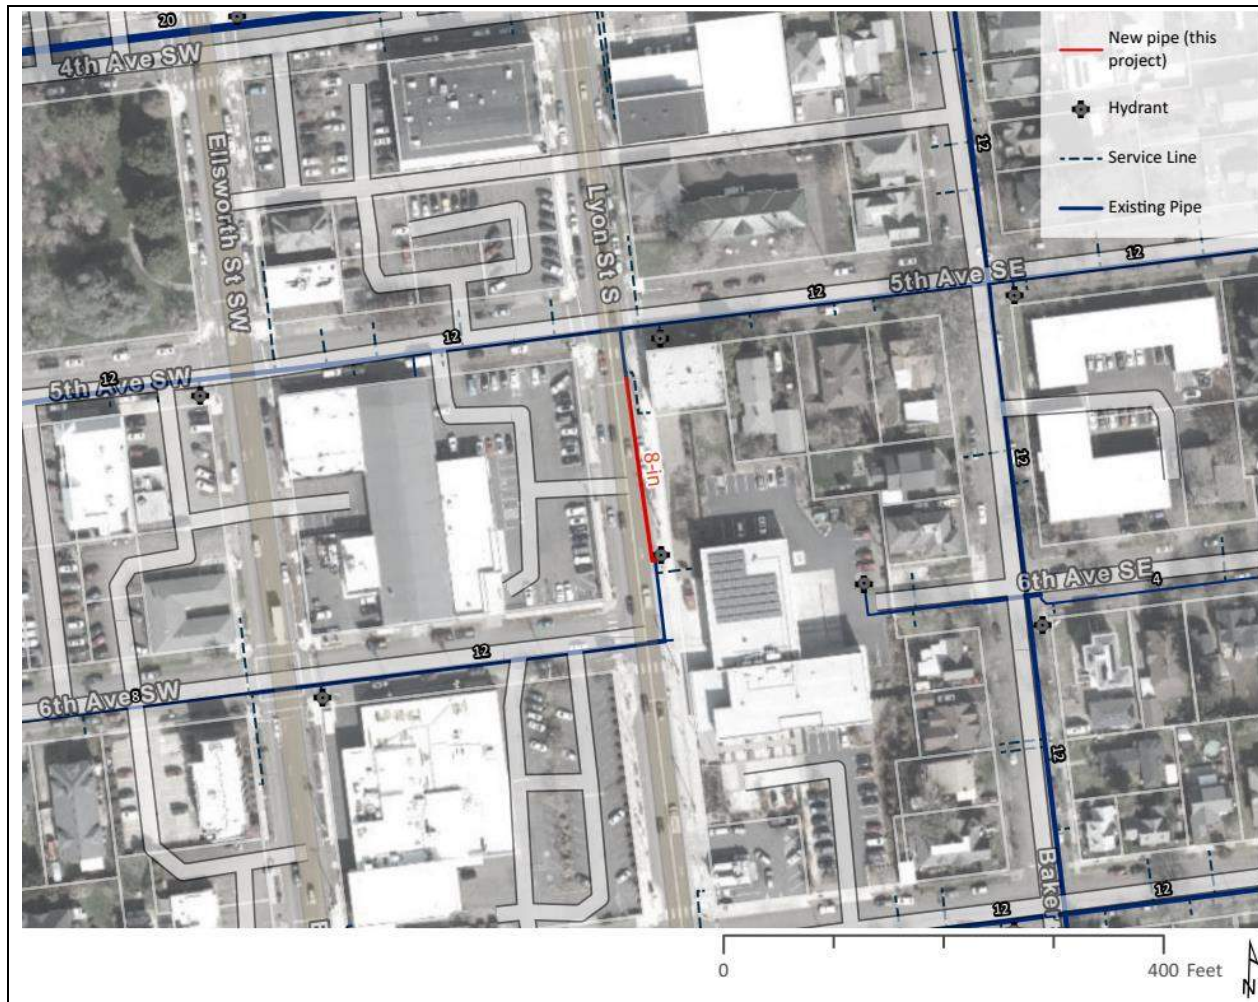
## Lyon St Fire Flow Improvement

This project is needed to supply the required 3,500 gpm fire flow to nearby commercial customers. This flow cannot be provided by the existing pipes due to insufficient looping. Adding 8-inch looping along Lyon St will allow the required flow to be provided.

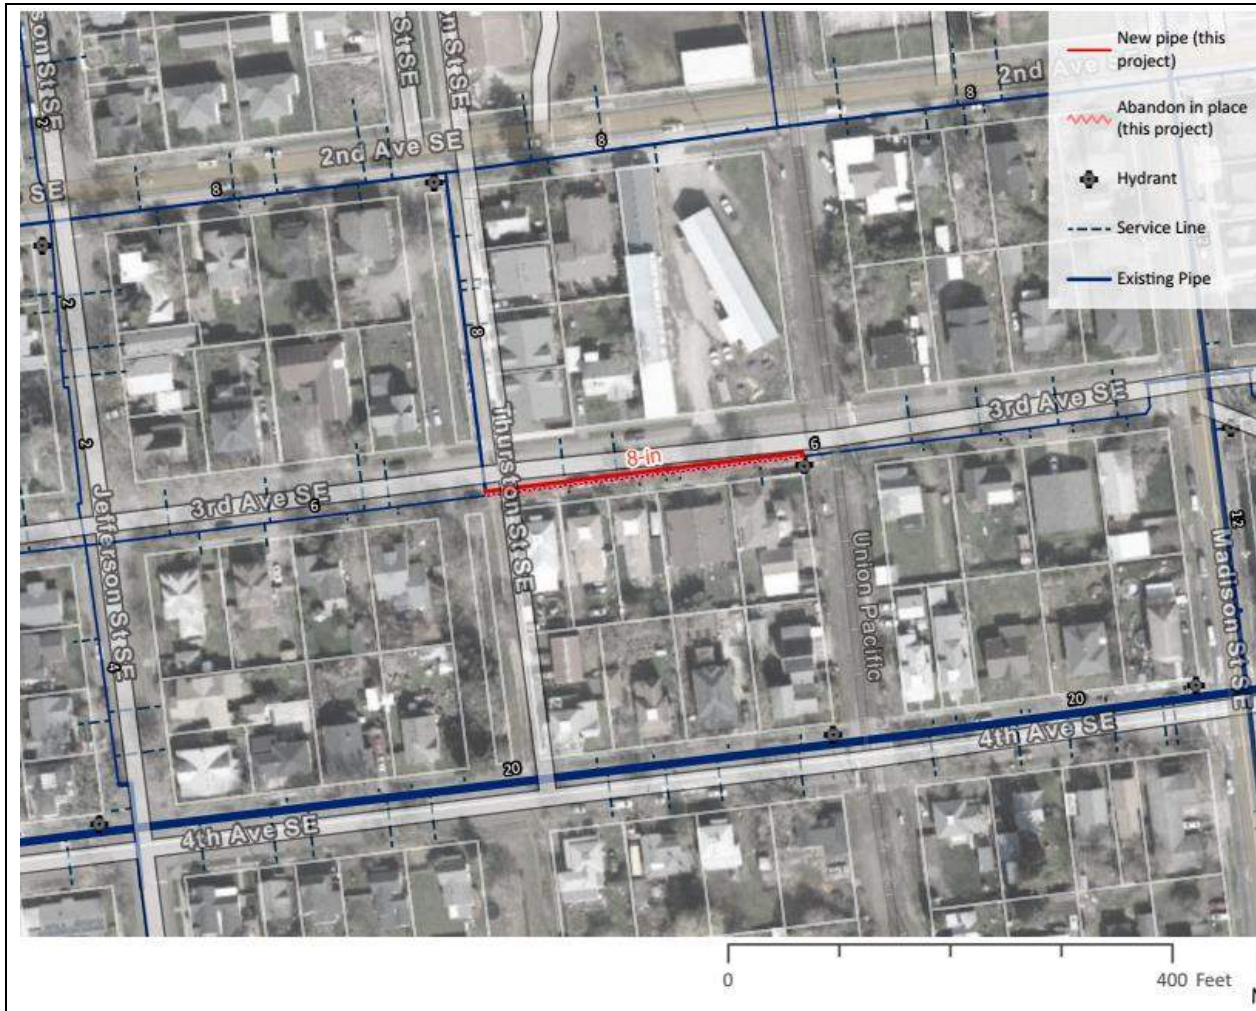
## 3<sup>rd</sup> Ave Fire Flow Improvement 2

This project is needed to supply the required 3,500 gpm fire flow to commercial customers in the area shown. This flow cannot be provided by the existing 6-inch pipes. Replacing the 6-inch pipe on 3rd Ave with 8-inch will allow the required flow to be provided.

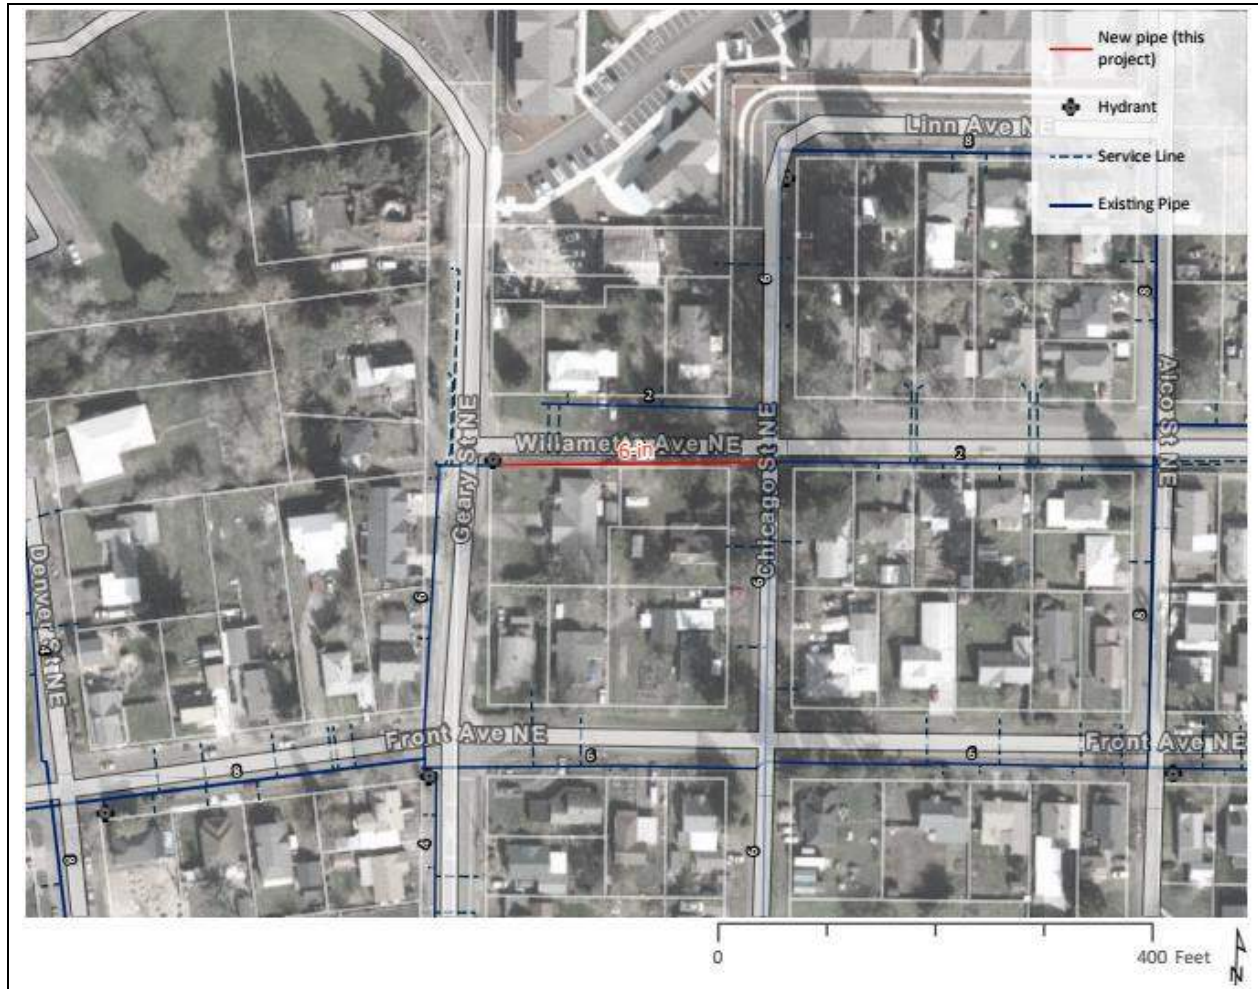
## Geary St Fire Flow Improvement

This project is needed to supply the required 2,500 gpm fire flow to medium-density residential customers on Geary St. This flow cannot be provided by the existing 6-inch pipe due to insufficient looping.

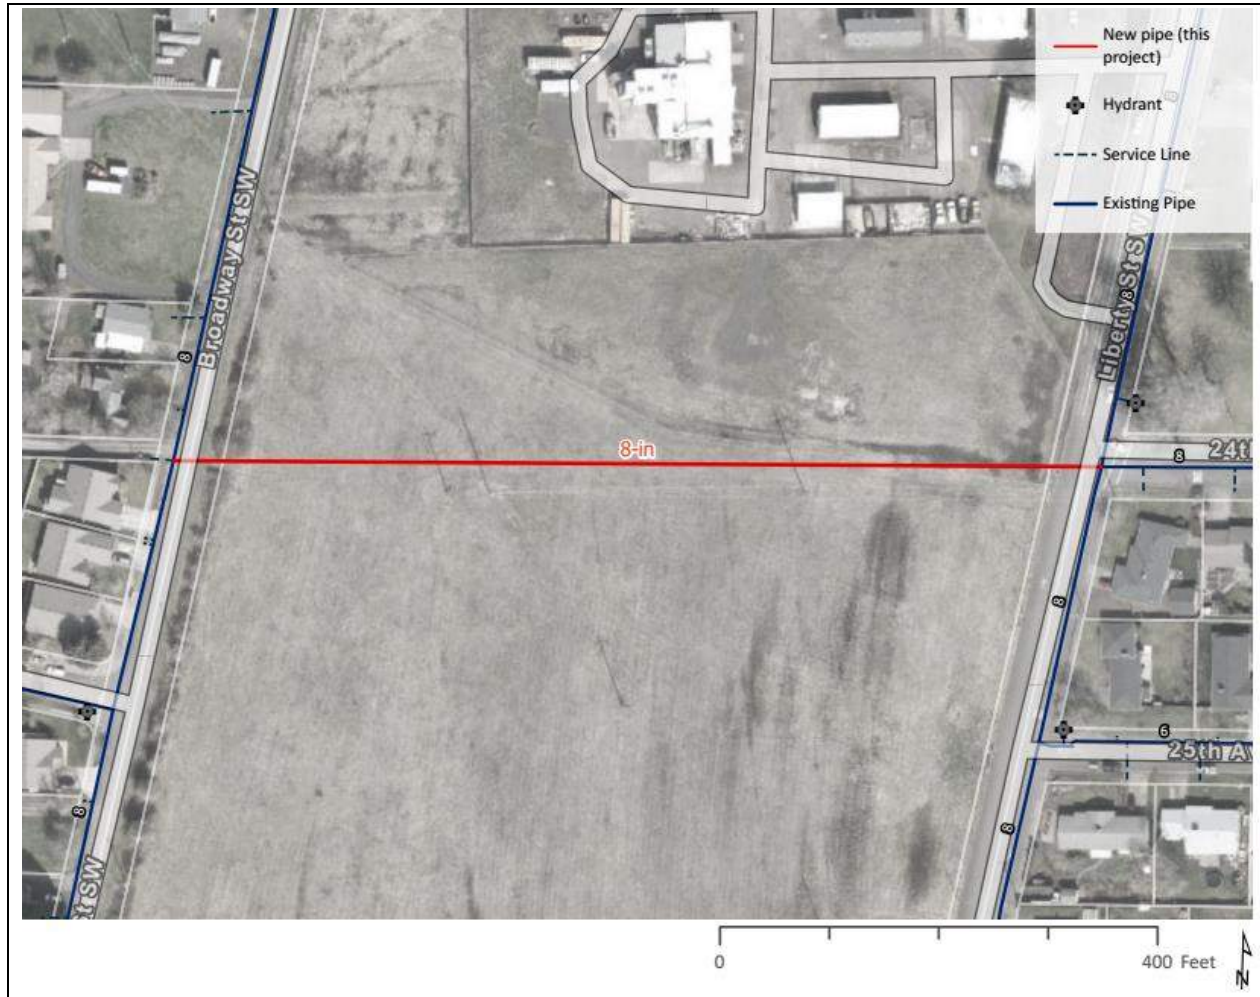
## Broadway Street Fire Flow Improvement

This project is needed to supply the required 3,500 gpm fire flow to the commercial customers on Broadway St. This flow cannot be provided by the existing pipes due to insufficient looping. Adding an 8-inch pipe from Liberty St will improve looping and allow the required flow to be provided.

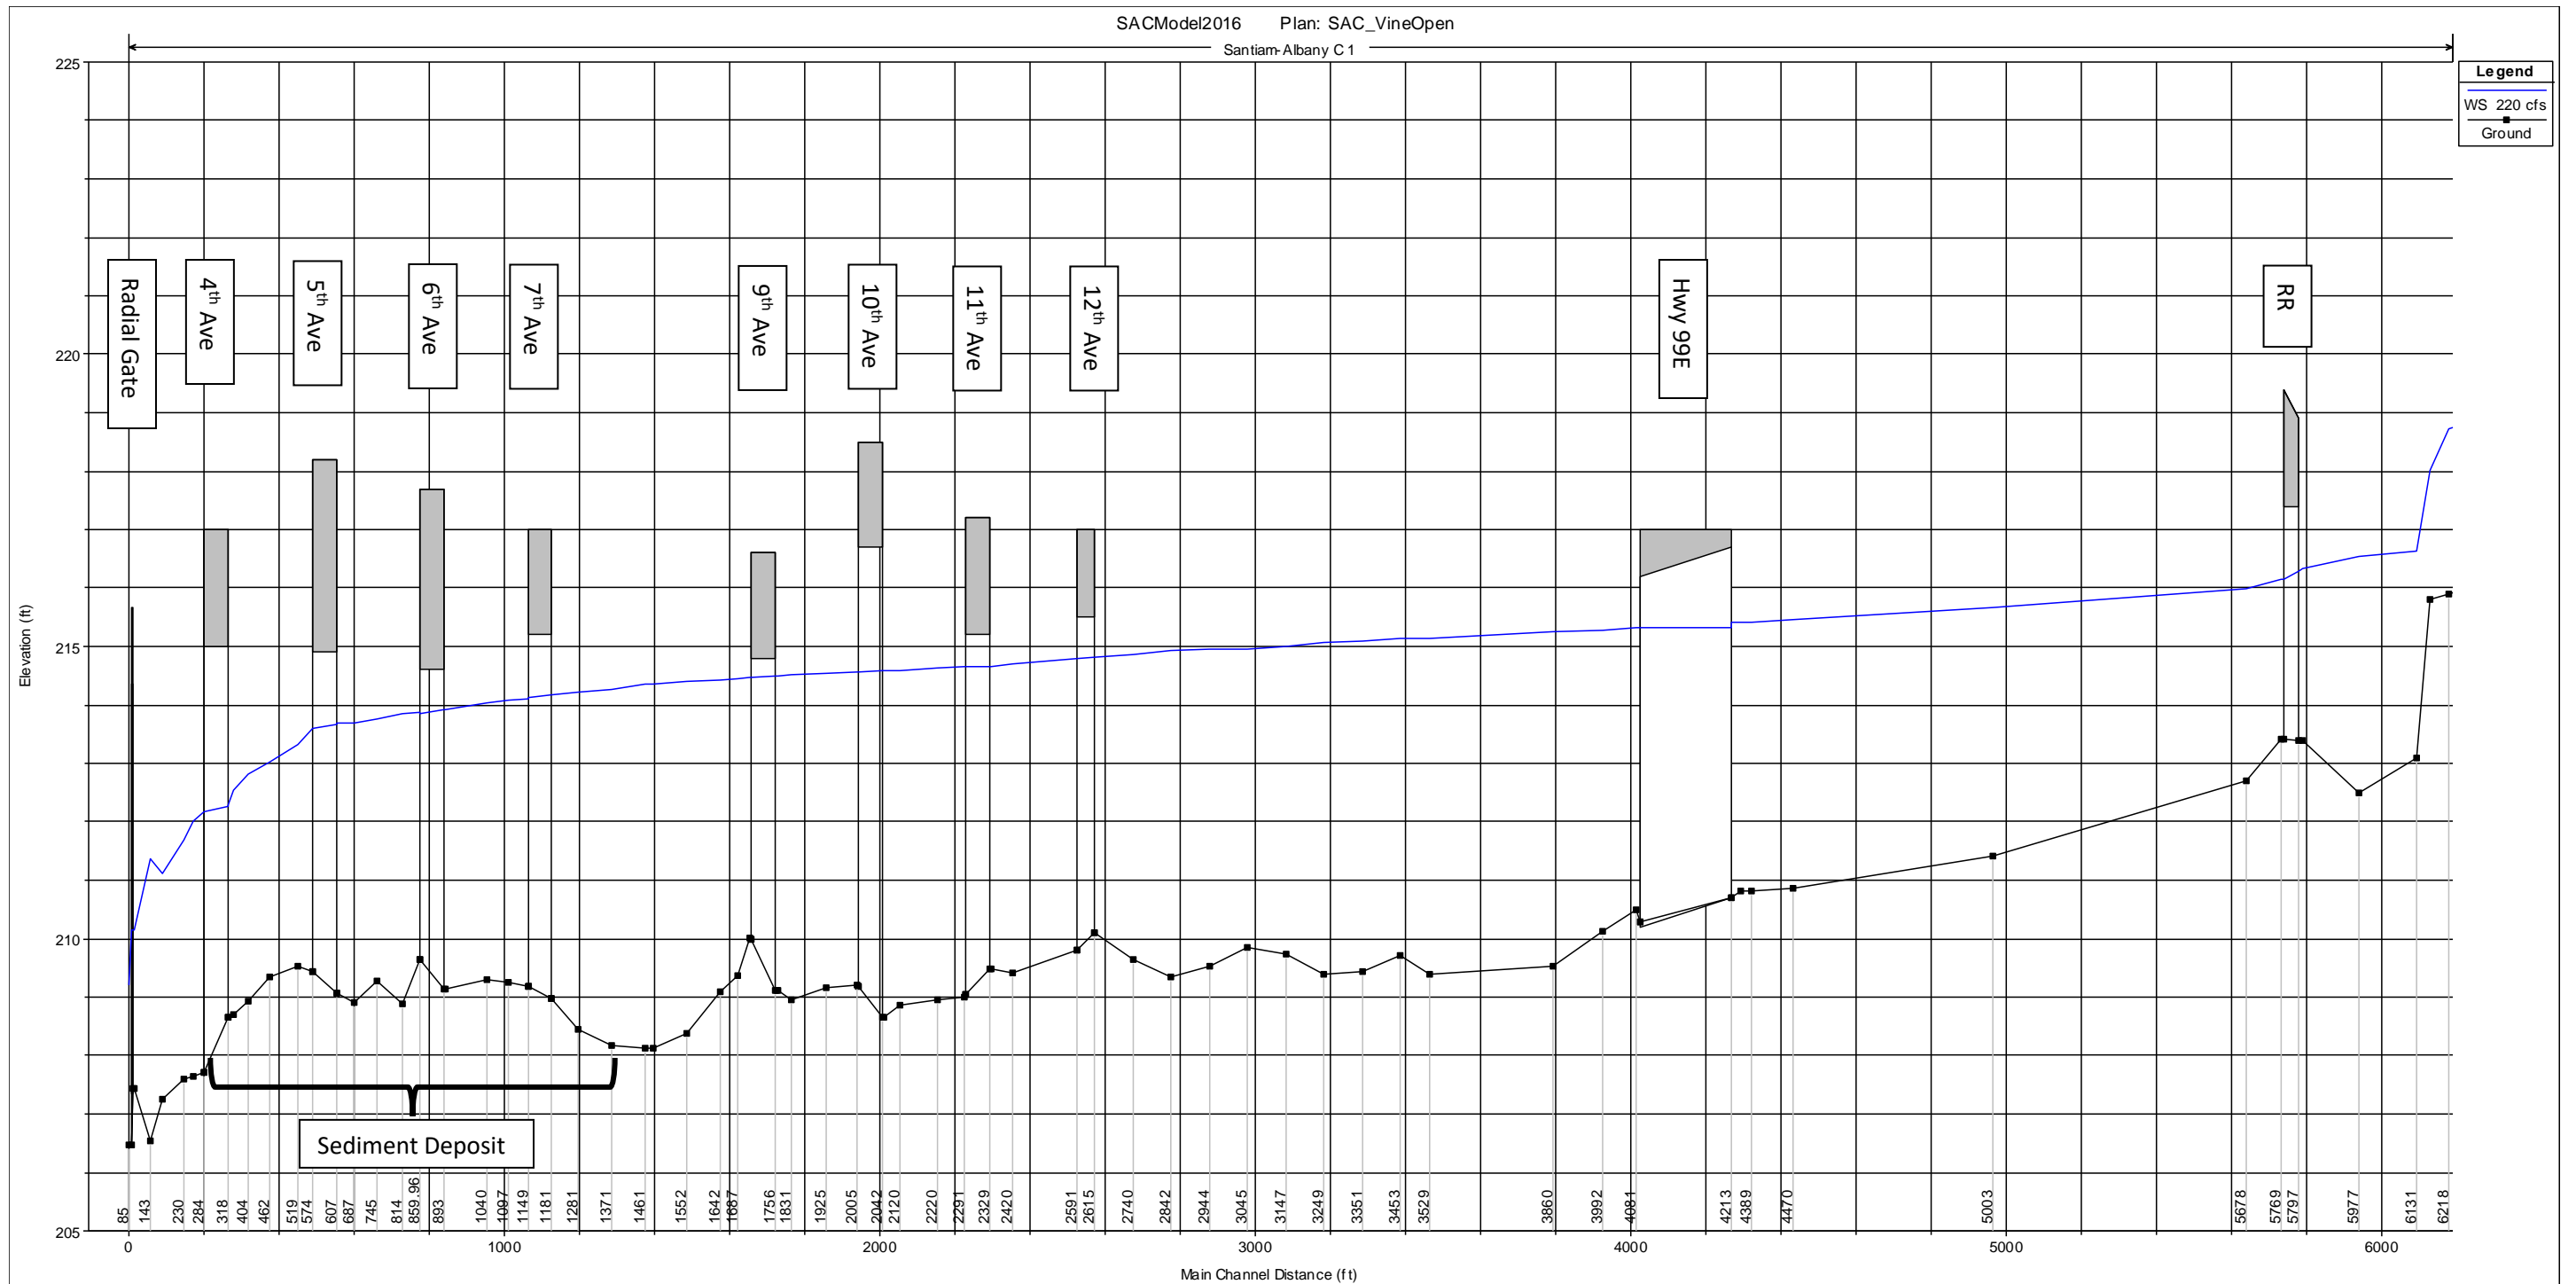
**Figure 6. Canal Thalweg Profile**

The City indicated that sedimentation is a concern in the lower part of Reach 1. Reach 1 begins at the downstream terminus of the canal and extends upstream to RS 3,860, approximately 300 ft downstream of Highway 99E. As seen in Figure 6, sediment deposition appears to be occurring between RS 284 and RS 1,281, with possible additional sedimentation occurring further upstream. A radial gate is located at RS 95, the outflow of which outfalls to the Calapooia River. The radial gate is 7 ft tall by 8.7 ft wide, and has a bottom sill elevation of 207.35 ft. The surface of the upstream sediment deposits extends approximately 2 to 3 ft above the bottom elevation of the gate depending on location. The City would like to understand if the radial gate can be operated in a manner to help flush upstream sediment through the gate and out of the canal, to eliminate or reduce the need for periodic dredging.

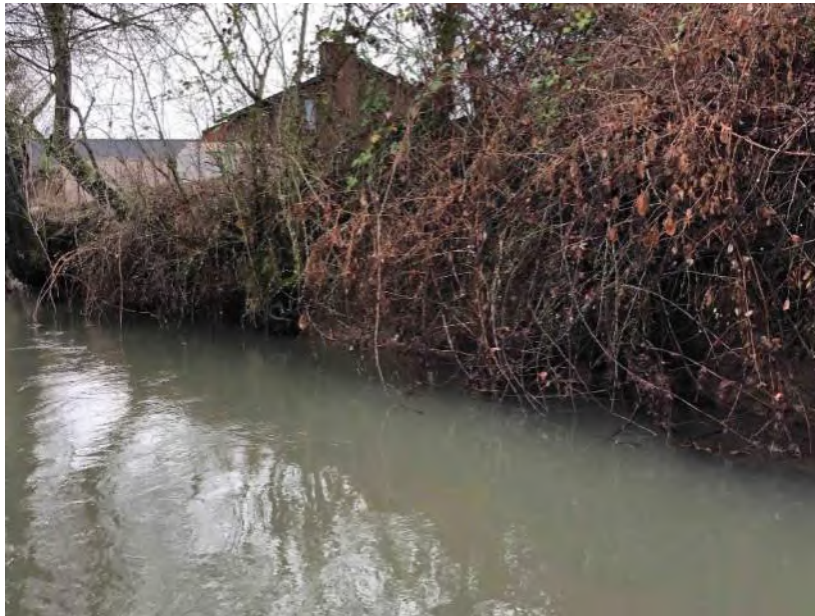
Photo 971: Upstream to downstream left bank panorama

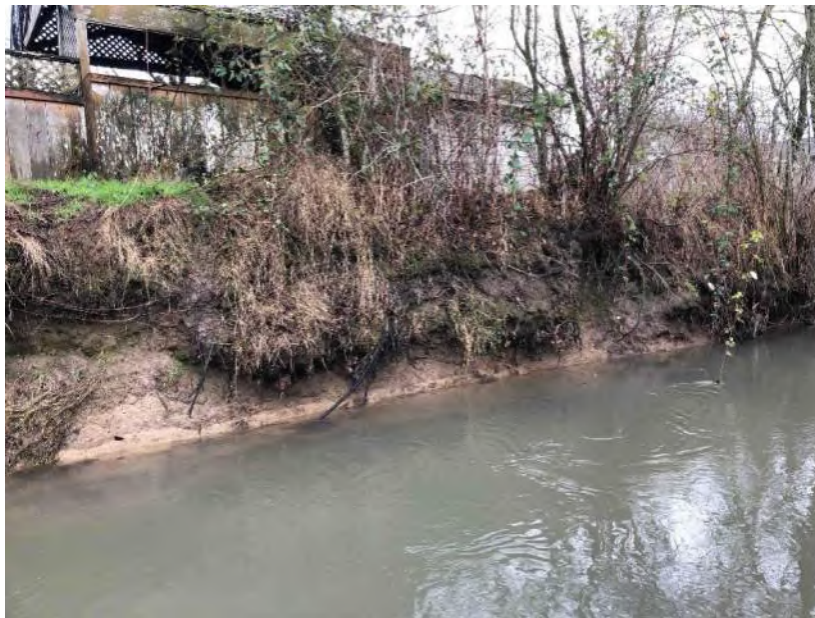
Photo 946: Upstream to downstream panorama of right bank

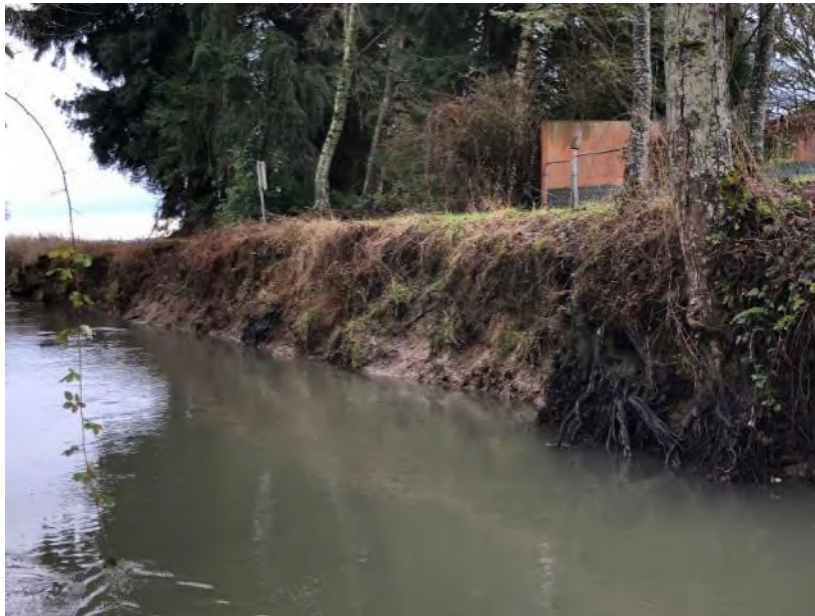
Photo 942: Upstream towards left bank (site plus upstream a ways)

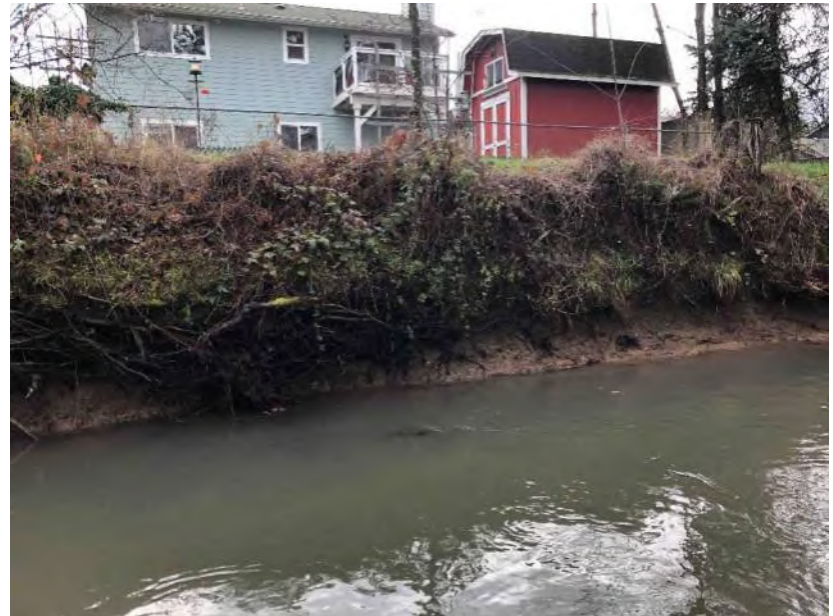
Photo 943: Downstream towards left bank (undercut downstream of site)

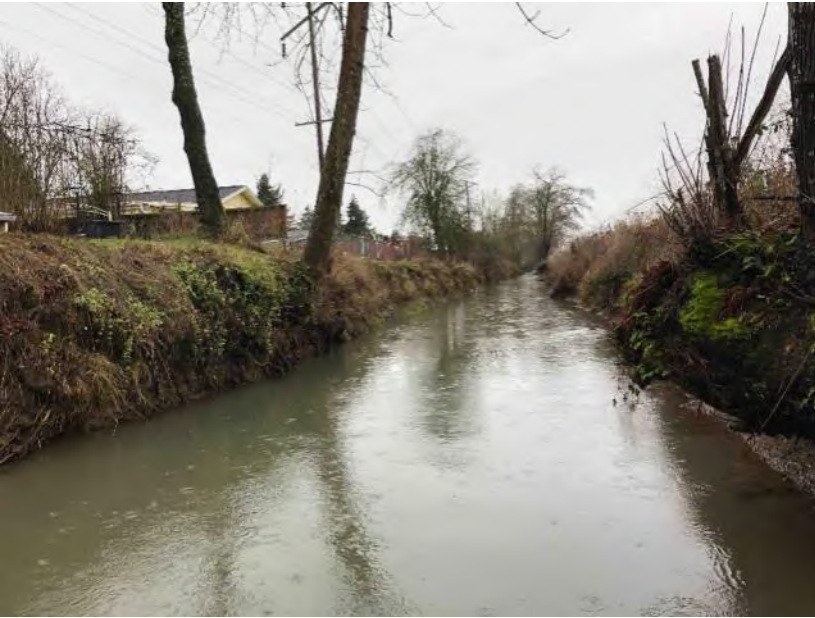
Photo 923: Upstream, see also right bank erosion upstream of tree

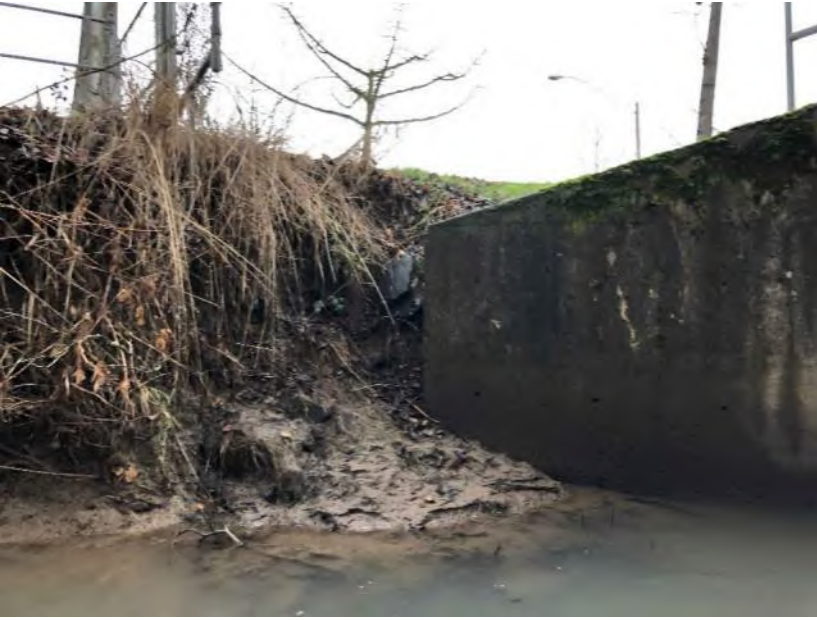
Photo 960: Right bank wingwall erosion

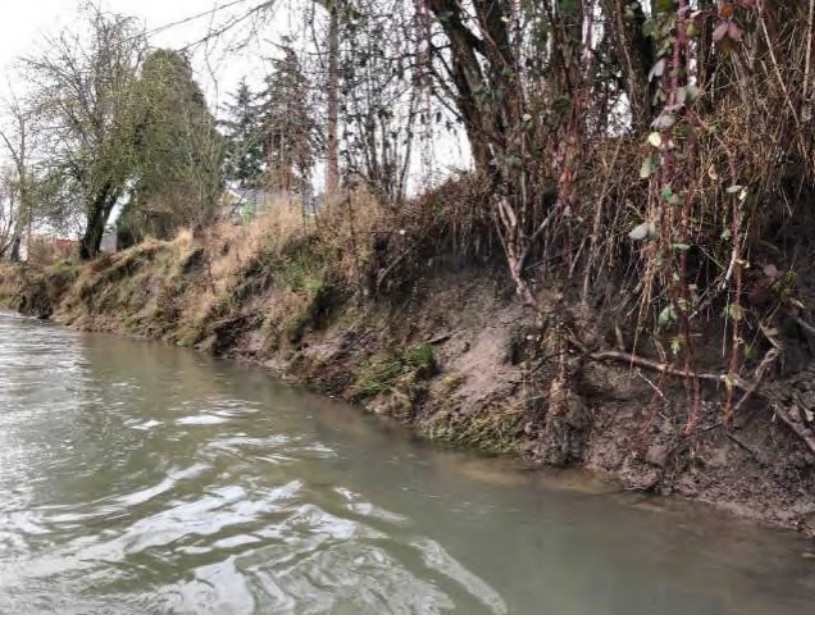
Photo 921: Downstream toward right bank

Photo 921: Downstream towards right bank

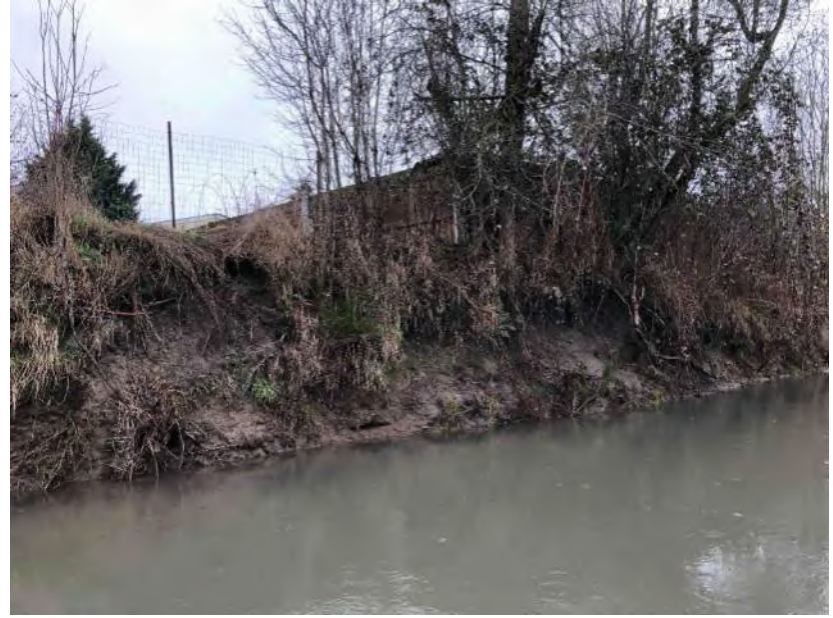
Photo 922: Right bank Upstream of photo 921

Photo 922: Right bank upstream of photo 921

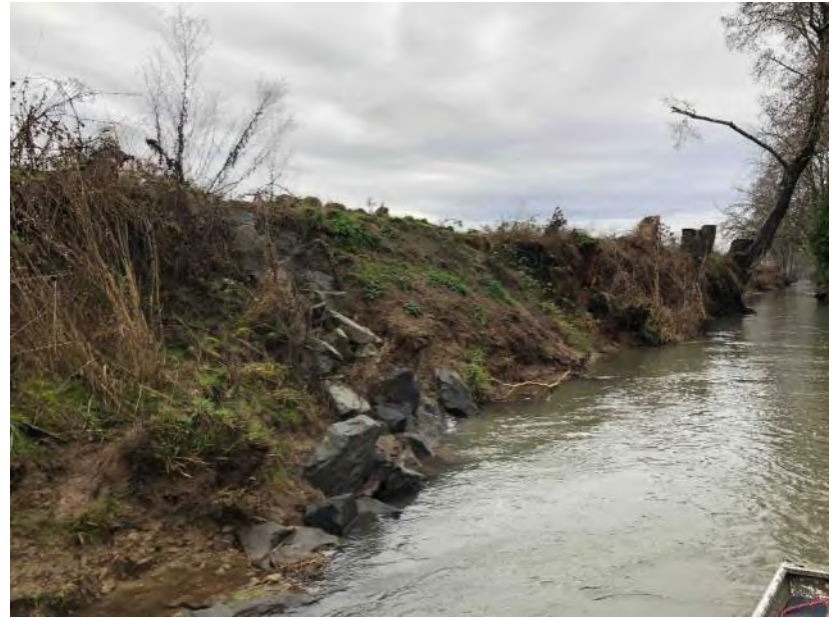
Photo 893: Downstream toward left bank, note riprap protecting small outfall

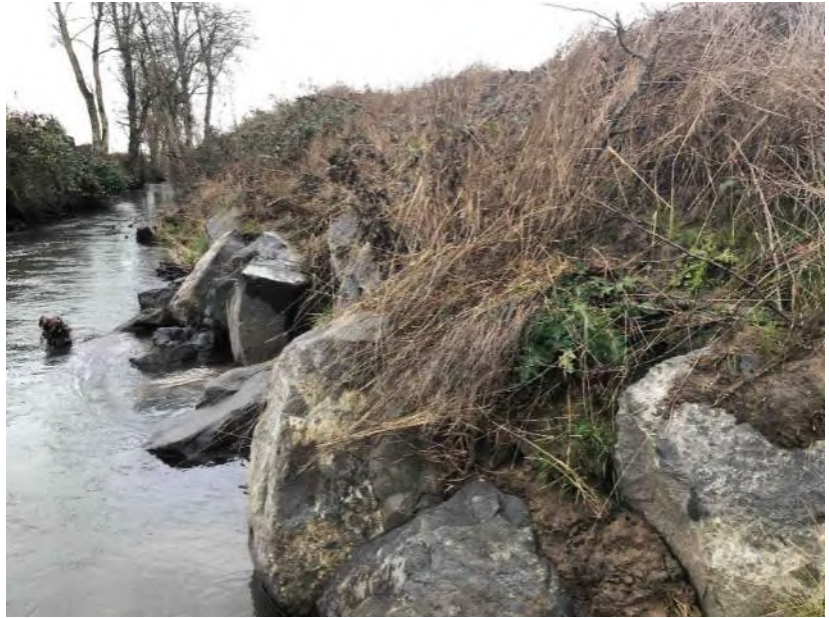
Photo 786: Right bank

Photo 786: Upstream towards right bank

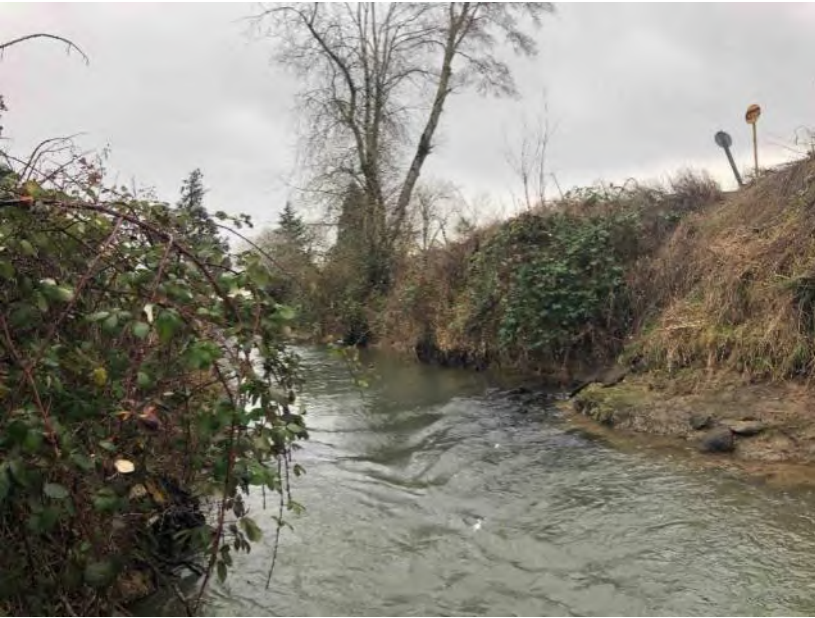
Photo 787: Right bank with Riprap

Photo 787: Downstream towards right bank

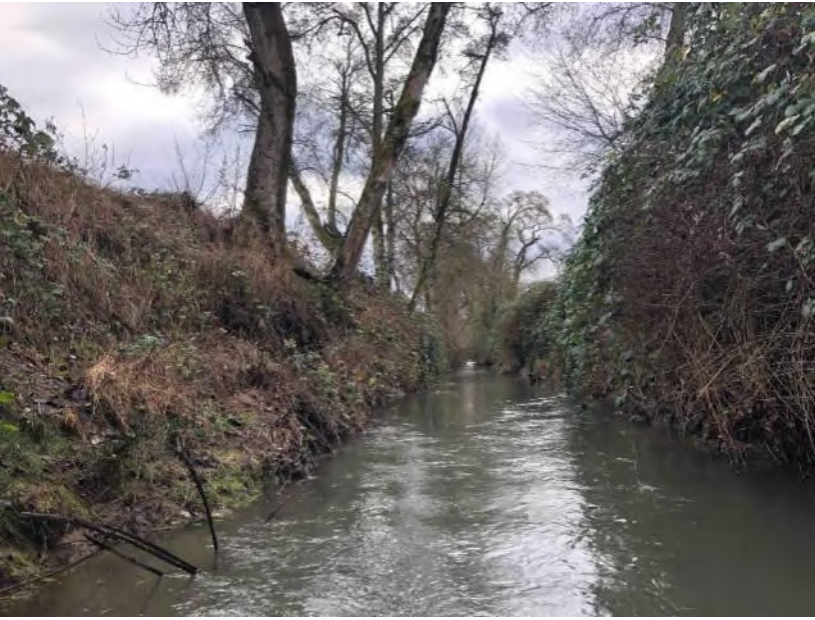
Photo 735: Right bank

wp637	26325	Rural	Agricultural	LB	48	15	Unknown	Condition unknown due to brush. However, there is a new failure directly opposite (WP 8, see photo 735)
wp633	26519	Rural	Agricultural	RB	50	14	Same	Stumps gone, water deeper this visit
wp616	27064	Rural	Agricultural	RB	Unknown	13	Unknown	Observation from top of bank. Condition unknown due to brush. Possibly steeper though
wp614	27166	Rural	Agricultural	RB	50	14	Worse	Observation from top of right bank. Toe material appears gone, now steeper, but protected by brush and trees
wp613	27233	Rural	Agricultural	LB	17	14	Unknown	Observation from top of right bank. Condition unknown due to brush. Possibly steeper though. Old rootwad and stump appear gone
wp610	27394	Rural	Agricultural	RB	70	14	Worse	Observation from top of right bank. Now 60-70' and steeper
wp579	29308	Rural	Agricultural	LB	26	13	Worse	Less trees and brush
wp577	29377	Rural	Agricultural	LB	40	13	Worse	Rootwad gone, bank close to vertical now

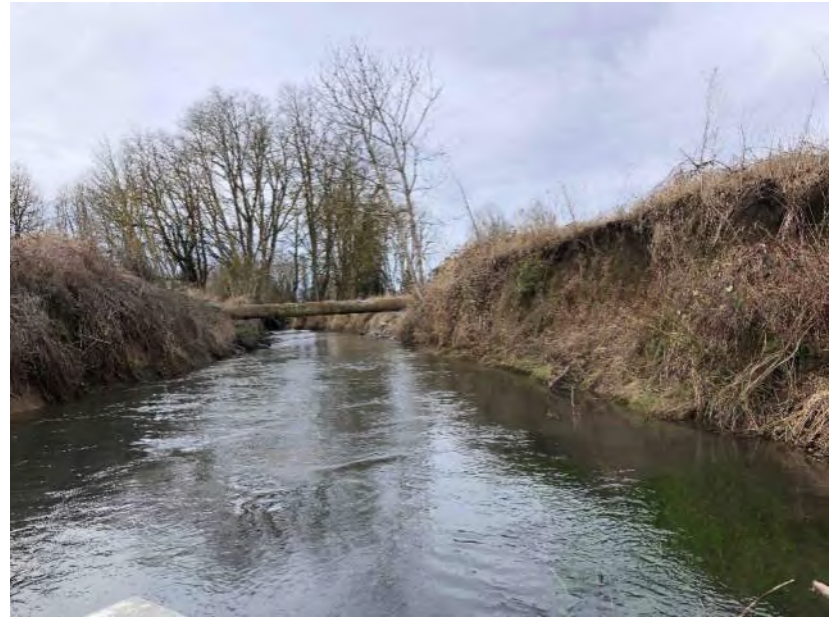
Photo 615: Upstream

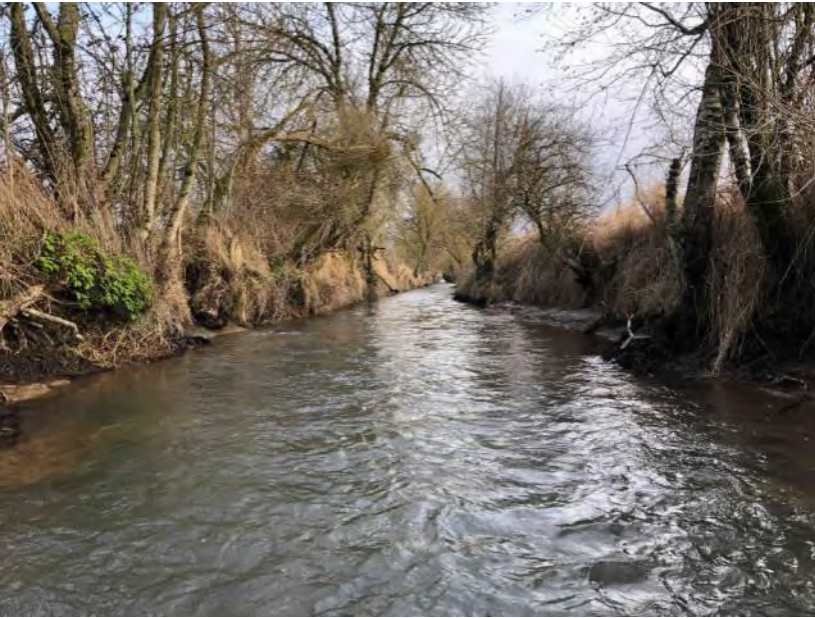
Photo 3058: Left bank

Photo 3057: Left bank failure

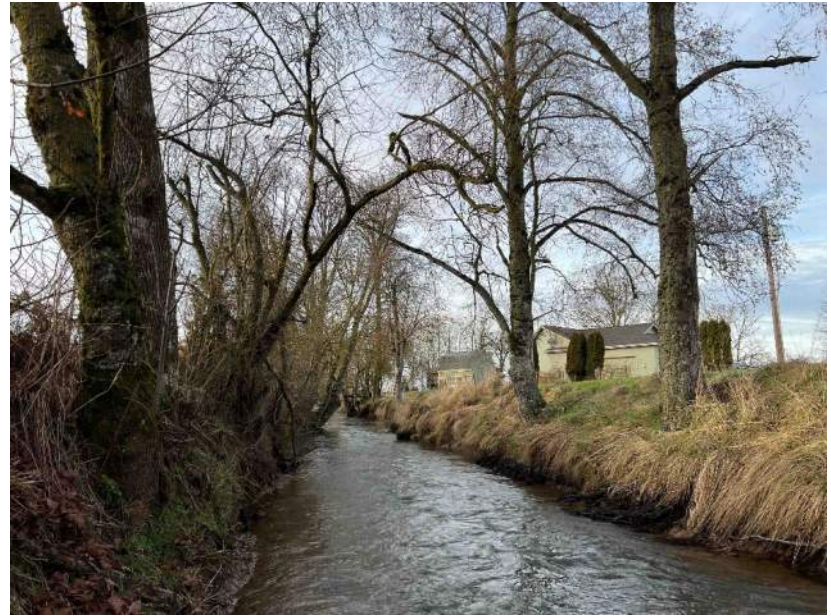
Photo 2970: Upstream
