Appendix F

Cheadle Lake Berm TM

Date: October 23, 2023
To: Mel Damewood, III, P.E., Principal Engineer I
West Yost Associates
From: David L. Running, P.E., G.E.
Senior Geotechnical Engineer
Subject: Cheadle Lake Berm Geotechnical Consultation
Project: Albany Water Master Plan
Project No.: 2221130

DATE: March 22, 2024
TO: Ryan Beathe, PE, City of Albany
CC: Ian Jaffe, Brown and Caldwell, PE 99388
FROM: Alan Peck, Brown and Caldwell, PE 16289
and Jon Harper, Brown and Caldwell, PE 70738
REVIEWED BY: Mel Damewood, West Yost, PE 13672
SUBJECT: Condition Assessments - Santiam Albany Canal
Ancillary Facilities

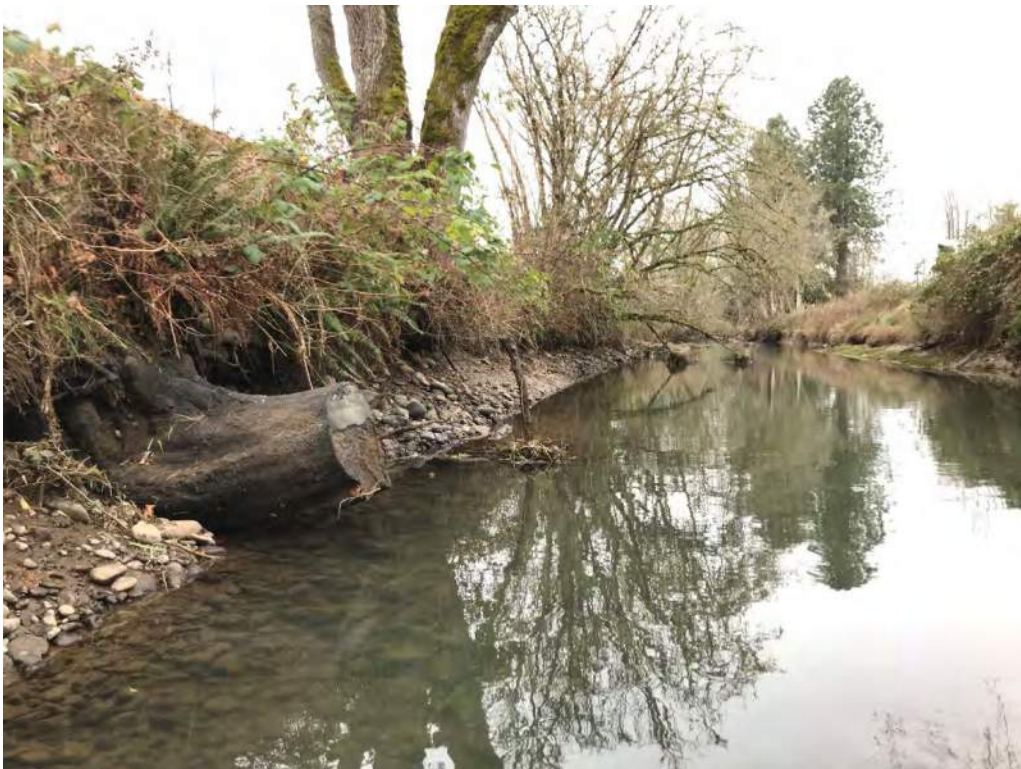
Photo 6. Stump of cut down tree facing west.

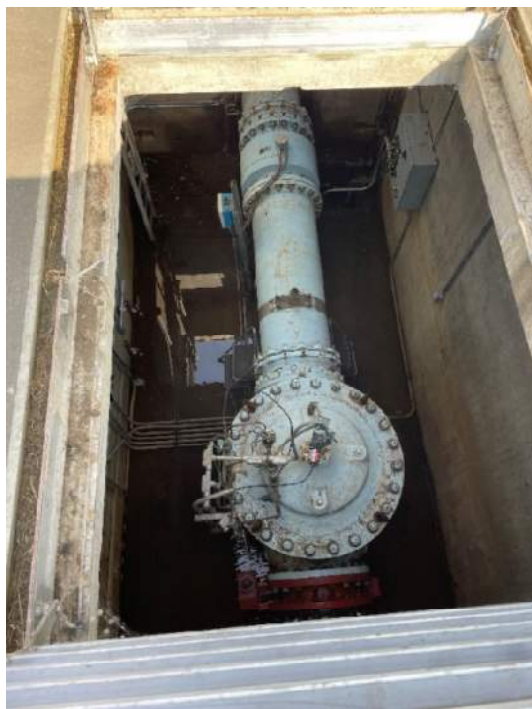
Photo 4-2-11
A&M WTP – Albany Meter Vault – Standing Water

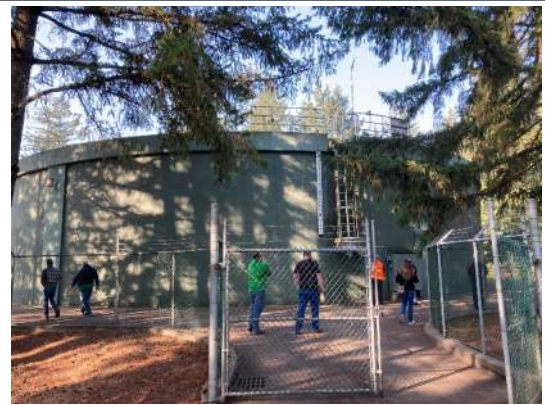
Photo 4-3-22
Wildwood Reservoir

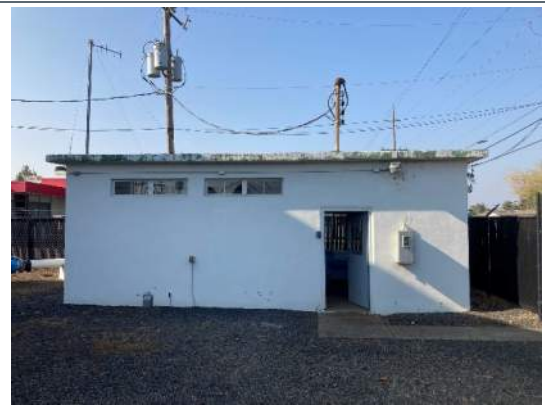
Photo 4-3-26
Queen & Hill Pump Station

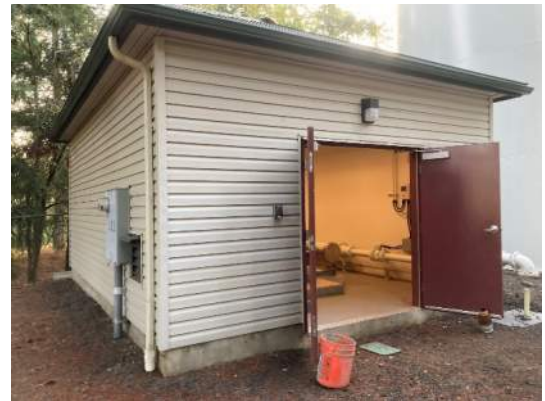
Photo 4-3-28
Valley View Pump Station

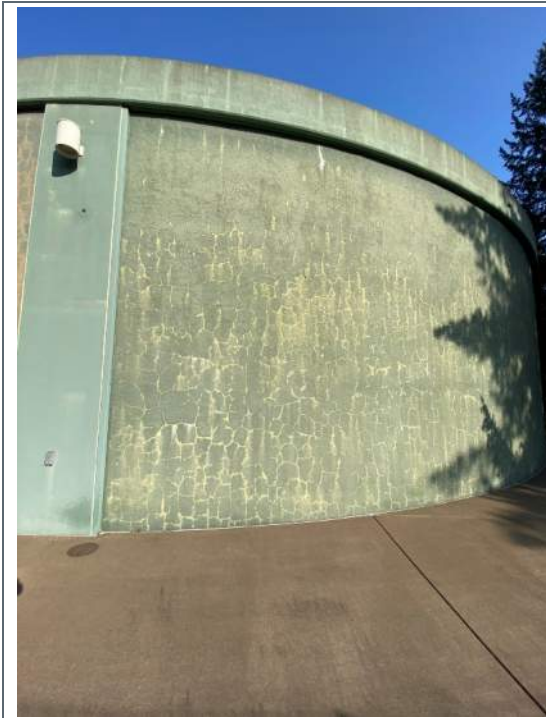
Photo 4-3-35
Wildwood Reservoir

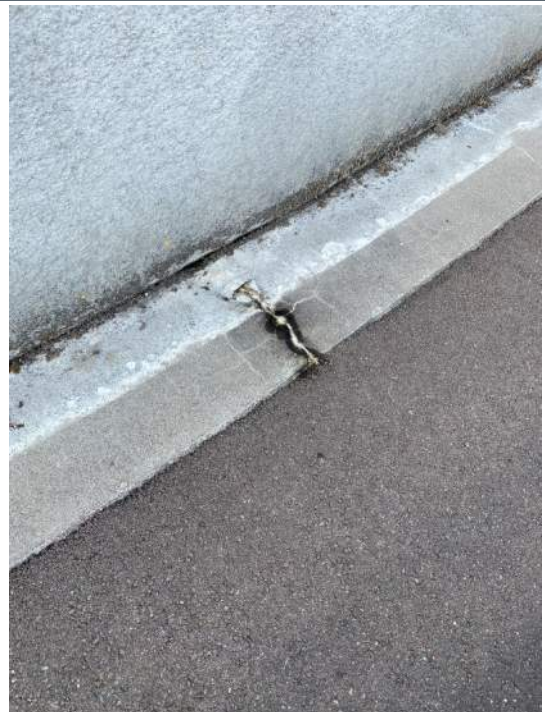
Photo 4-3-38
WPT2 (A&M) Reservoir

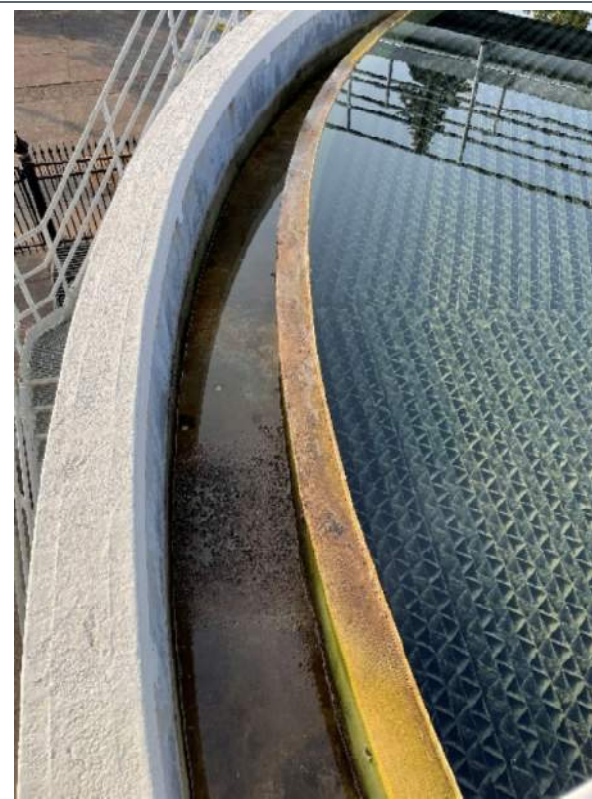
Photo 4-4-12
Vine St – Accelerator Launder

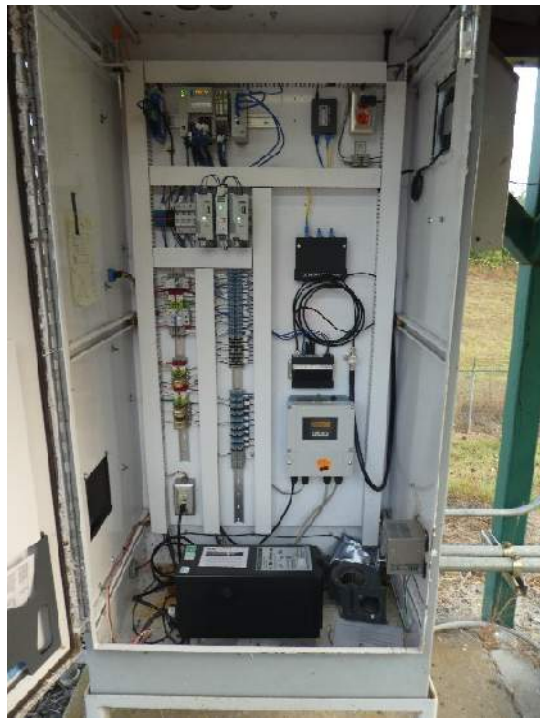
Photo 4-5-2
Broadway - Telemetry Panel

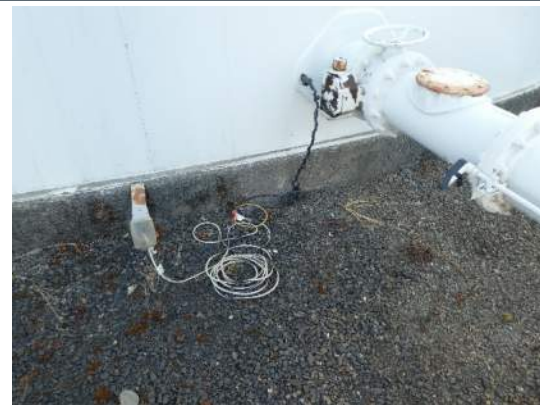
Photo 4-5-4
Queen Ave – Level Sensor Pilot Line

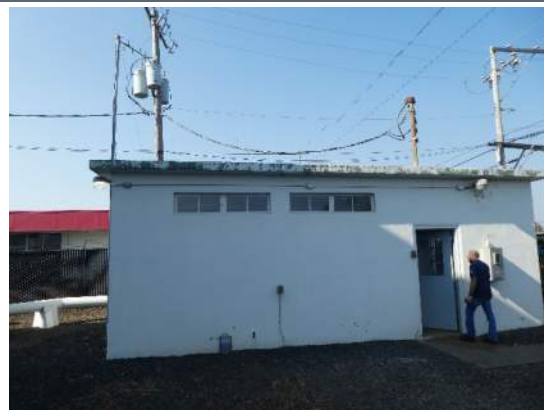
Photo 4-5-7
Queen Ave – Utility Service

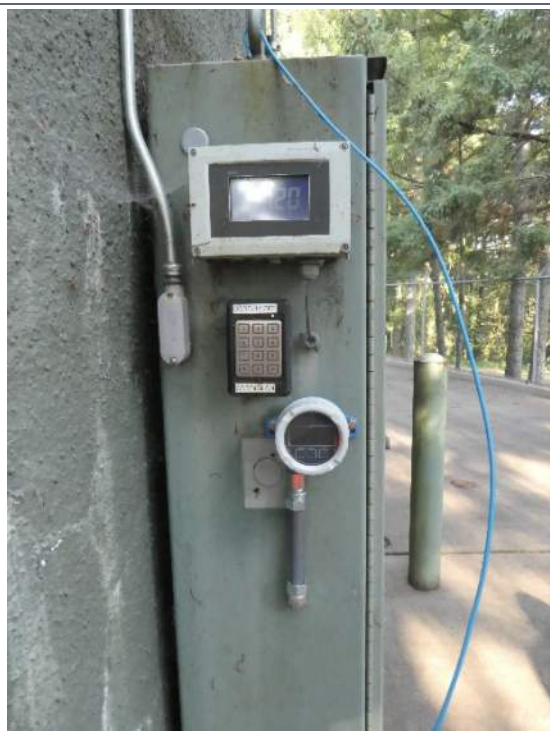
Photo 4-5-10
Wildwood – Level Sensor Transmitter

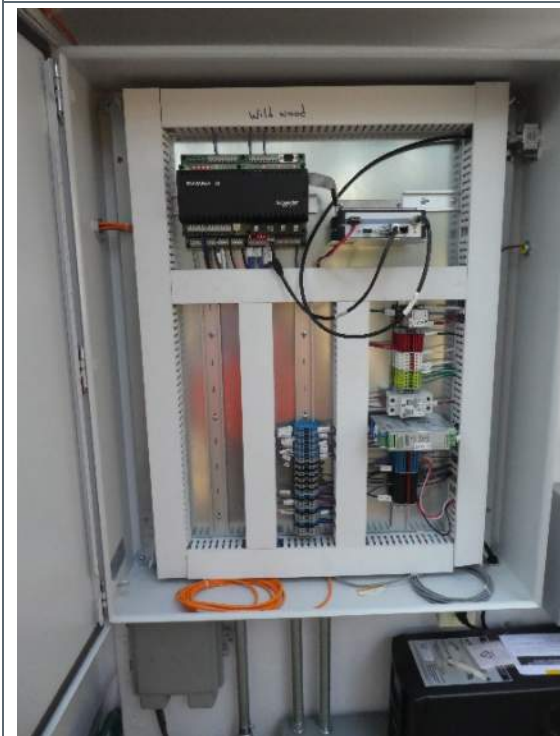
Photo 4-5-11
Wildwood – SCADAPack 32

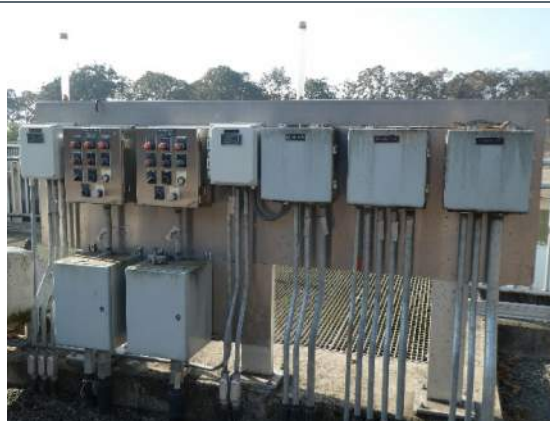
Photo 4-5-12
WTP(A&M) – Supernatant Wetwell Level Transmitters

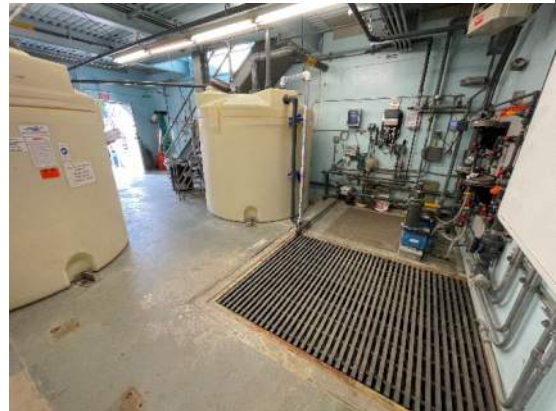
Photo 4-6-6
Vine St - Chemical Room – Add tank anchorage and MSDS

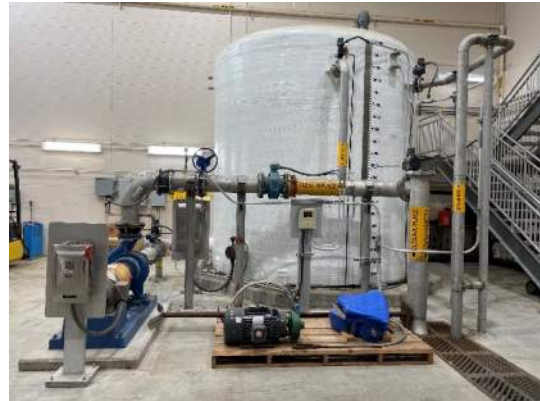
Photo 4-6-8
A&M WTP – CIP Tank
